Oref : 19002/BR(en0713xr)

PRE-PURCHASE CONDITION SURVEY REPORT

S/Y ENJOY

At Aghios Nikolaos Jul/19

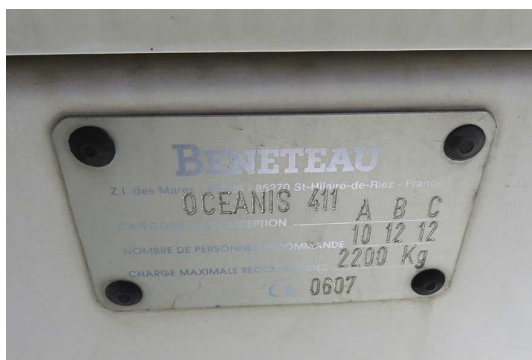
CE Plate

The yacht is CE marked for Category A Ocean with 10 persons on board. The HIN number was not found on the yacht. The hull number is marked as 0584. This is in agreement with the HIN number of the documentation FR-BEY76584L001 which indicates a 2001 model built in 12/2000.

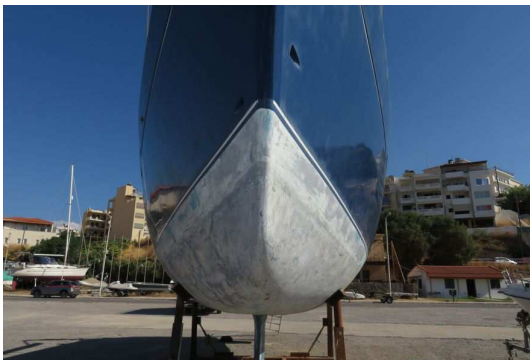
No damages at bow

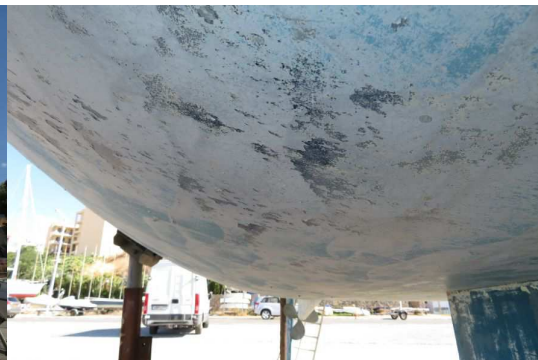
The hull below waterline surfaces were fair. There were no osmosis blisters. Hammer sounding did not find any delamination or void. The antifouling was scraped and a blue pigmented gelcoat was found which was suitably hard, the antifouling layers were few.

Hull surfaces fair

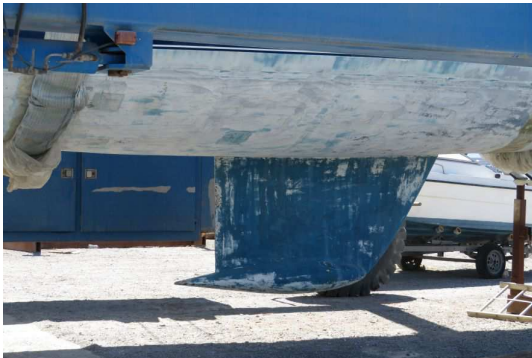
No spacing when lifting the yacht

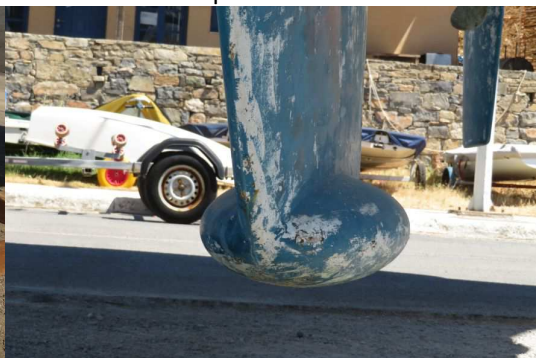
No damages at leading edge

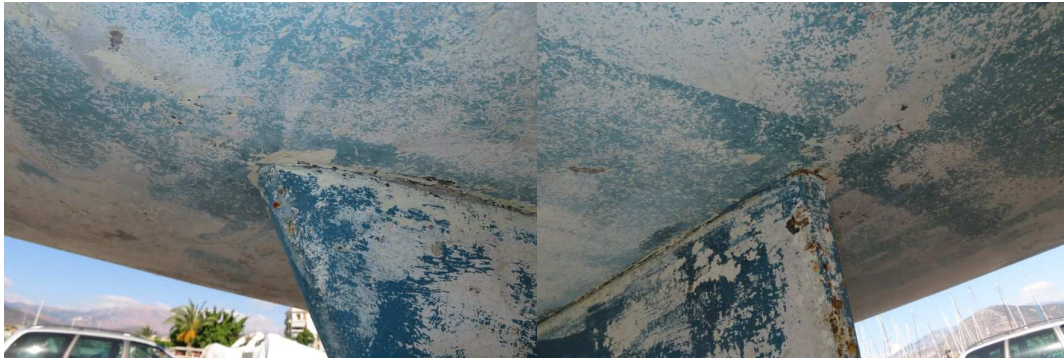
No cracks or deflection to hull
around hull to keel join

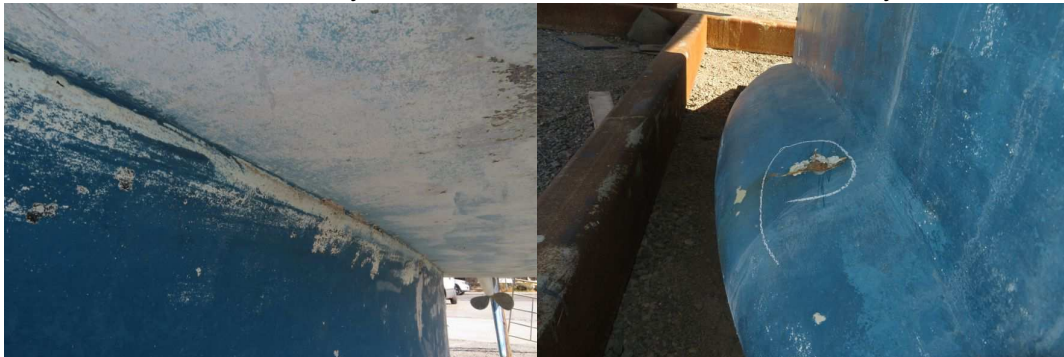
Iron keel bolted to the hull. The keel was without wastage but has small chips of the coating that require filler and priming. The hull to keel join was without spacing when lifting the yacht. The keel was square to the hull. There were no damages to the leading or trailing edges. The hull around the hull to keel join was without cracks or deflection.

Hull to keel join was tight

Minor areas of broken filler and coating

Suggestion : Keel has small chips of the coating that require filler and priming.

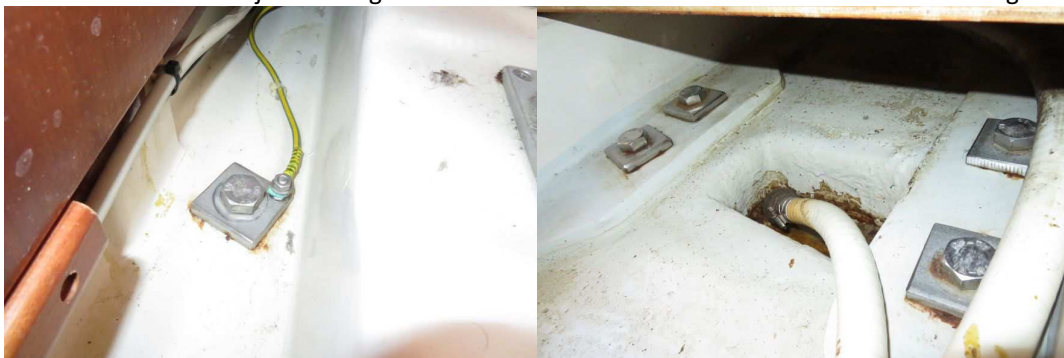
Keel bolt without corrosion

No cracks or separation of liner from hull

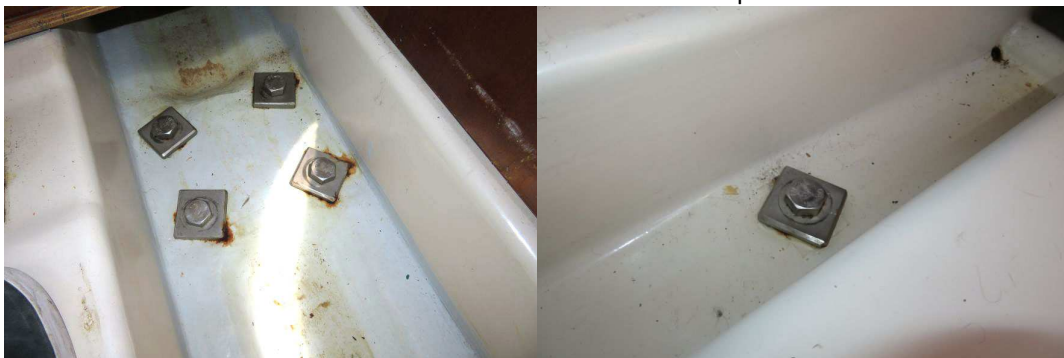
Keel bolts without corrosion

No cracks to liner

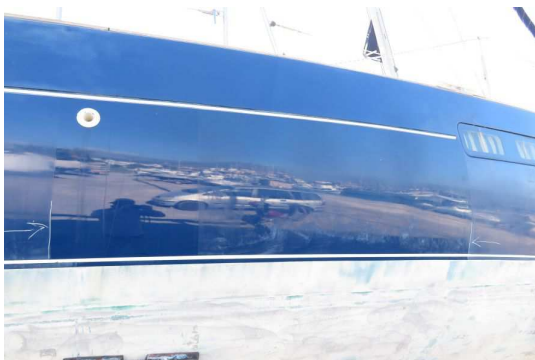
Topsides gelcoat is part painted over 2.0m x 0.60m at starboard side after previous contact with the dock (damage said to be only a scrape). There were no damages seen. The stern requires a small gelcoat repair.

Topsides part painted

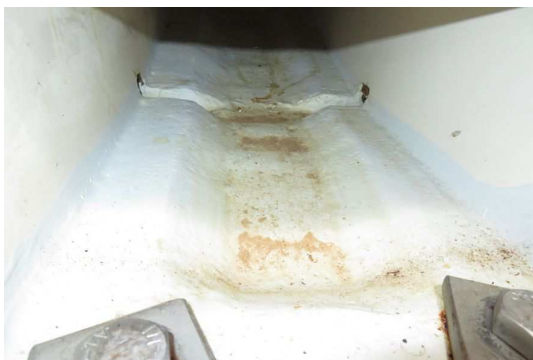
Bilge structures intact

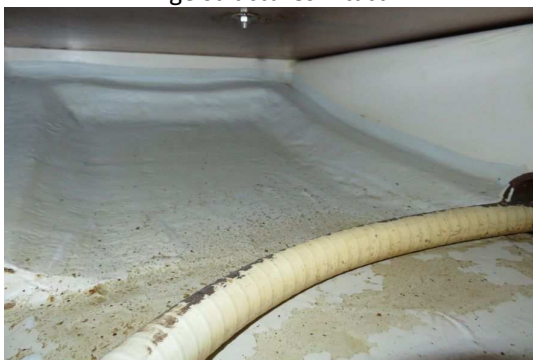
No separation of liner and hull

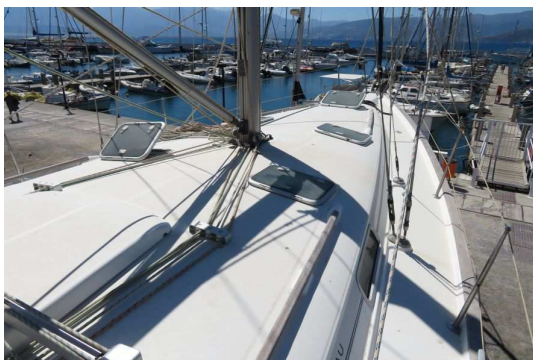
Deck

The deck was sound underfoot without cracking sounds or deflection. There was not any significant crazing. Hammer sounding did not find any delamination or void.

The wooden caprail is cracked/split at both stern cleats. At the interior side there are fiberglass repairs.

Suggestion : The wooden caprail is cracked at both stern cleats. The cracked section could be replaced for cosmetic improvement.

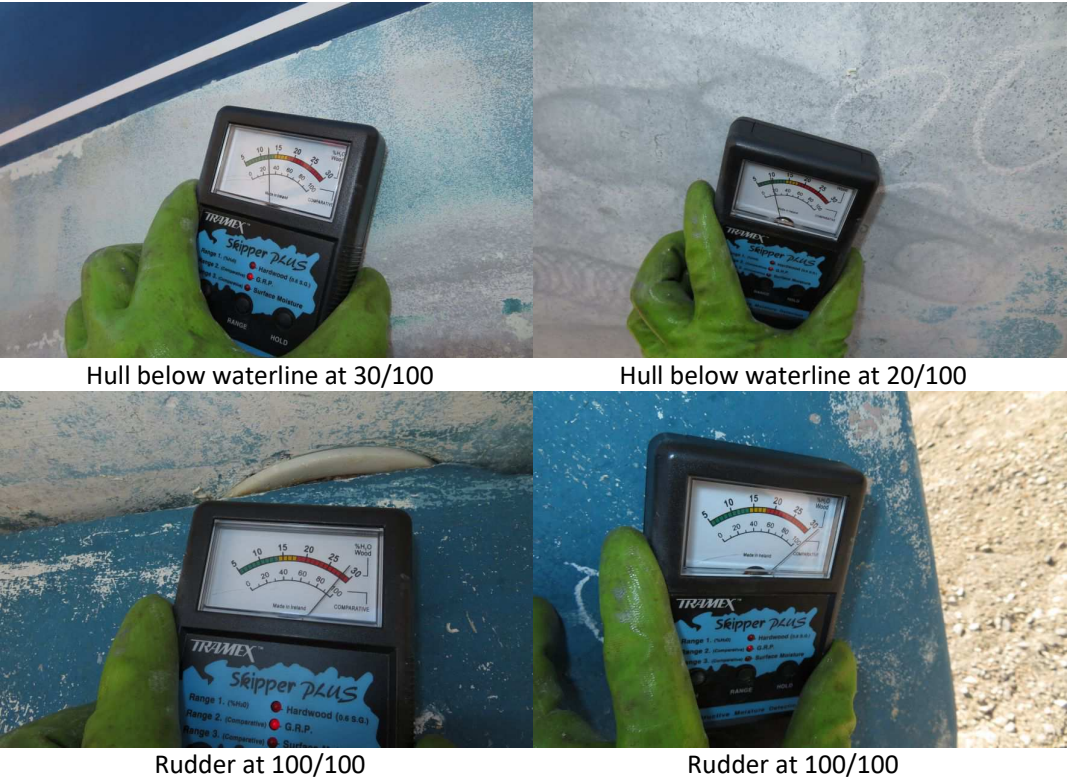
Hull and topsides were low moisture. Rudder was with high moisture which is typical and can be left.

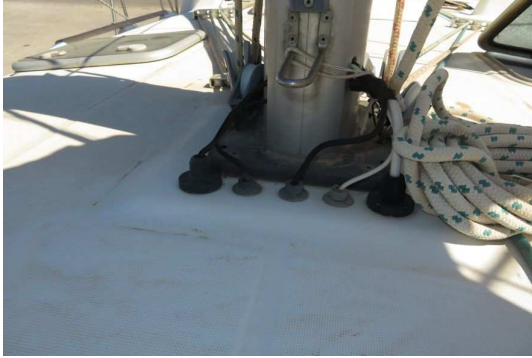
No compression or cracks at mast deck step

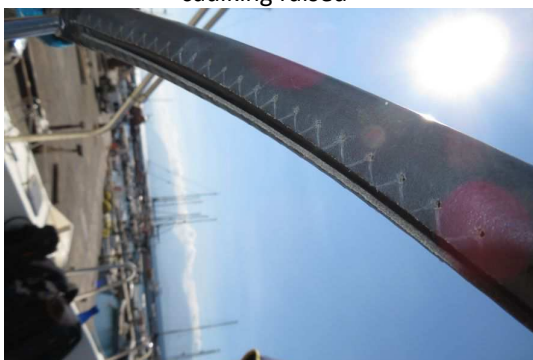
Helm wheel stitching missing

Suggestion : Helm wheel leatherette cover requires restitching.

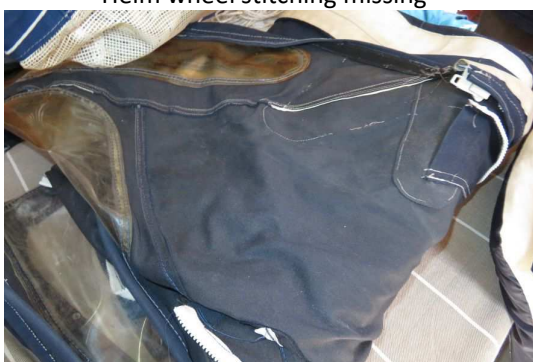
Sprayhood requires restitching. Previous stitching repairs were done with poor thread.

Sprayhood stitching repairs failed

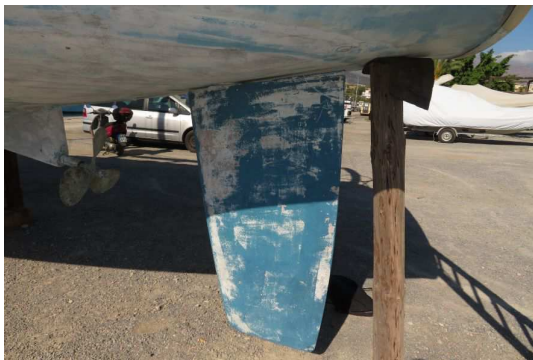
Rudder generally intact

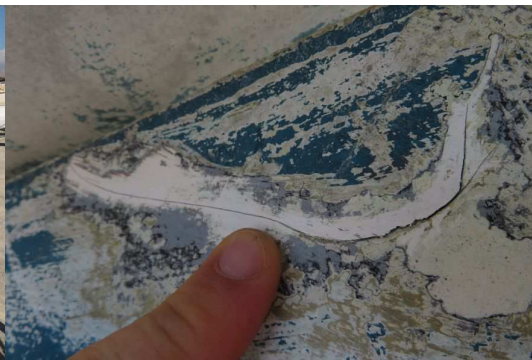
Port aft upper corner of rudder is with a crack to the gelcoat that requires gelcoat repairs. As there is no delamination detected it is cosmetic.

Gelcoat crack to rudder

Suggestion : Port aft upper corner of rudder is with a crack to the gelcoat that requires gelcoat repairs. As there is no delamination detected it is cosmetic.

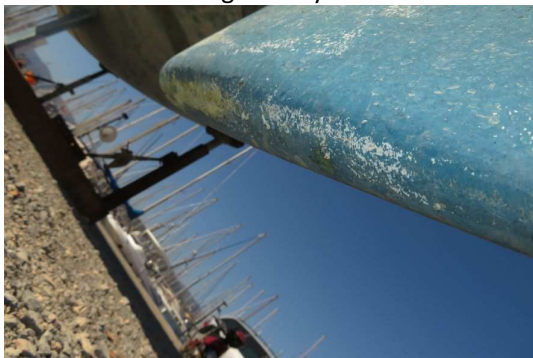
Underside without grounding damages

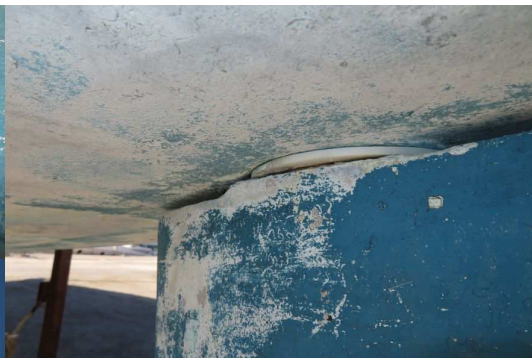
No cracks near rudder post

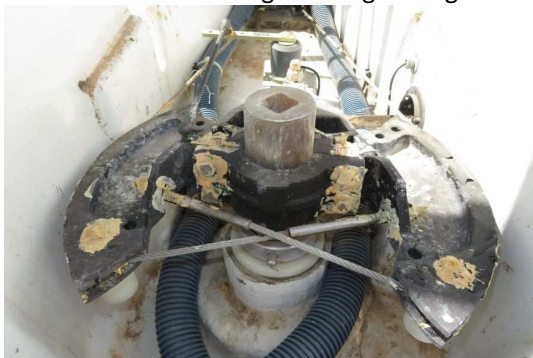
Steering gear without corrosion

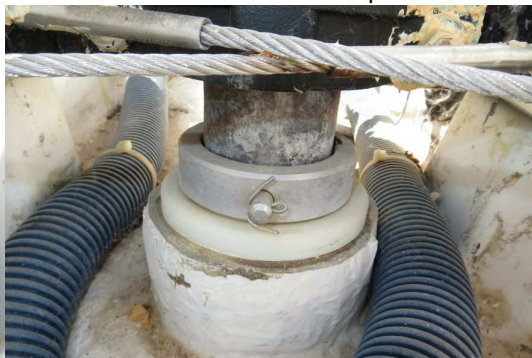
Rudder tube top without crack

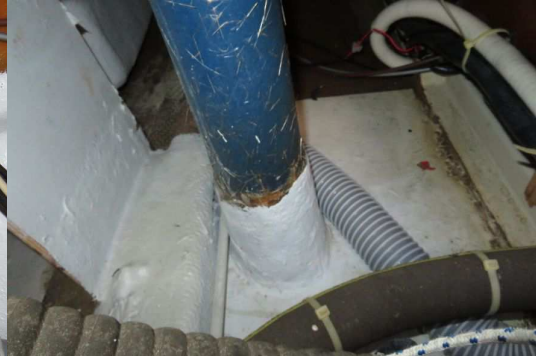
Rudder tube secure

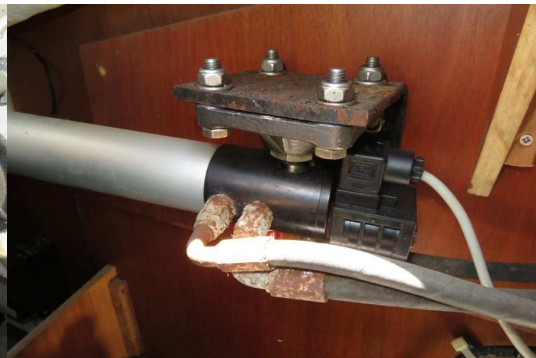
Hydraulic autopilot. Hydraulic power pack and cylinder without leaks. Connections at cylinder with typical minor corrosion. Autopilot was checked working on sea trial.

Connections at cylinder corroded

Suggestion : Hydraulic connections at autopilot cylinder require cleaning up from corrosion and painting.

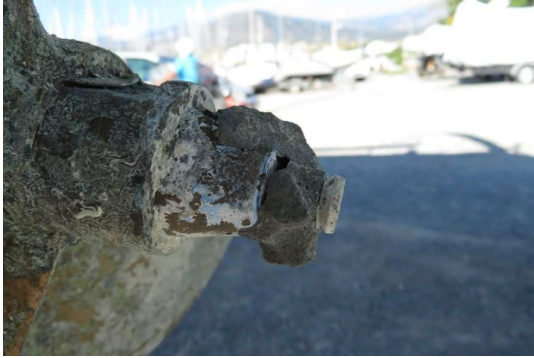
Propeller nut anode fully wasted

Suggestion : Propeller anode requires replacement.

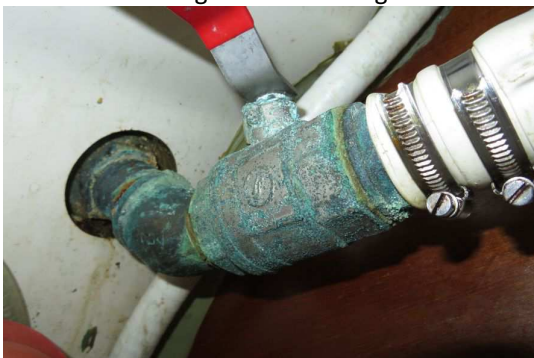
Valve without corrosion

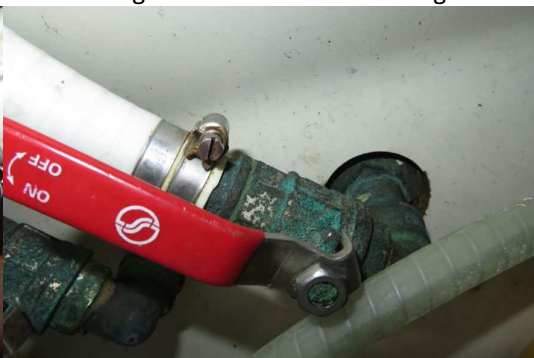
Hoses double clipped

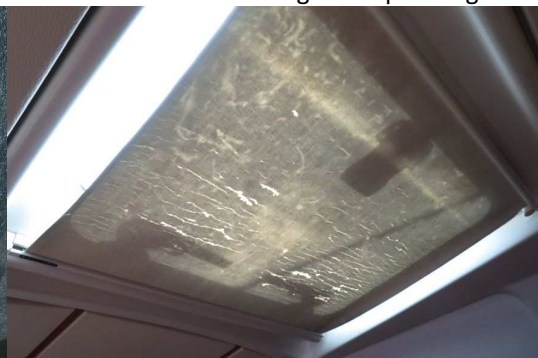
Sunshades were deteriorated.

Sunshades deteriorated

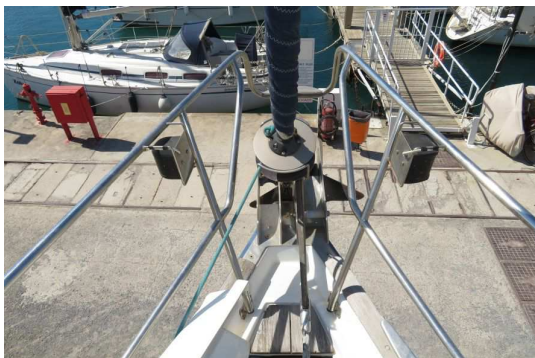
Pulpit without damages

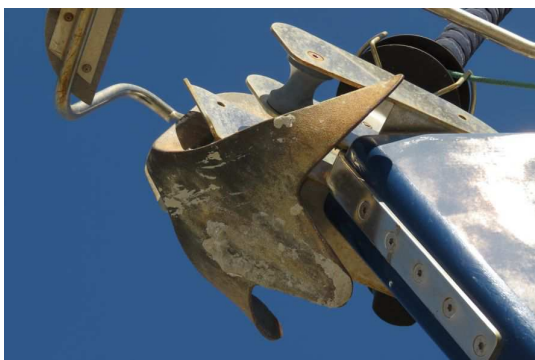
Main anchor without wastage

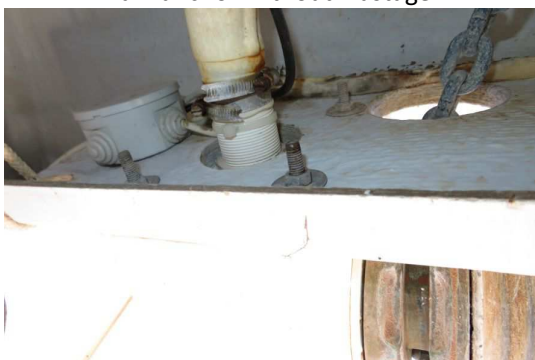
Anchor windlass bolts without corrosion

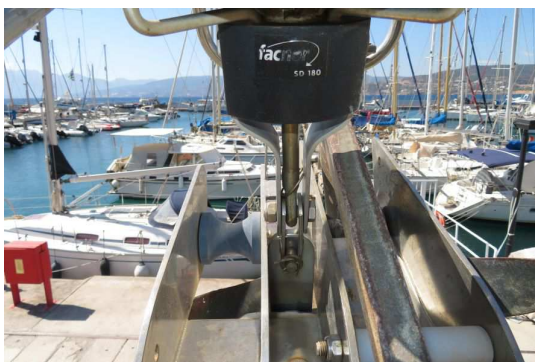
Furler fork not twisted

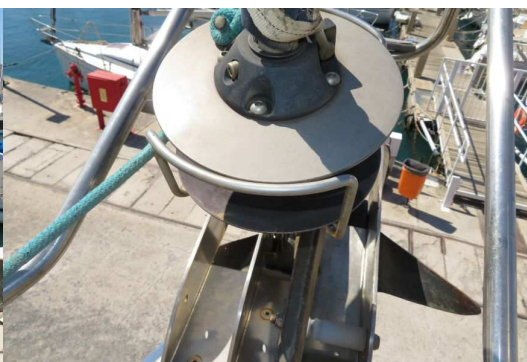
Drum without damages

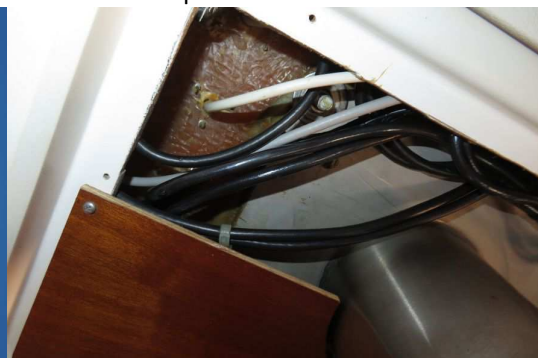
No cracks to deck at mast step

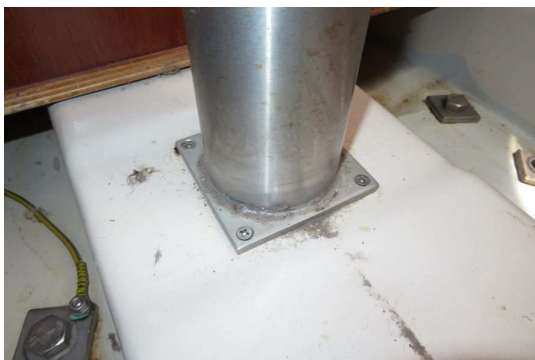
No damages at compression post step

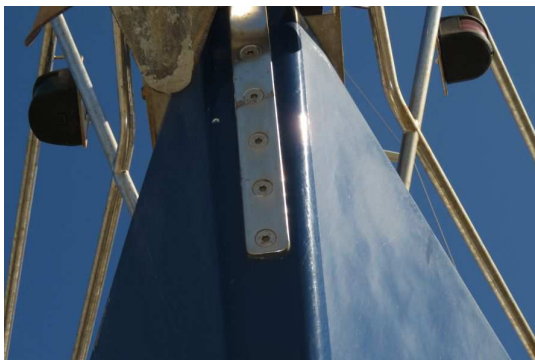
Stemhead bolts without corrosion

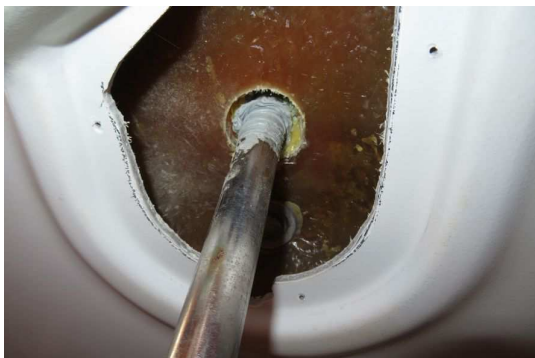
No cracks below shroud deck plates

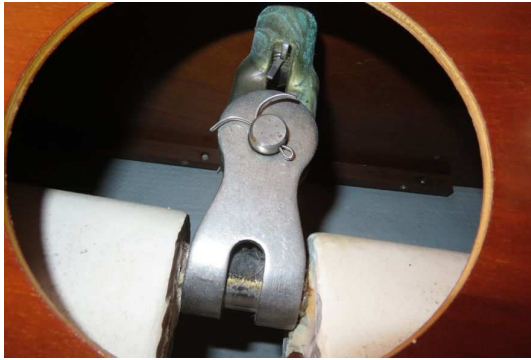
No damages at shroud tie rod attachments

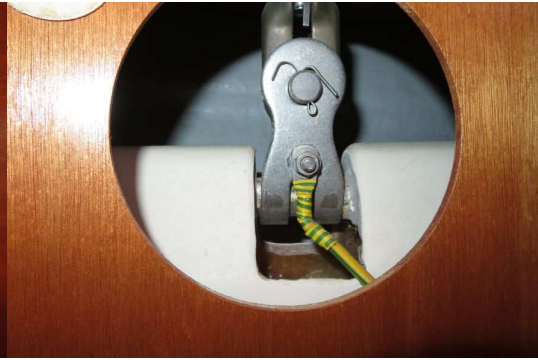
No damages at shroud tie rod attachments

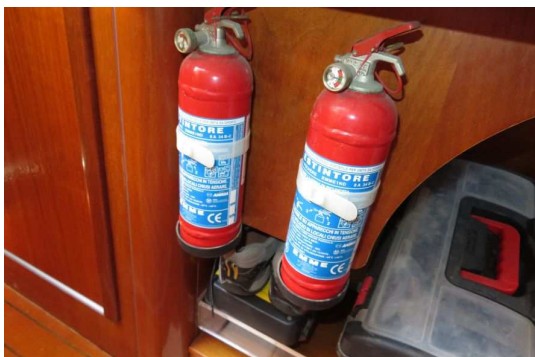
Portable dry powder extinguishers which require servicing or replacement.

Fire extinguishers without corrosion

Recommendation : Fire extinguishers require servicing or replacement.

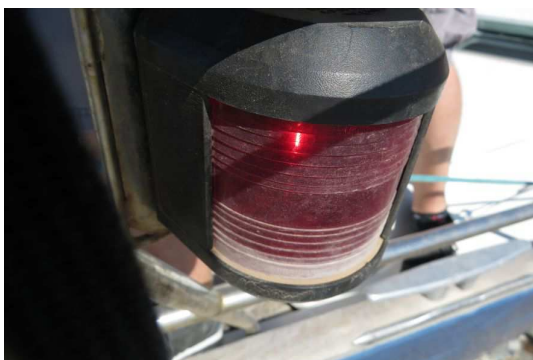
Side lights working

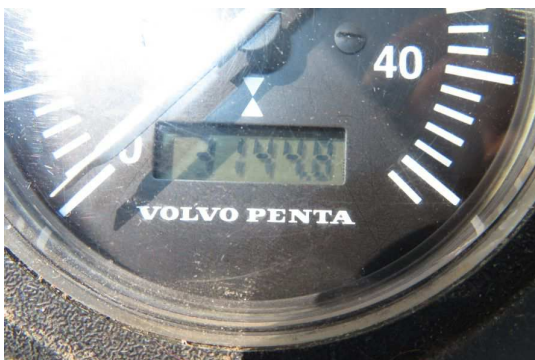
Engine hours 3144

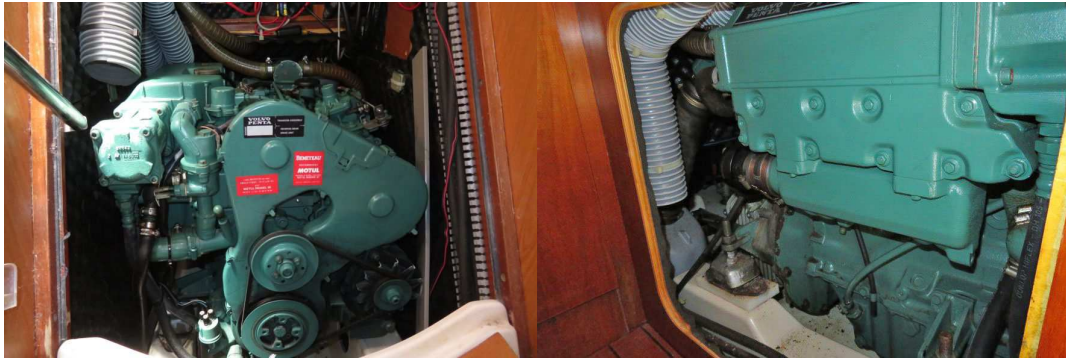
Engine with coatings intact

No leaks of oil

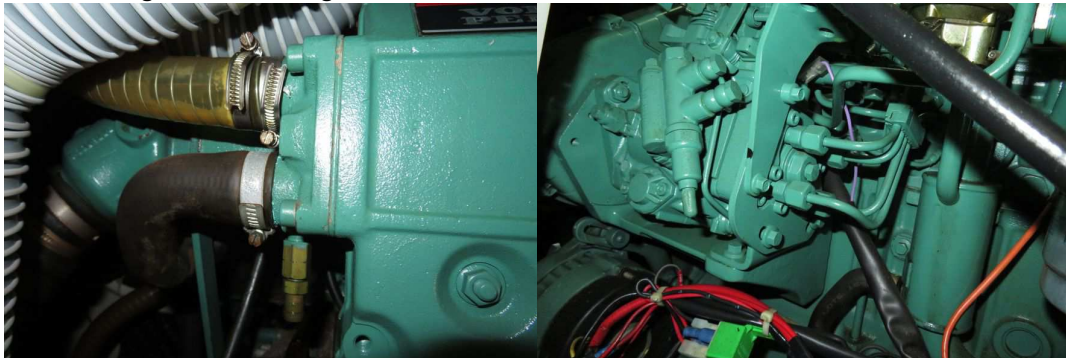
Heat exchanger ends without leaks

No fuel leaks at injection pump

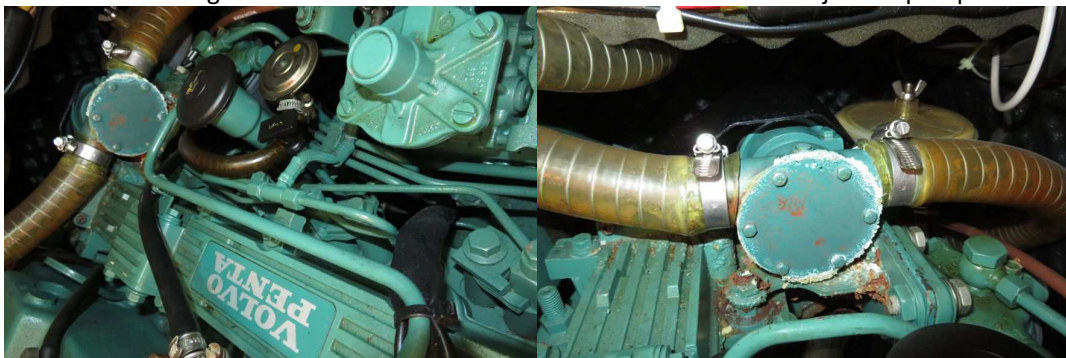
The engine impeller was with previous leak because of failed o-ring. There is cosmetic corrosion in way that requires cleaning up and painting.

No fuel leaks at injectors

Impeller was with previous leak

Suggestion : The engine impeller was with previous leak because of failed o-ring. There is cosmetic corrosion in way that requires cleaning up and painting.

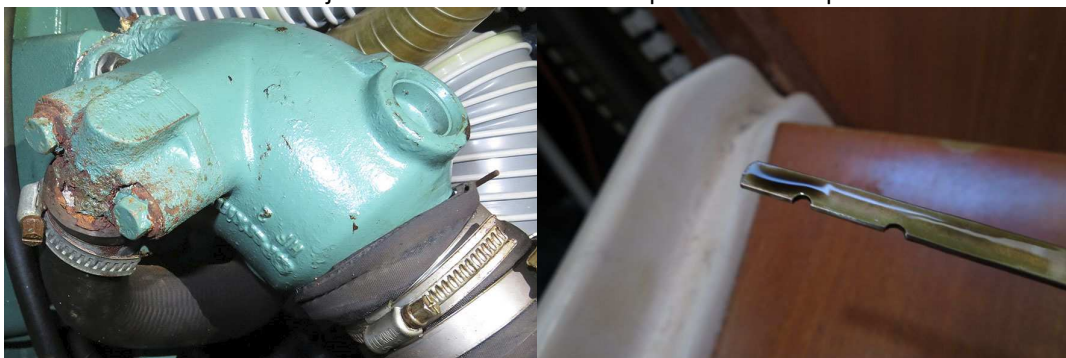
The engine exhaust elbow is with external corrosion and requires removal for checking.

Corrosion at exhaust mixing elbow

Oil looked normal

Suggestion : The engine exhaust elbow is with external corrosion and requires removal for checking.

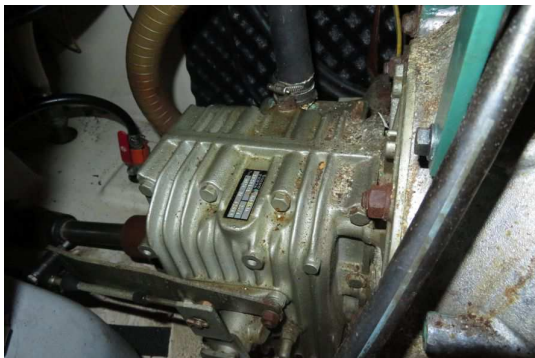
Reverse gear Volvo Penta MS25A with coatings intact and no leaks of oil.

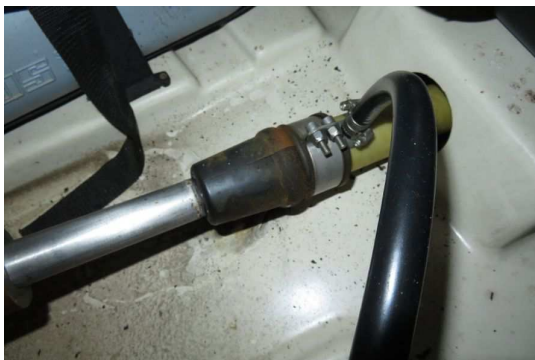
Shaft seal gland material not deteriorated. Hose clip without corrosion. Seawater lubricated. No leaks in operation.

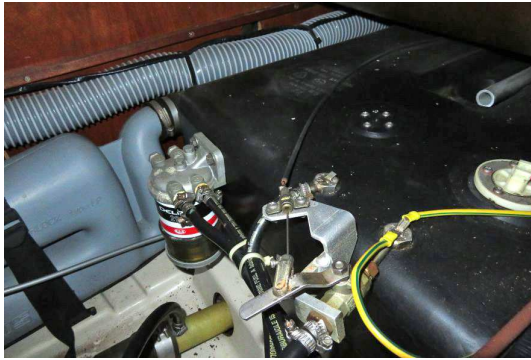
No leaks at connections

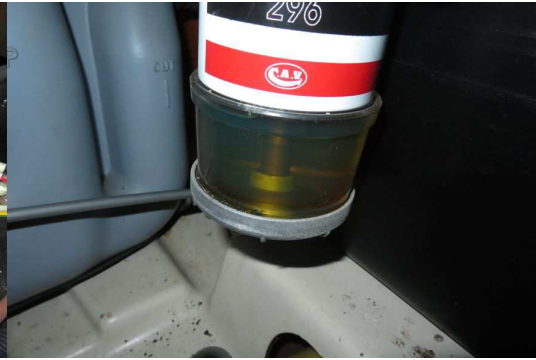
Primary filter clean

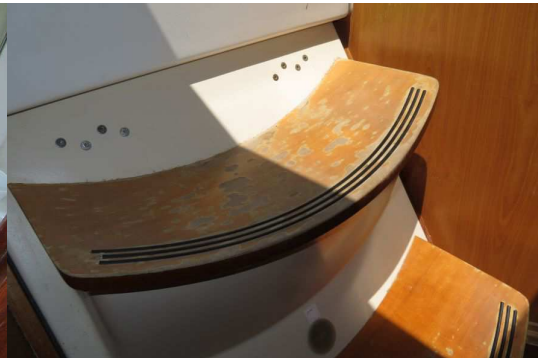
Typical deterioration to varnish at companionway

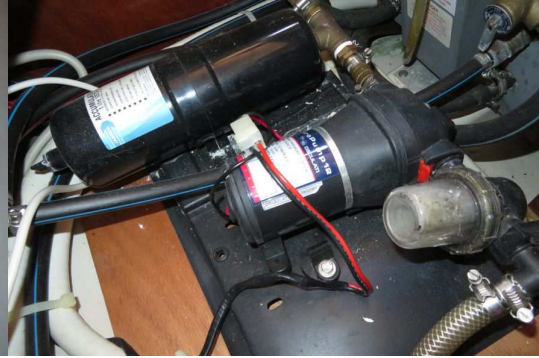
No leaks at pump

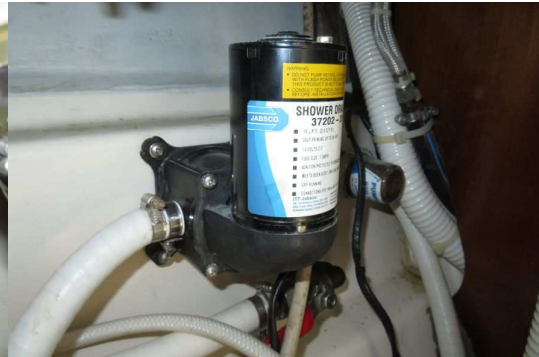
Shower drain pump without leak

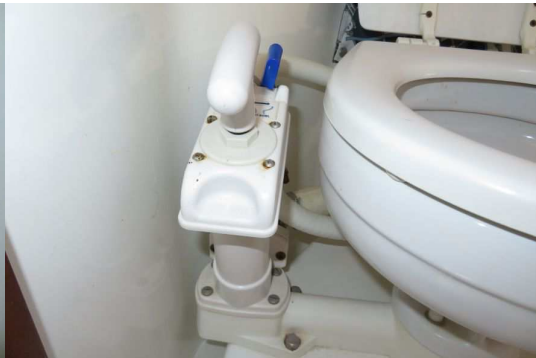
Manual pump no sign of leak

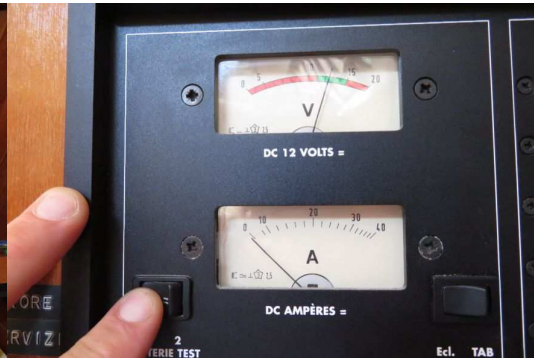
Battery levels good

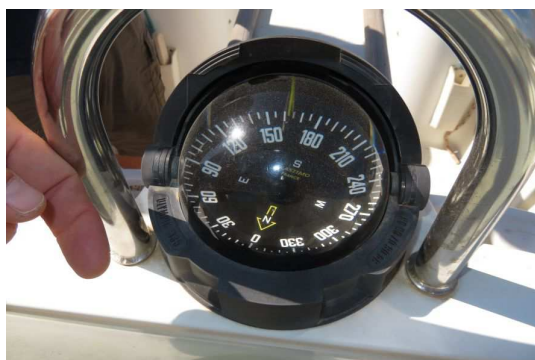
Magnetic compass no bubble

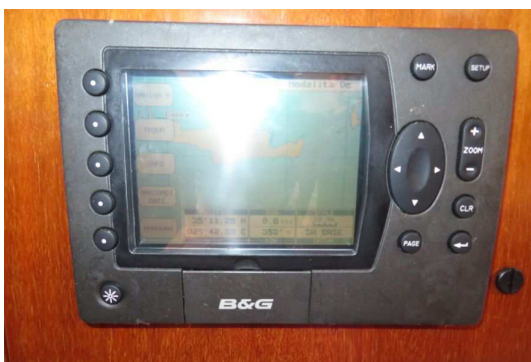
Chartplotter working

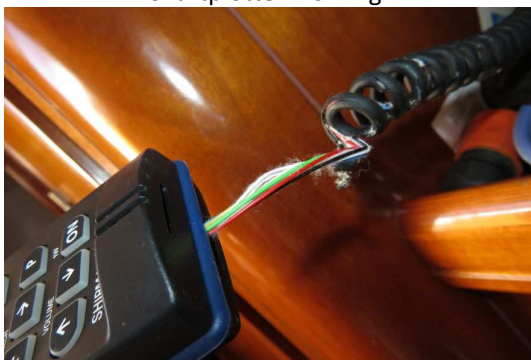
VHF cable damaged

Recommendation : The VHF cable is damaged and requires replacement.

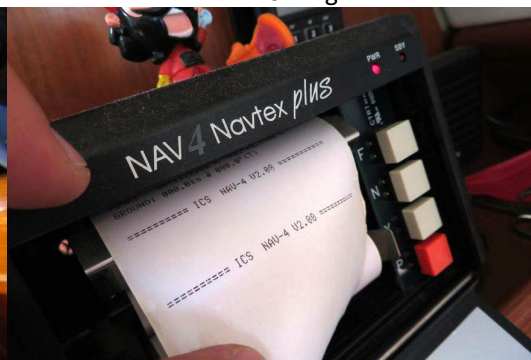
Navtex appears working

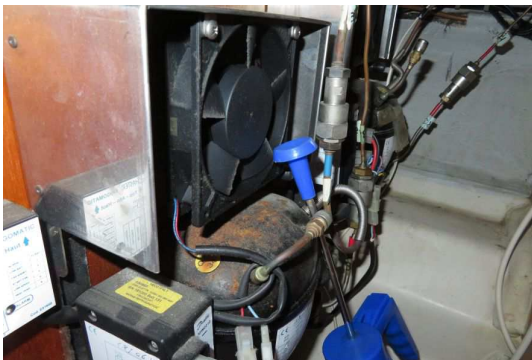
The top opening refrigerator compressor requires gas refilling. The compressors were with minor corrosion. Checked working. Refrigerator internals were intact.

Compressors minor corrosion

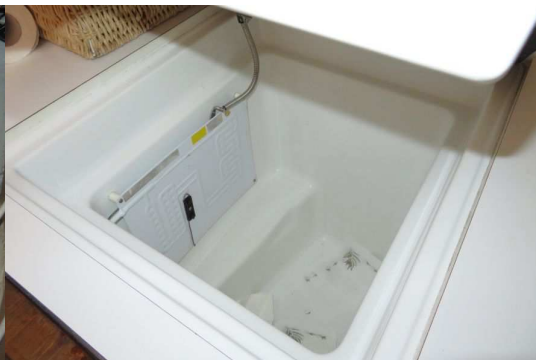
Refrigerator internals intact

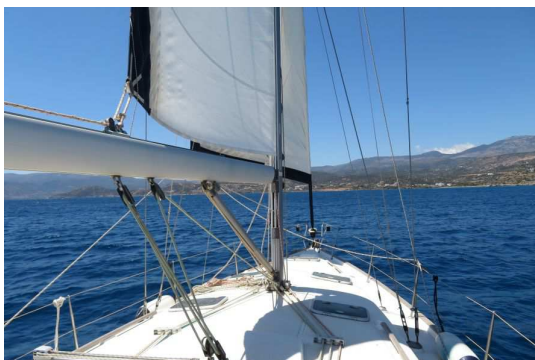
On sea trial
