Date : 25 January 2021

PRE-PURCHASE CONDITION SURVEY REPORT

S/Y LAGOON 420 At Poros-Koilada Jan/20

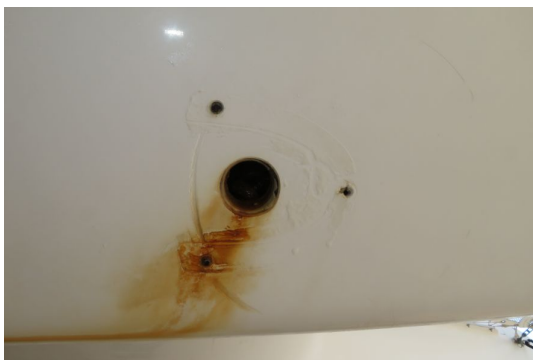
Bridge deck underside is missing one stainless clamshell drain cover.

Bridge deck underside near starboard forward edge. There is crazing in this location which requires grinding and gelcoat minor repair. There was no delamination detected by hammer sounding there however which means it is cosmetic.

Clamshell drain cover
missing at bridge deck underside

Suggestion : Bridge deck underside is missing one stainless clamshell drain cover.

Suggestion : Bridge deck underside near starboard forward edge. There is crazing in this location which requires grinding and gelcoat minor repair. There was no delamination detected by hammer sounding there however.

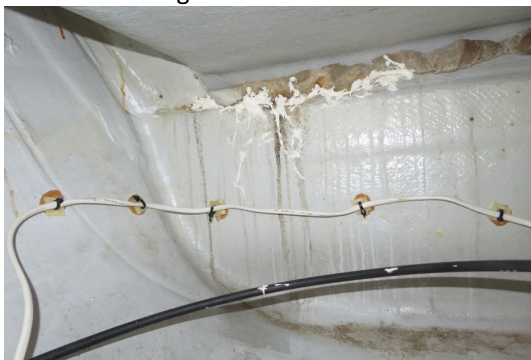
There was some sealant applied at the port stern interior to close a minor leak.

Sealant applied at stern minor leak

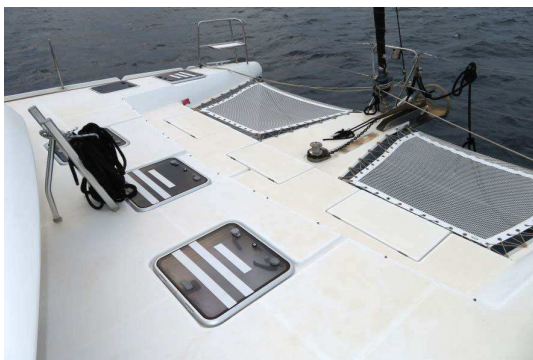
Deck

Starboard hull forward of engine hatch. The deck has a circular minor void that could be grinded out and filled with gelcoat as a cosmetic repair.

Suggestion : Starboard hull forward of engine hatch. The deck has a circular minor void that could be grinded out and filled with gelcoat as a cosmetic repair.

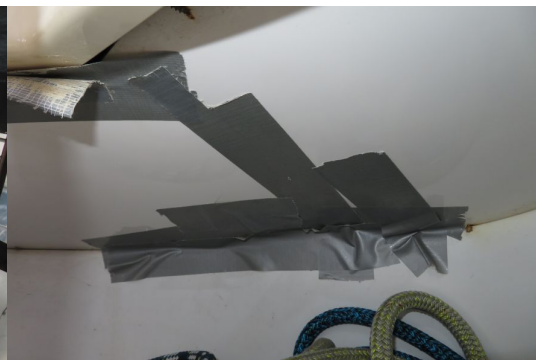
The underside of helm station is with tape repairs.

Tape repairs at helm station

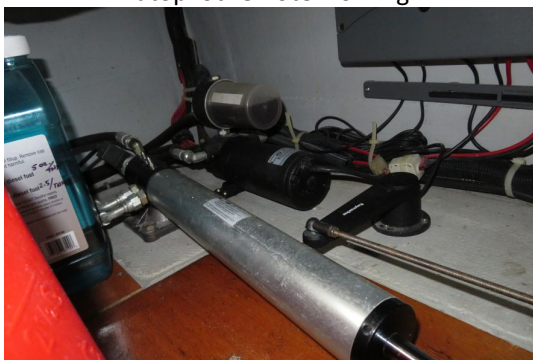
Autopilot control at the cockpit Raymarine ST6002 Smart. It is not connected with any wires (data or power). The chartplotter has autopilot display/control but it is not really useful. The autopilot remote was working but is without holder and power cable at the cockpit. The cockpit autopilot control requires to be provided and may not be working.

Autopilot control not working

Suggestion : Cockpit autopilot Raymarine ST6002 is not connected and may not work.

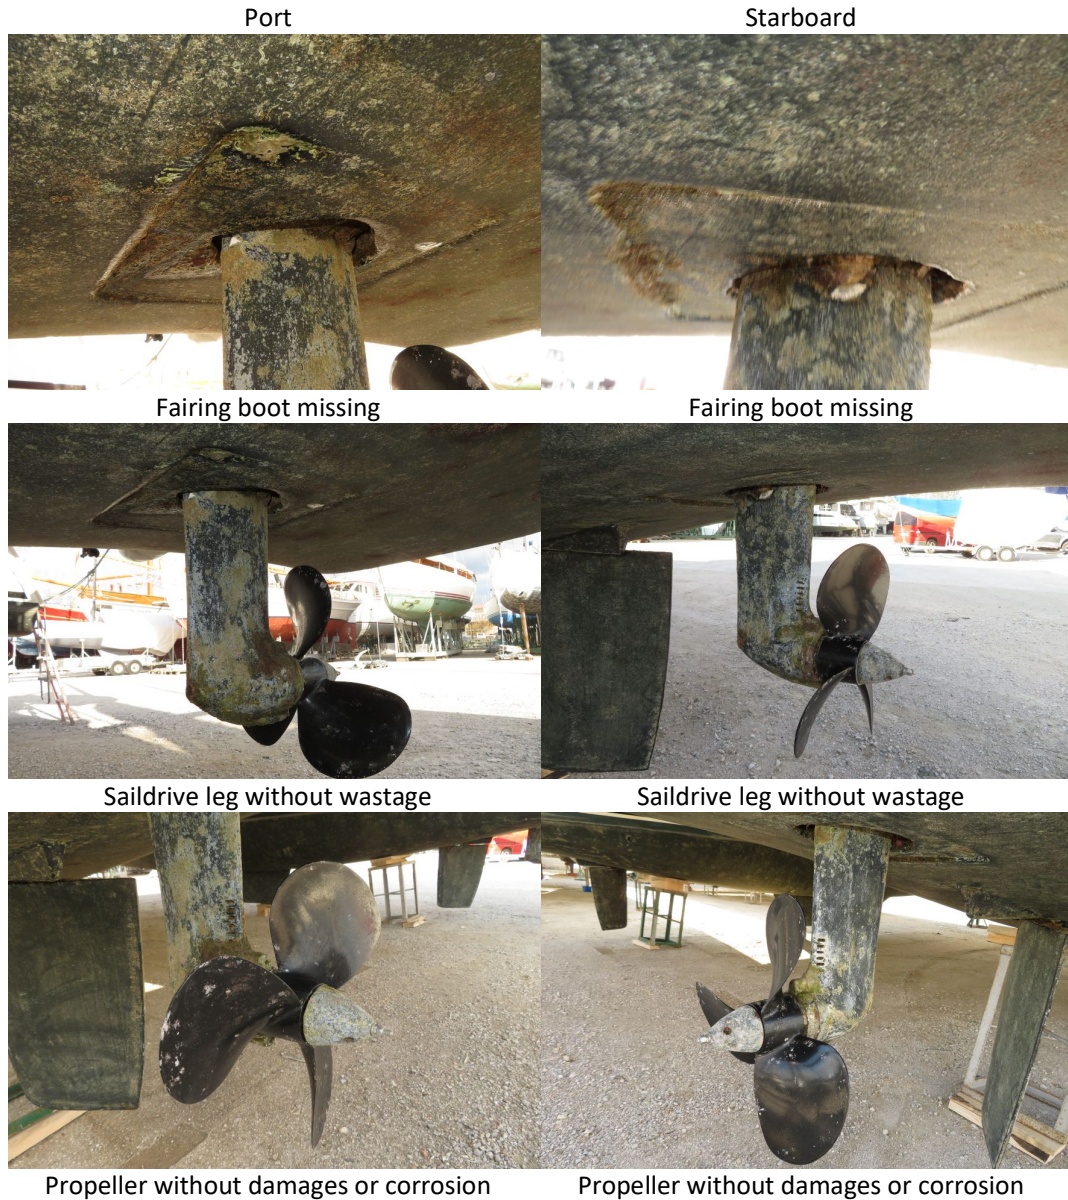
Saildrive rubber fairing boots that cover the saildrive hull apertures are missing and could be fitted.

Port saildrive is with about 1mm play in the shaft. Requires checking by mechanic at next service. Propellers were without play on the rubber hubs and were without damages to the blades.

Suggestion : Saildrive rubber fairing boots that cover the saildrive hull apertures are missing and could be fitted.

Suggestion : Port saildrive is with about 1mm play in the shaft. Requires checking by mechanic at next service.

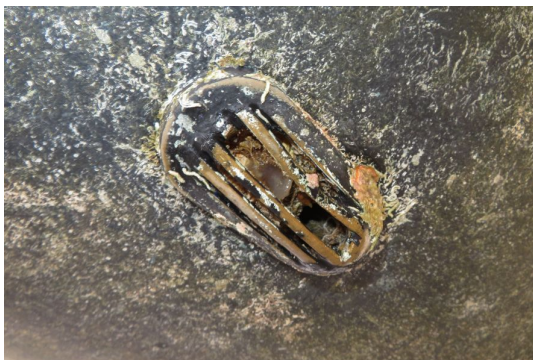
Starboard forward toilet. The seawater inlet grating is missing one line of the grating but is still of use.

Grating missing one line

Suggestion : Starboard forward toilet. The seawater inlet grating is missing one line of the grating but is still of use. Could be replaced or left.

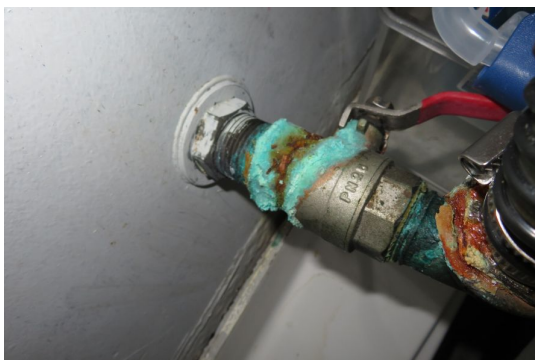
Small leak at sink drain valve

Suggestion : Owner sink outlet valve has a small leak that requires hose to be reseated.

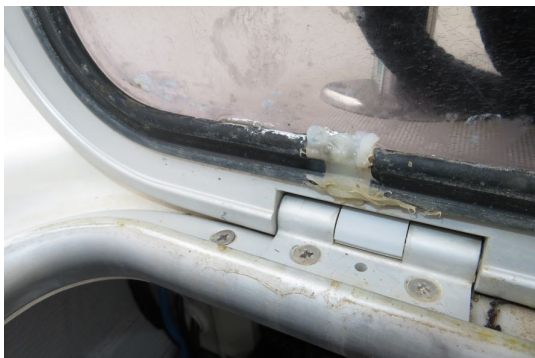
Hatch windows have various homemade repairs to spacing of the seals. There are certainly leaks at the storage area hatches. The seals require replacement. The plexiglass was without cracks and the framing secure.

Hatch seal requires replacement not this temporary repair

Suggestion : Hatch windows have various homemade repairs to spacing of the seals. There are certainly leaks at the storage area hatches. The seals require replacement.

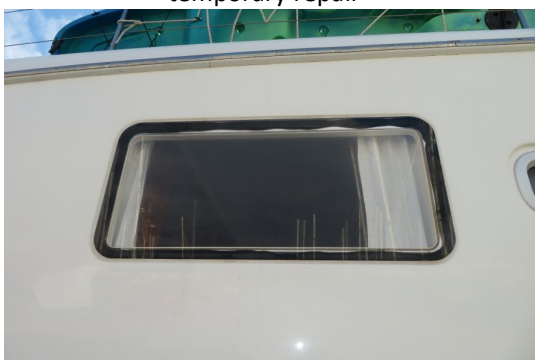
Vertical hatch windows at forward saloon windows. The painted aluminium is with heavy paint deterioration at the interior side. They require removal for gritblasting, etch prime and spray paint.

Failure of coating at saloon forward windows

Suggestion : Vertical hatch windows at forward saloon windows. The painted aluminium is with heavy paint deterioration at the interior side. They require removal for gritblasting, etch prime and spray paint.

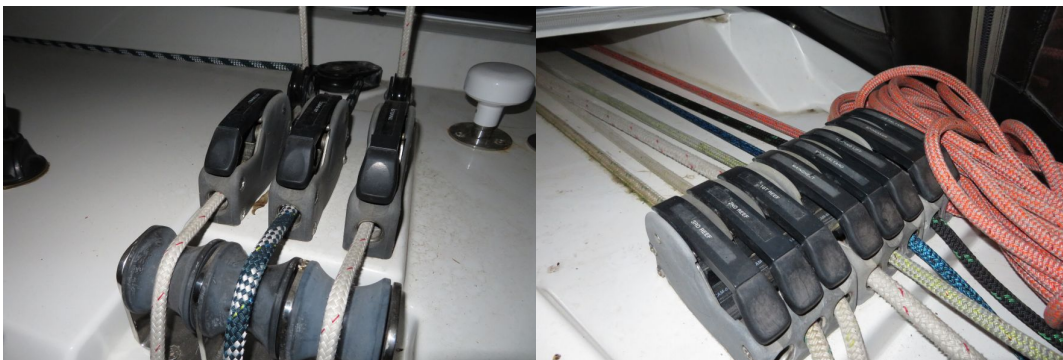
Mainsheet traveller sheave at the helm. Requires replacement due to heavy chafe wear.

Sheave with chafe

Suggestion : Mainsheet traveller sheave at the helm. Requires replacement due to heavy chafe wear.

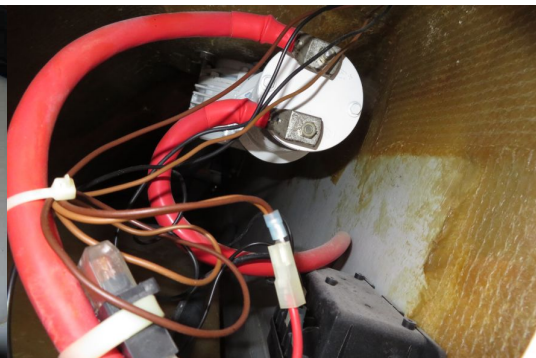
Aft cockpit winch footswitch type buttons require replacement because they are deteriorated. All electric winches were working and the motors externally without corrosion.

Aft cockpit winch footswitches to replace

Suggestion : Aft cockpit winch footswitch type buttons require replacement because they are deteriorated.

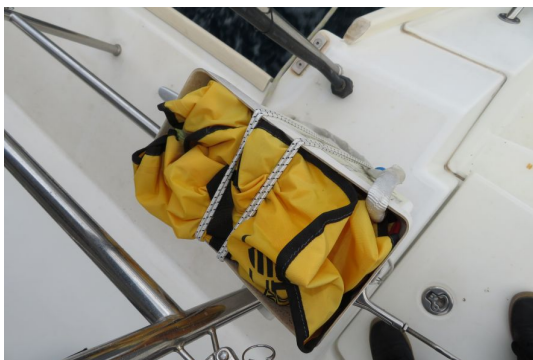
Rescue sling at the stern. The box top is missing. It requires a cover.

Rescue sling missing cover to box

Suggestion : Rescue sling at the stern. The box top is missing. It requires a cover.

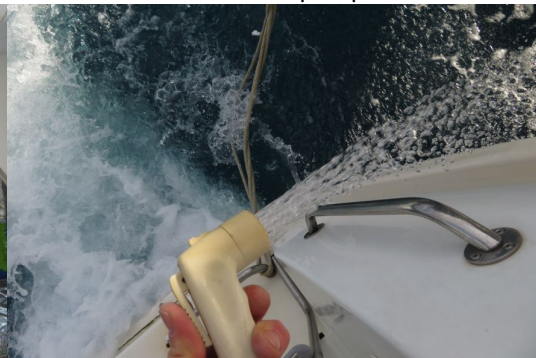
Deck shower leaks

Suggestion : Deck shower head requires replacement because it leaks and the button sticks.

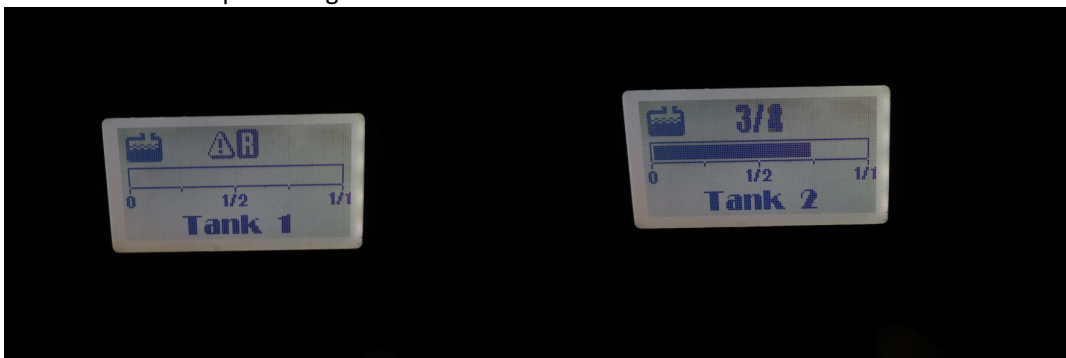
Tank 1 empty or gauge not working

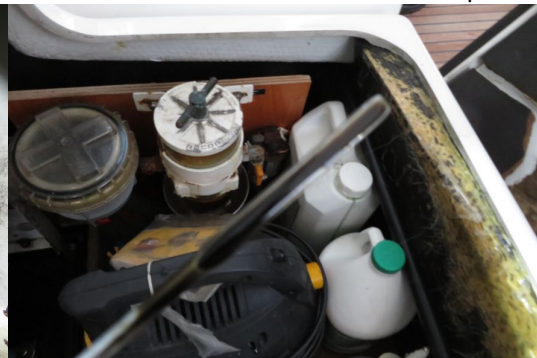
Generator casing soundproofing is deteriorated and requires replacement.

Soundproofing deteriorated

Suggestion : Generator casing soundproofing is deteriorated and requires replacement.

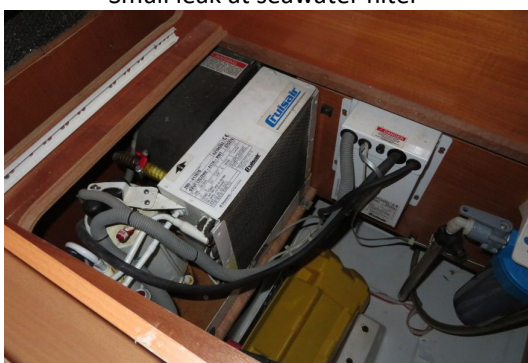
Airconditioning pump at owner cabin bilge. There is a small leak at the pump which requires attention. The remainder of seawater pumps were without leak.

Small leak at seawater pump

Suggestion : Airconditioning pump at owner cabin bilge. There is a small leak at the pump which requires attention.
