Date : 13 January 2020

## PRE-PURCHASE CONDITION SURVEY REPORT

### S/Y BAVARIA 46

At Athens Jan/20

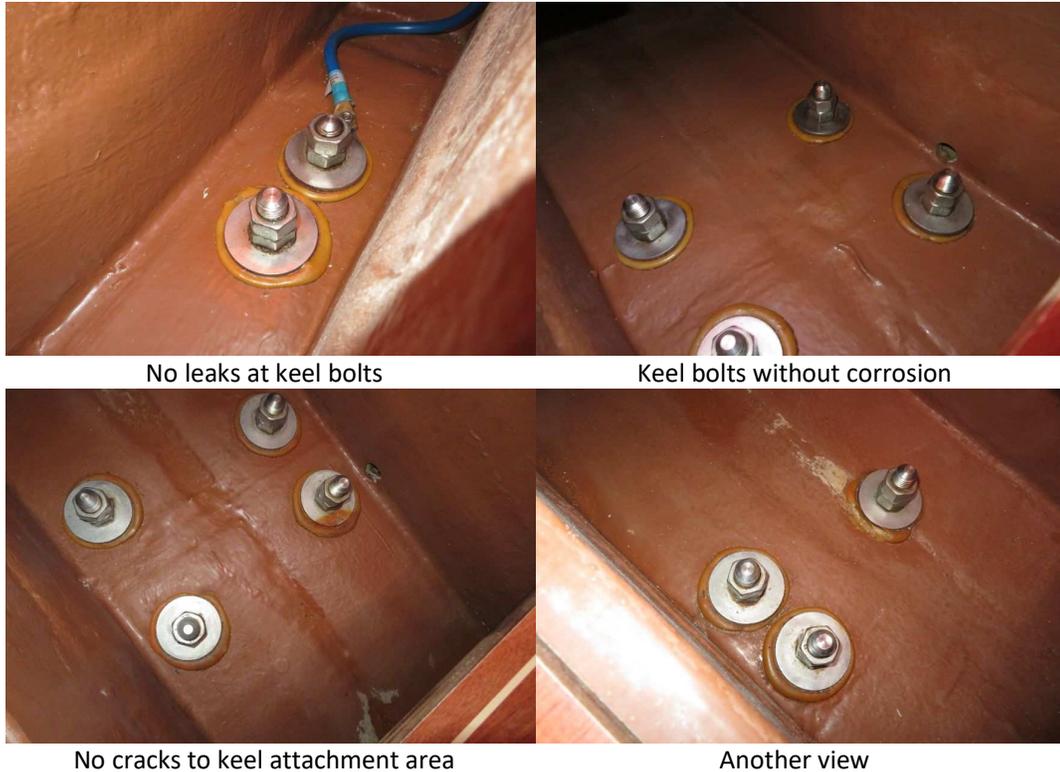
The keel is with some cosmetic corrosion and pitting under the paint. At some point before it becomes in a poor cosmetic condition the keel requires sandblast, fairing, prime and antifoul.

Keel with various minor corrosion under the paint

*Suggestion : The keel is with some cosmetic corrosion and pitting under the paint. At some point before it becomes in a poor cosmetic condition the keel requires sandblast, fairing, prime and antifoul.*

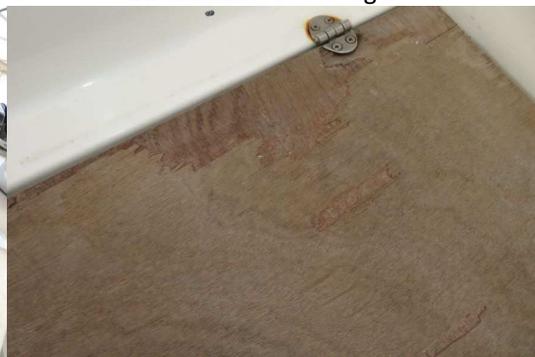
The companionway step hatch at the cockpit is of deteriorated plywood. Better to replace with teak or another plywood.

Deteriorated companionway step

*Suggestion : The companionway step hatch at the cockpit is of deteriorated plywood. Better to replace with teak or another plywood.*

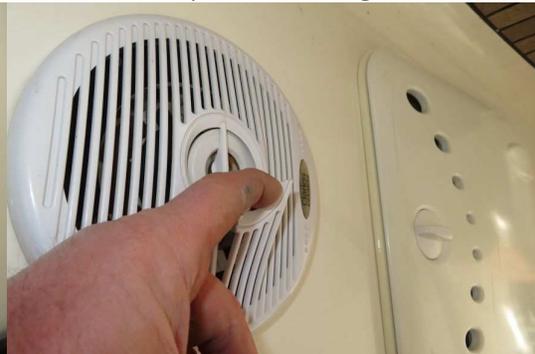
Both cockpit stereo speakers are with their grilles cracked and could be replaced.

Damaged stereo speaker grille

*Suggestion : Both cockpit stereo speakers are with their grilles cracked and could be replaced.*

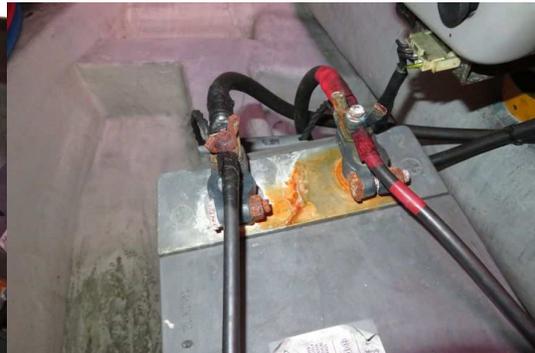
Bow thruster battery terminal bolts and butterfly nuts are corroded due to the deck window leak, and require replacement.

Terminal bolts corroded

*Suggestion : Bow thruster battery terminal bolts and butterfly nuts are corroded due to the deck window leak, and require replacement.*

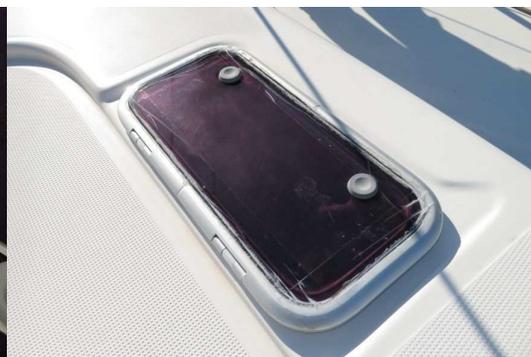
Forward cabin hatch window leaks. It requires removal and resealing around the perimeter. Twin cabin deck skylight leaks. The plexiglass is to be replaced. It is on order.

Skylight plexiglass to be replaced

*Suggestion : Twin cabin deck skylight leaks. The plexiglass is to be replaced. It is on order.*

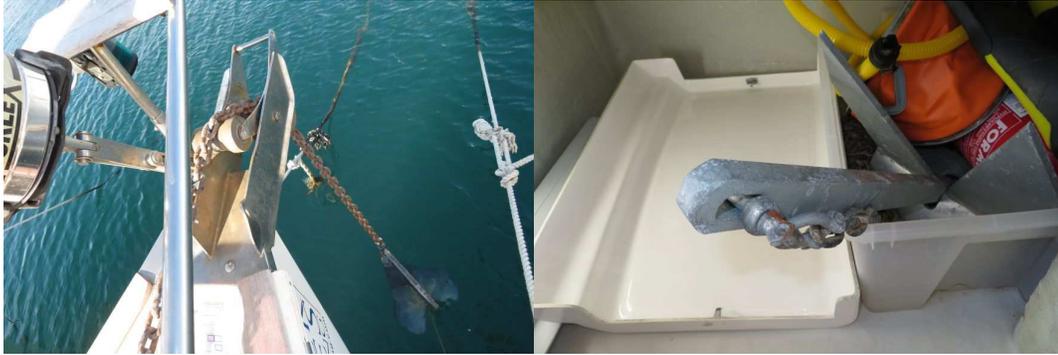
CQR galvanised main anchor without wastage. The anchor chain is corroded and could be replaced.

Chain with corrosion

*Suggestion : The anchor chain is corroded and could be replaced.*

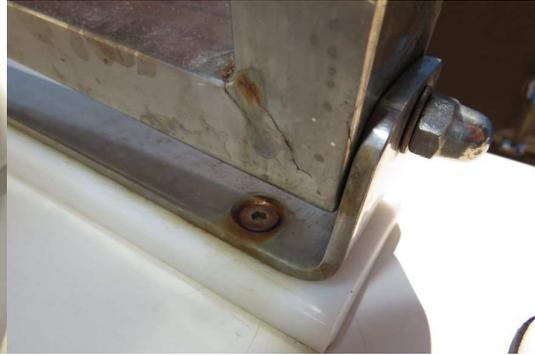
Manual passerelle is cracked at the starboard side next to the securing bracket. The crack requires grinding out and welding on the top and underside.

Cracked framing

*Suggestion : Passerelle is cracked at the starboard side next to the securing bracket. The crack requires grinding out and welding on the top and underside.*

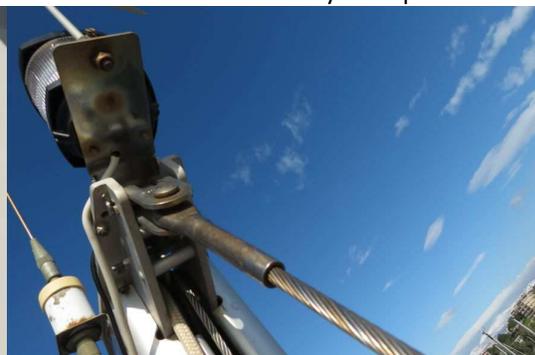
The adjustable backstay aluminium cylinder is with corrosion pitting but still of use.

Small areas of wastage at backstay cylinder

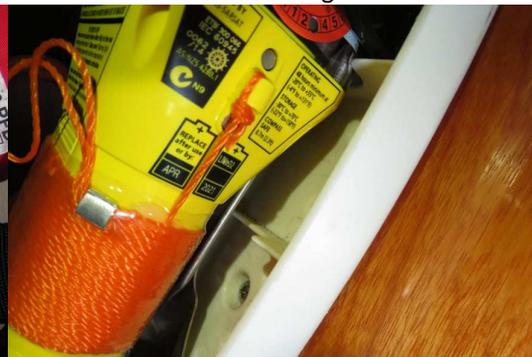
Lifejacket cylinder minor corrosion

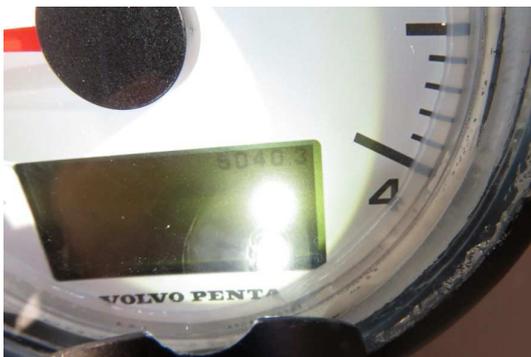
Engine hours does not work. Check wiring. Consider to install analog hours meter.  
Engine impeller casing is with small leak and probably requires o-ring replacement.  
Engine air filter is missing and requires to be fitted.

Engine hours not working

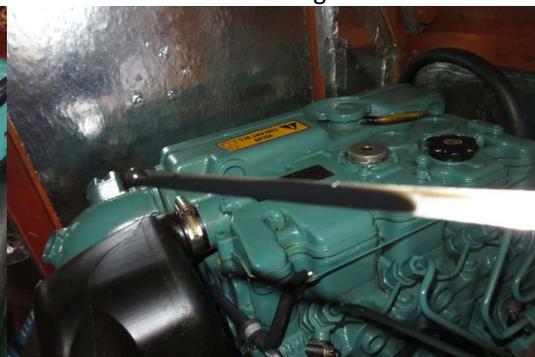
Air filter missing

*Suggestion : Engine air filter is missing and requires to be fitted.*

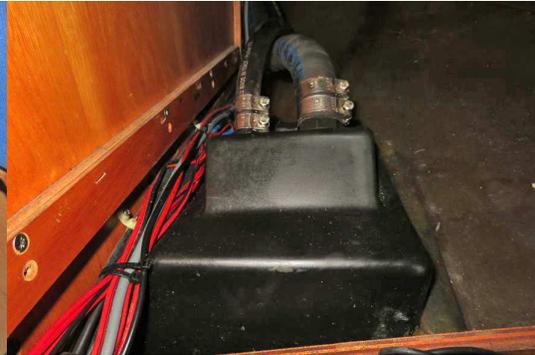
Fuel tank has small leak at the level sensor. It requires to be removed and resealed with sikaflex.

Small leak at level sensor

*Suggestion : Fuel tank has small leak at the sensor. It requires to be removed and resealed with sikaflex.*

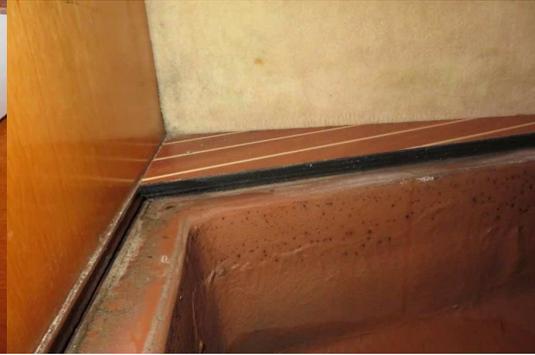
Due to leaks from the cabin hatch windows the plywood flooring in the forward cabin, twin cabin and corridor from the saloon to the forward cabin is blackened at the edges therefore rotting and requires replacement with original bavaria replacement flooring.

Blackening of sole boards due to leaks

*Suggestion : Due to leaks from the cabin hatch windows the plywood flooring in the forward cabin, twin cabin and corridor from the saloon to the forward cabin is blackened at the edges therefore rotting and requires replacement with original bavaria replacement flooring.*

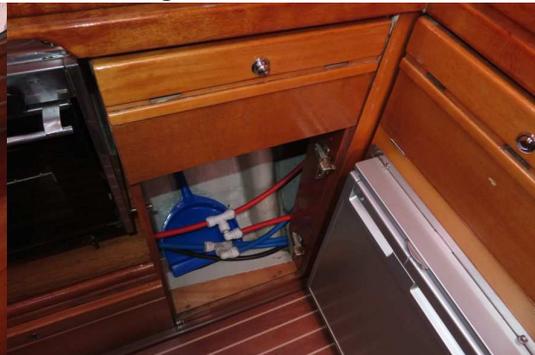
Galley cupboard for the garbage bin is missing the door.

Missing galley cupboard door

*Suggestion : Galley cupboard for the garbage bin is missing the door.*

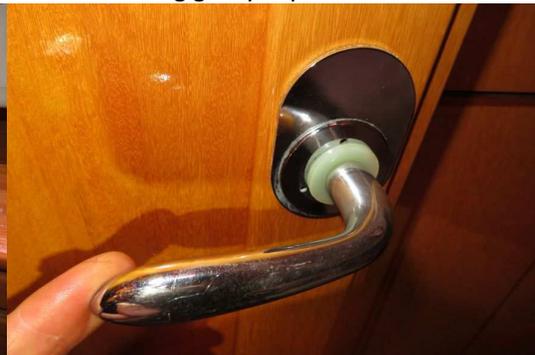
Aft port cabin door handle is loose it requires replacement.

Door handle wobbly and missing part

*Suggestion : Aft port cabin door handle is loose it requires replacement.*

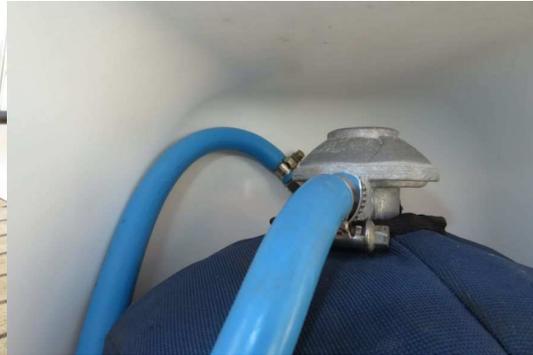
Dedicated gas locker with vent and drain via the door. The gas cylinders are corroded and require exchanging. Single cylinder installation. Regulator not corroded. Gas flexible hoses were not labelled. Cooker with minor corrosion. Gimbal lock working. Shut off valve provided near the cooker.

Gas cylinder corroded

*Suggestion : The gas cylinders are corroded and require exchanging.*

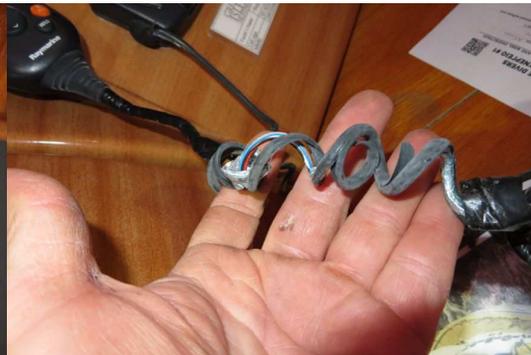
VHF cable insulation failed

*Recommendation : VHF cable requires replacement because the insulation is deteriorated.*

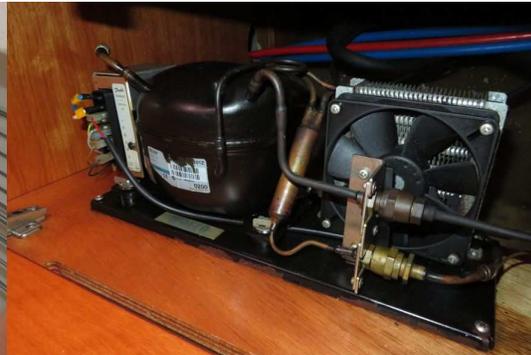
Refrigerator fan grille corroded
