## PRE-PURCHASE CONDITION SURVEY REPORT

### ACHILLEAS II At Lavrio Nov/21

IN accordance with instructions received from CLIENT, the undersigned performed a condition survey on the following yacht on 04/11/2021. The following report details the condition of the yacht on the date of survey.

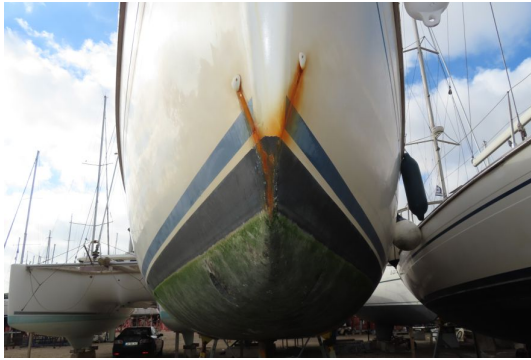
No damages at bow

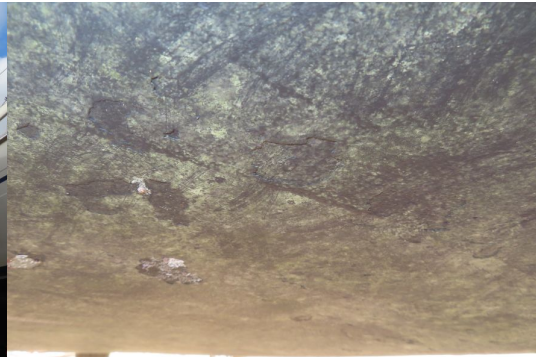
Antifouling is detaching. Requires sanding back to primer before new antifouling.

Antifouling detaching

*Suggestion : Antifouling is detaching. Requires sanding back to primer before new antifouling.*

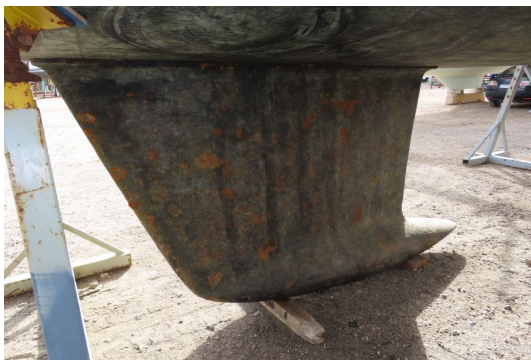
Keel overview

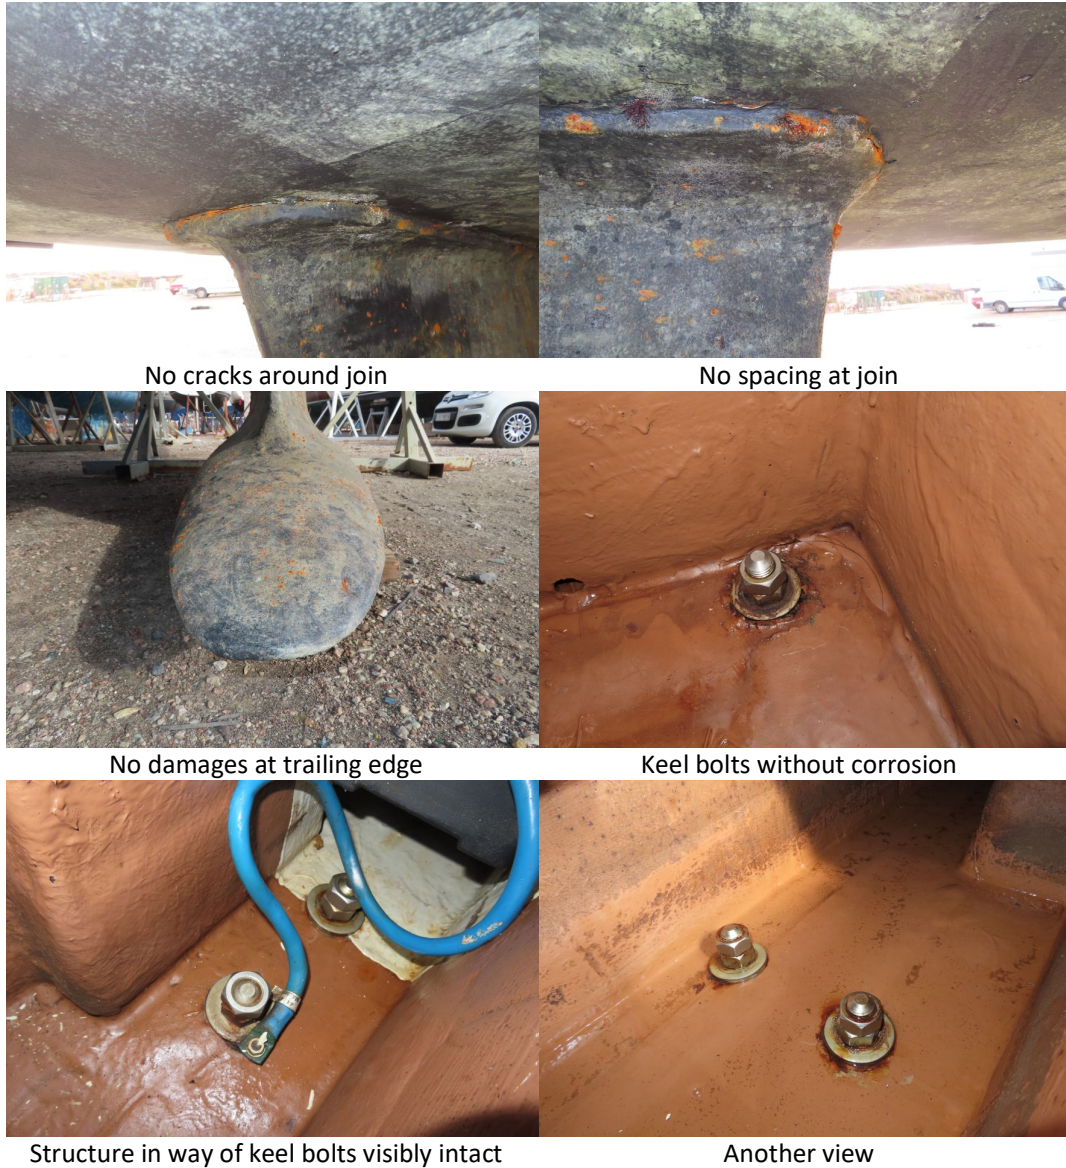
Keel was with some minor areas of corrosion, requires grinding with flapper disc and angle grinder before primer applied.

Keel looks square to the hull

*Suggestion : Keel was with some minor areas of corrosion, requires grinding with flapper disc and angle grinder before primer applied.*

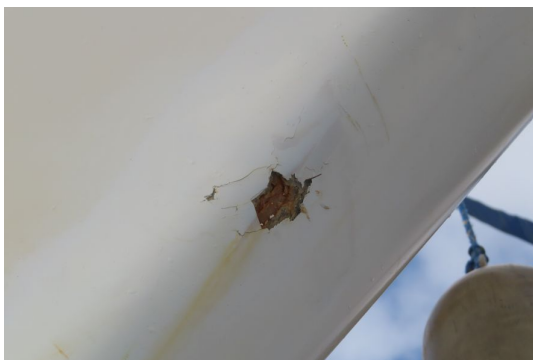
Cosmetic chip at bow stem

*Suggestion : Chipping of gelcoat at bow stem requires gelcoat repairs.*

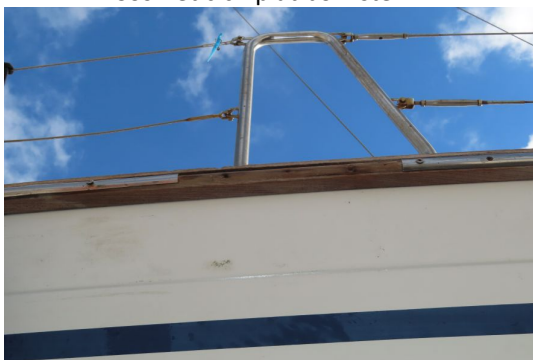
Missing stainless rubbing strake

*Suggestion : Stainless rubbing strake part missing at starboard topsides.*

*Suggestion : Stainless rubbing strake part missing at port topsides.*

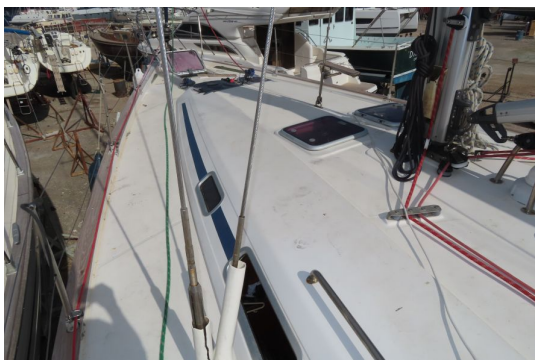
Teak caprail is broken in many locations and requires part replacement (Aft port cleat, Port stanchions Nos. 2, 4 and 5, Starboard stanchions Nos. 3,4 and missing No. 6 stanchion to stern).

Cracked caprail

*Suggestion : Teak caprail is broken in many locations and requires part replacement (Aft port cleat, Port stanchions Nos. 2, 4 and 5, Starboard stanchions Nos. 3,4 and missing No. 6 stanchion to stern).*

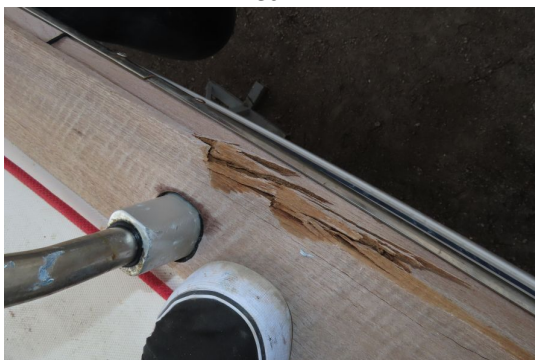
Damaged caprail

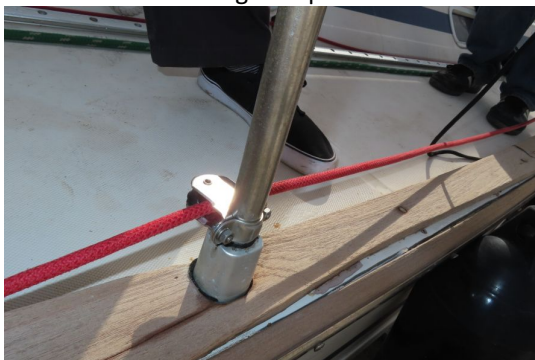
Damaged caprail

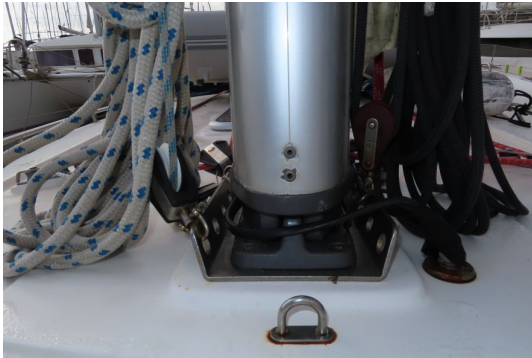
No cracks or compression at mast deck step

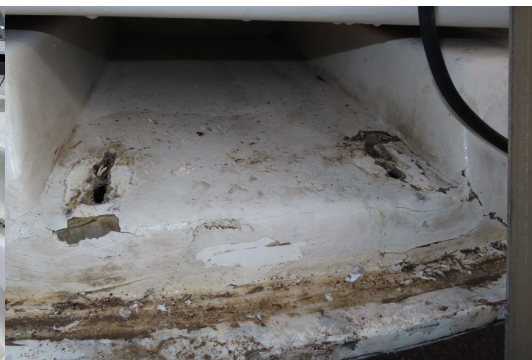
Laminate repairs are required to holes at boarding ladder.

Repairs required to holes at bathing ladder

*Recommendation : (B) Laminate repairs are required to holes at boarding ladder.*

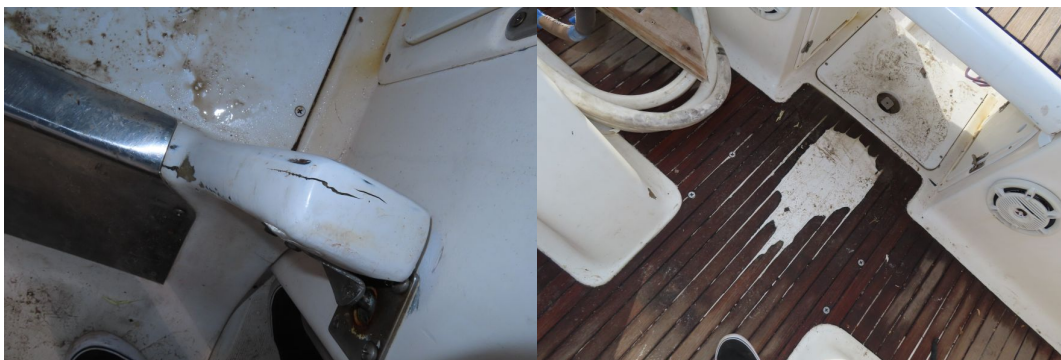
Aft removable seat requires repairs

Teak missing at cockpit floor

*Suggestion : Laminate repairs are required to stern seating hatch.*

*Suggestion : Cockpit teak decking is partly missing. Requires replacement/recaulking.*

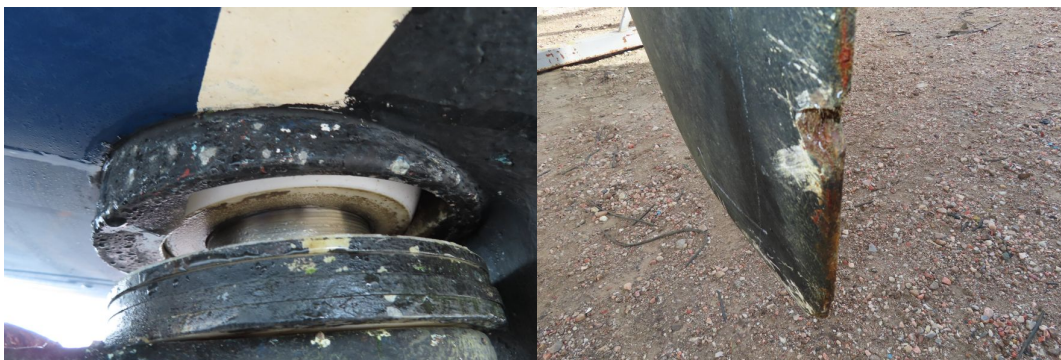
Rudder is with damages at the lower part. Requires laminate repairs.

Rudder is set too low

Various damages to rudder

*Suggestion : Rudder is with damages. Requires laminate repairs.*

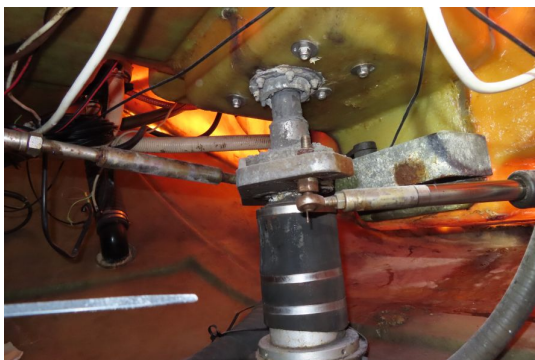
Steering quadrant has leaks from deck level and corrosion. Looked satisfactory for now but requires cleaning for close inspection.

Steering gear

Leaks from deck level leading to corrosion

*Suggestion : Steering quadrant has leaks from deck level and corrosion. Looked satisfactory for now but requires cleaning for close inspection.*

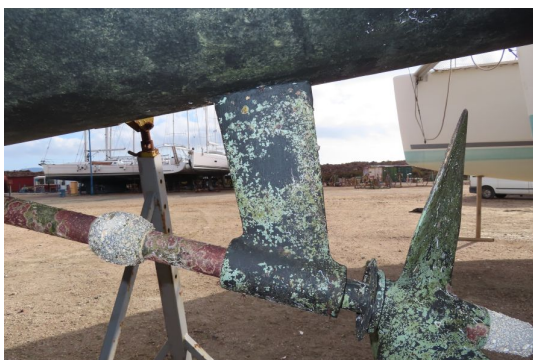
P-bracket without wastage

Propeller without damages

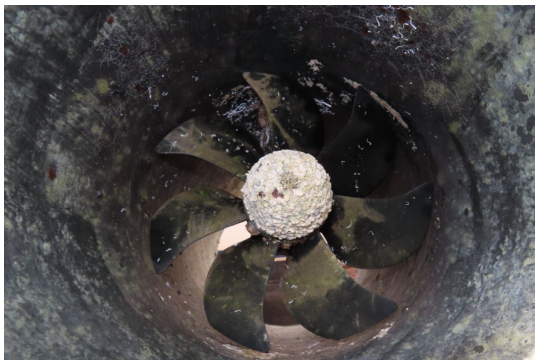
Bow thruster propeller without damage

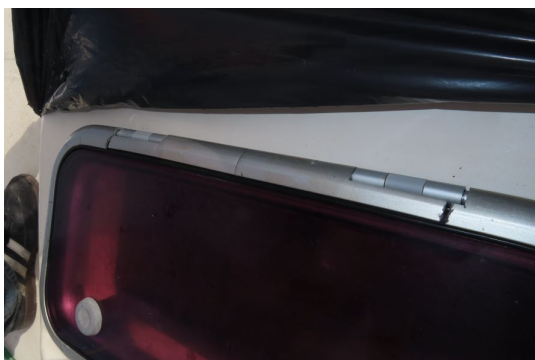
Frame of hatch window separating

Missing clip

*Recommendation : (B) Various saloon side windows require missing aluminium clips to be installed (No. 1 port, No. 1 and No. 2 starboard).*

*Suggestion : No. 1 skylight port forward cabin the framing is broken. Requires replacement.*

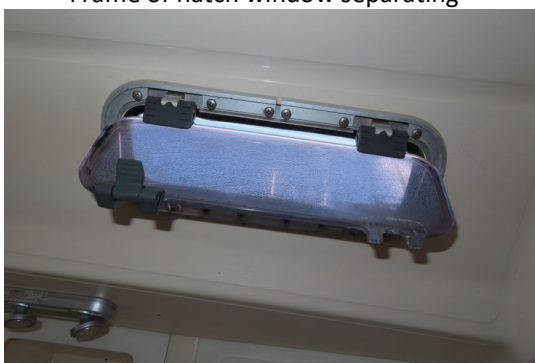
Missing handle

*Recommendation : (B) Forward toilet side window one handle is missing.*

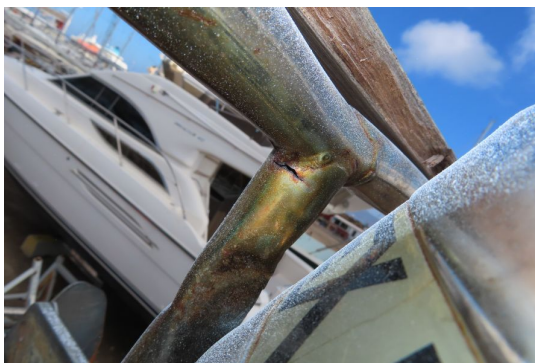
Pulpit is loose requires better securing. The teak step requires replacement, The tubing is cracked and damaged at the middle stanchion. Requires welding repair.

Pulpit framing cracked

*Suggestion : Pulpit is loose requires better securing. The teak step requires replacement, The tubing is cracked and damaged at the middle stanchion. Requires welding repair.*

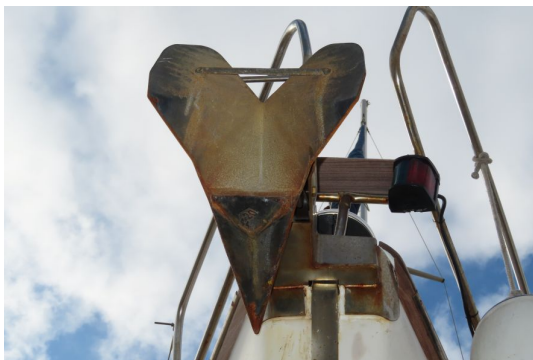
Anchor with minor corrosion

Anchor windlass was secure

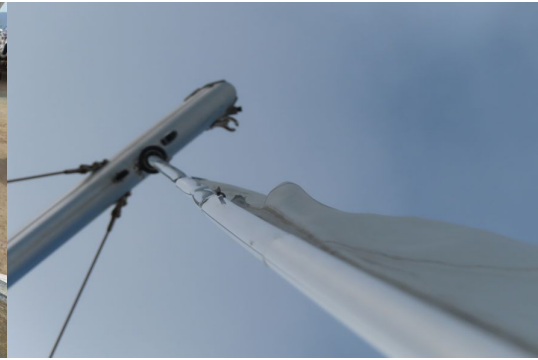
Genoa furler foil has a damaged section at the top which requires replacement.

Foil is damaged

*Recommendation : (B) Genoa furler foil has a damaged section at the top which requires replacement.*

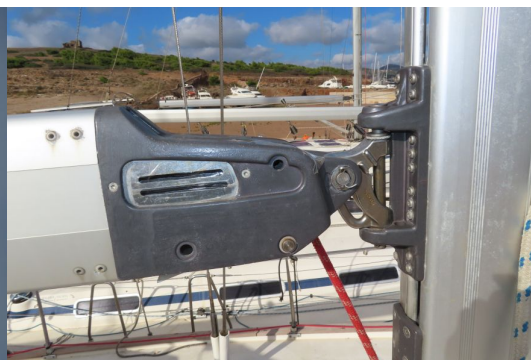
Boom gooseneck without fracture

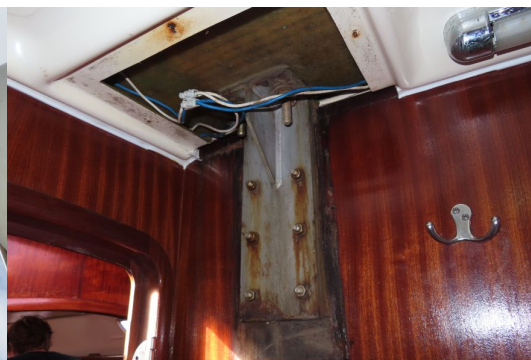
Babystay deck fitting requires resealing because it leaks.

Babystay leaks

*Suggestion : Babystay deck fitting requires resealing because it leaks.*

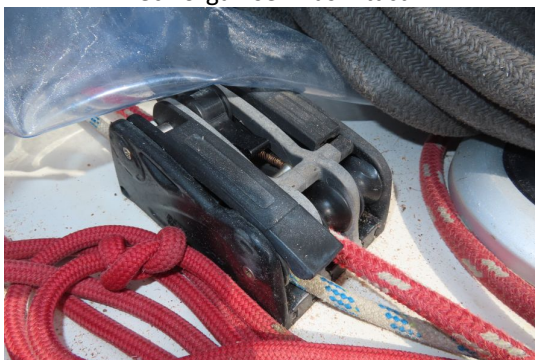
Missing handles of rope jammer

*Recommendation : (B) Starboard cockpit rope jammers two missing handles require fitting.*

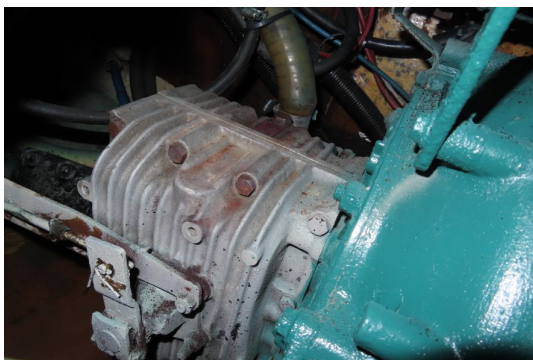
Reverse gear Volvo Penta MS25A-A. Reverse gear was without corrosion or leak of oil. Gearbox does not work well. Requires checking by mechanic. Controls and cable also require checking/greasing or replacement.

Minor external corrosion of reverse gear

*Recommendation : (B) Gearbox does not work well. Requires checking by mechanic. Controls and cable also require checking/greasing or replacement.*

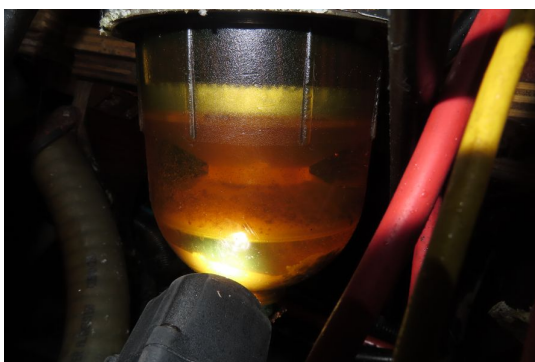
Fuel tank requires cleaning and diesel bug treatment. Primary filter was not clean.

Primary fuel filter with sediment

*Recommendation : (B) Fuel tank requires cleaning and diesel bug treatment. Primary filter was not clean.*

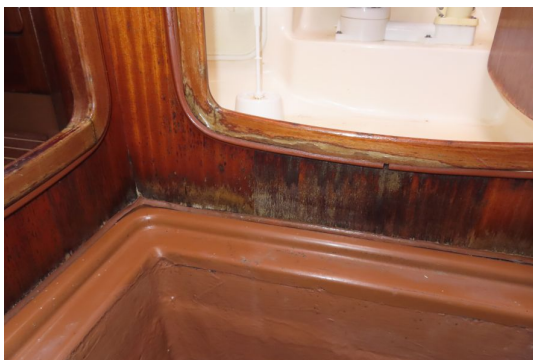
Wet damage at toilet door

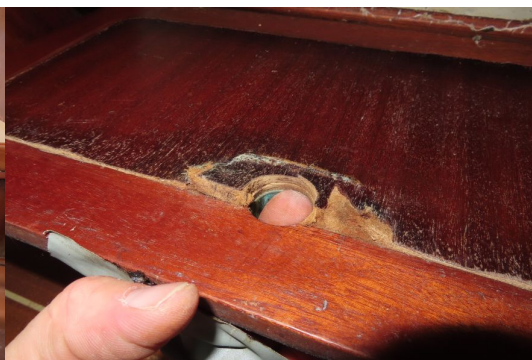
Galley lower cupboards are wet damaged.

Wet damage at galley

*Suggestion : The accommodation has many cosmetic wet damages (galley lower cupboards, saloon wooden linings at side windows, Aft port heads exterior panelling, linings near port hull portlight) and requires the services of carpenter.*

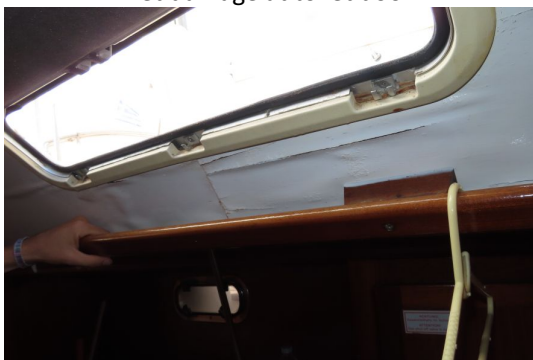
Saloon wooden linings at side windows requires replacement because wet damaged.

Wet damage at saloon sides

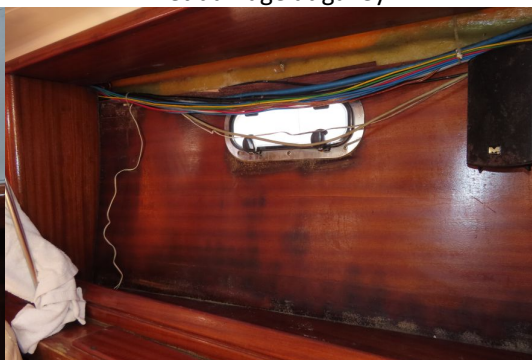
Wet damage at saloon sides

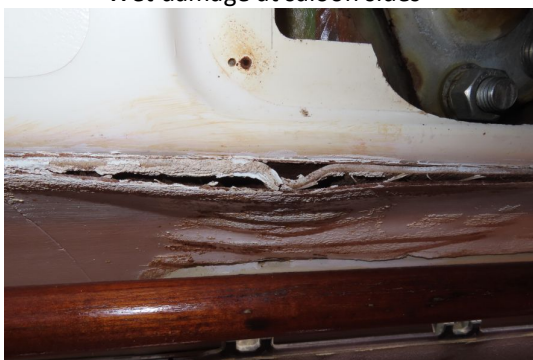
Wet damage at saloon sides

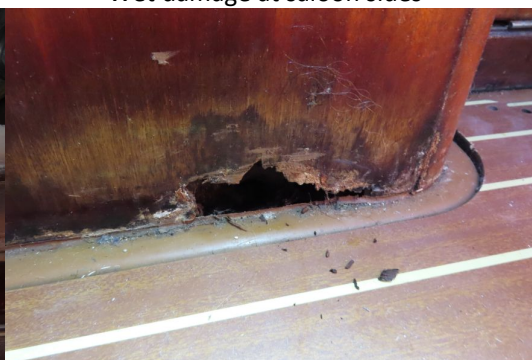
Wet damage at aft port heads exterior

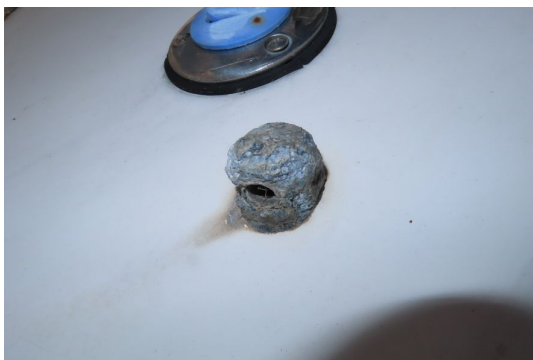
Corroded tank vent

*Suggestion : Aft port water tank vent is corroded. Requires replacement.*

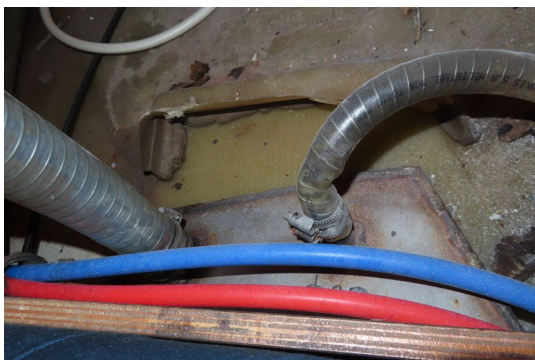
Plastic tank requires better securing

*Recommendation : (B) Port forward fresh water tank requires better securing with cargo straps.*

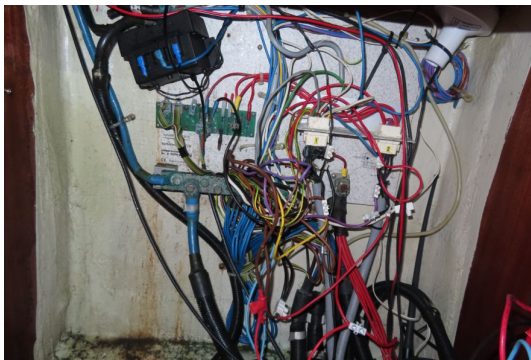
Electrics are corroded at main switchboard and also fuses for anchor windlass. The electrics were working properly but future problems may occur due to the corrosion.

Electrics with corrosion

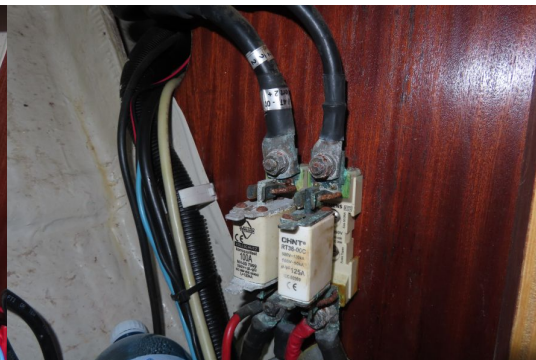
Electrics with corrosion

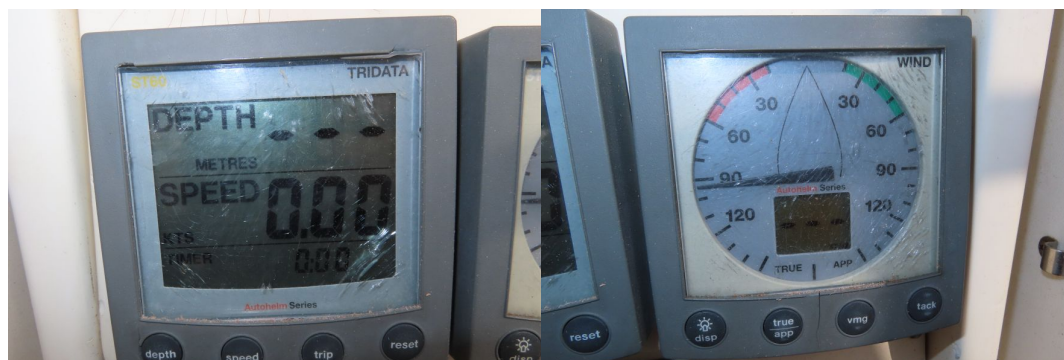
Depth speed powers on

Wind indicator no data
