## PRE-PURCHASE CONDITION SURVEY REPORT

### M/Y MAIORA At Cannes Jan-Feb/17

IN accordance with instructions received from CLIENT, the undersigned performed a pre-purchase survey on the following yacht on 16/Jan/17 and 22/Feb/17. The following report details the condition of the yacht on the dates of survey.

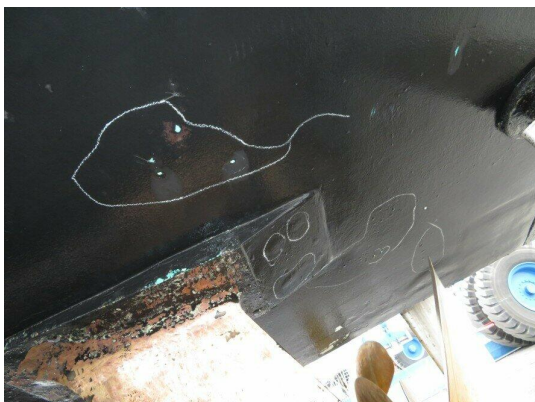
Underwater hull osmosis blisters with small foul smelling hydrolysed resin inside behind gelcoat in outer laminate found in localised areas at the stern bottom as follows :

Blisters at port side

Blisters to be individually ground out and filled with epoxy. Monitor at future haul outs. May occur more blisters with some more days ashore. Possibly consider full osmosis treatment of underwater hull at great expense in the future (it is guaranteed any yard will recommend this immediately to make good money). I do not recommend full osmosis at this stage as present status is localised blisters of small area extent.

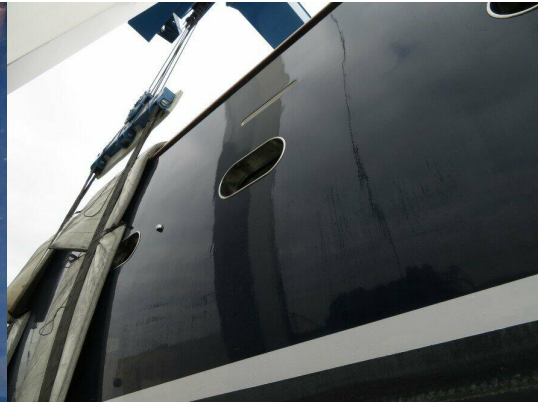
Topsides otherwise fair and no damages

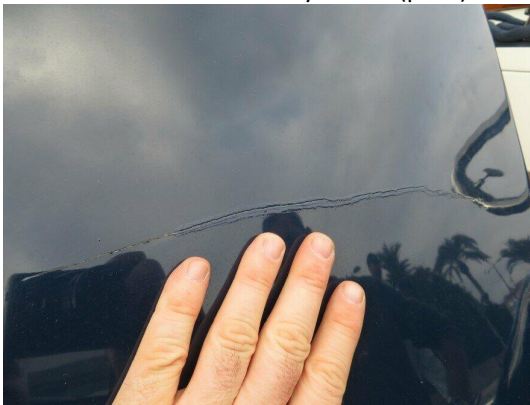
The topsides navy blue paint was not faded but the fairing underneath the paint is detaching and cracking in various areas. It was a cheap job. Therefore the yacht requires repair and paint at great expenses. No stress crazing or damages seen at the topsides which were fair.

Fairing of paint cracking

*Suggestion : The topsides require fair and repaint which will be a major expense.*

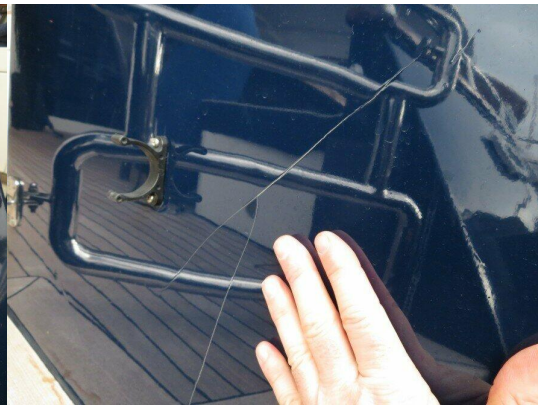
Fairing of paint cracking

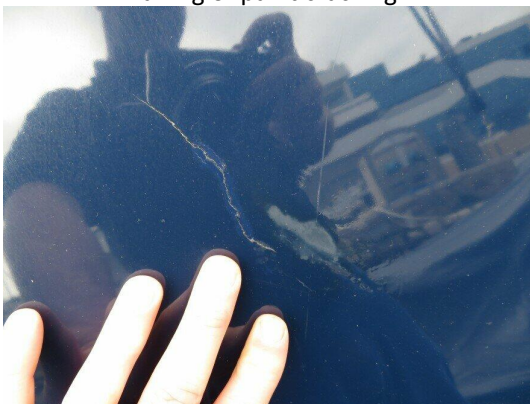
Fairing of paint cracking

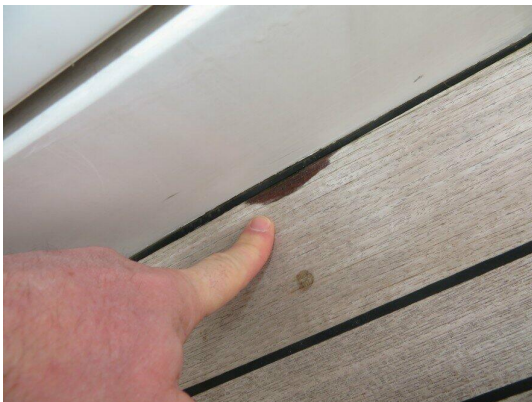
Caulking leaking

*Suggestion : The teak decking caulking is leaking in various places and likely localised caulking repairs can be successful. There was also water under several planks and therefore localised renewal of planking cannot be excluded.*

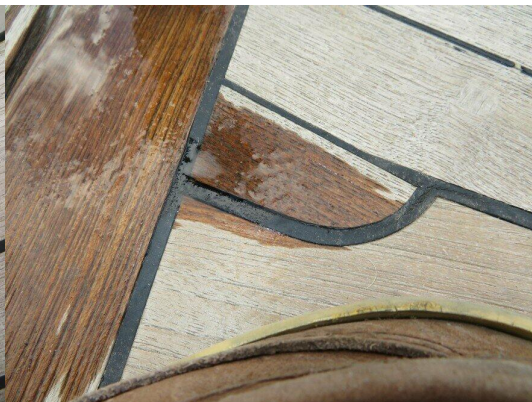
Caulking leaking

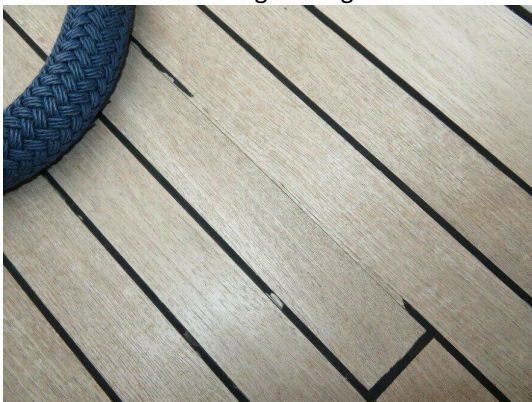
Caulking missing

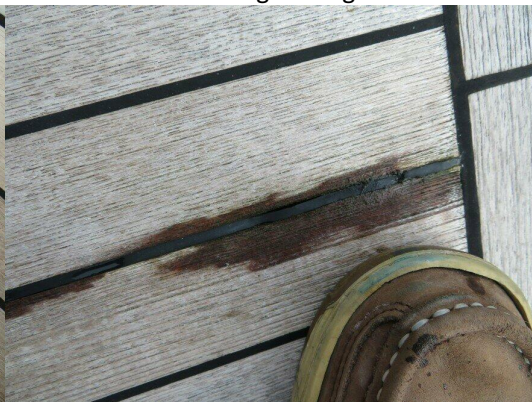
Caulking leaking

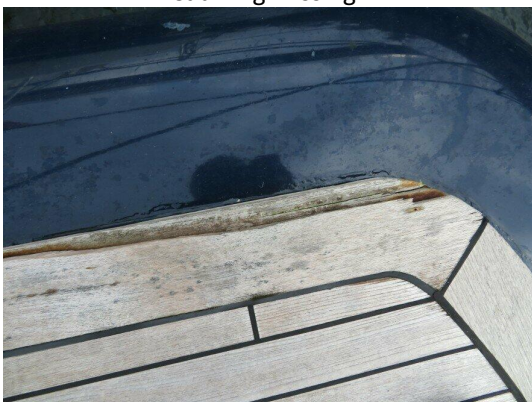
Broken plank at stern platform

*Suggestion : The stern platform has a broken teak plank and requires localised refurbishment of caulking in deteriorated areas.*

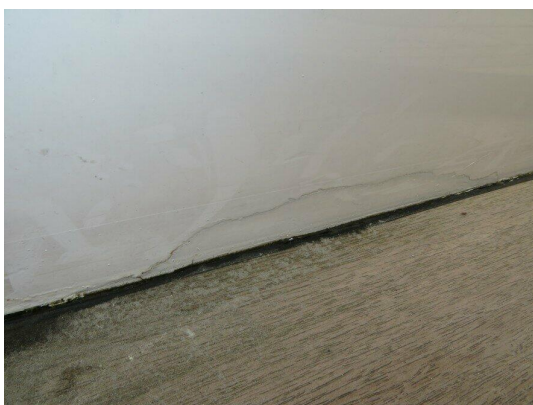
Coating defects on bulwark inboard side

*Suggestion : The superstructure and interior side of the bulwark has minor localised coating defects. Localised painting repairs could be considered.*

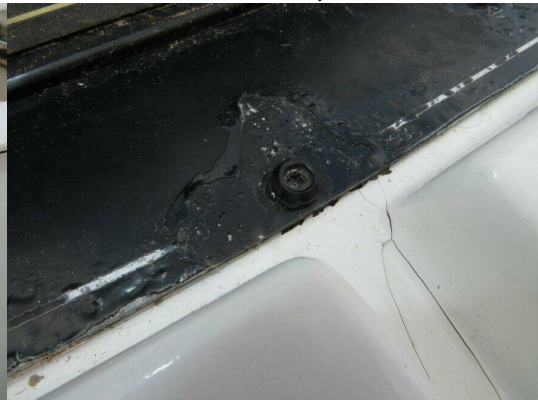
The flybridge was in satisfactory condition. The flybridge console could use some refurbishment and paint.

Flybridge console requires refurbishment

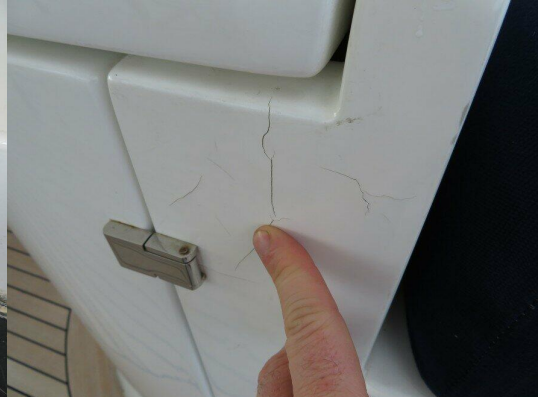
Small cracks flybridge furniture

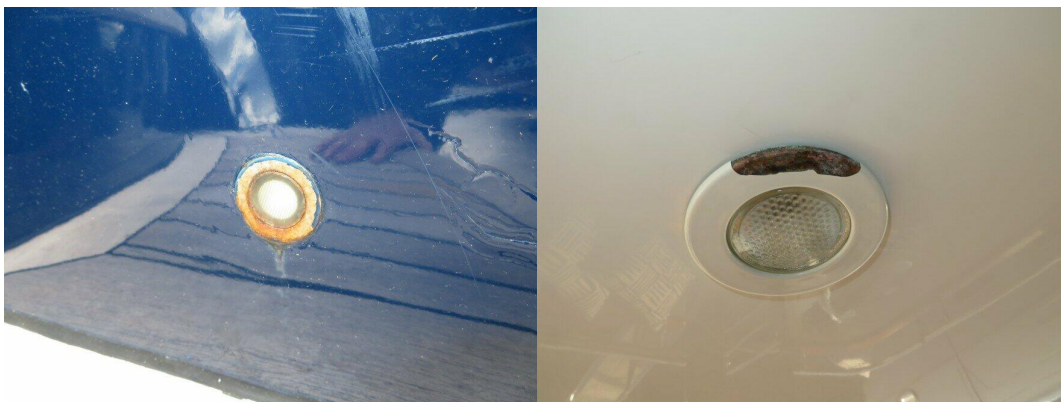
The exterior night lights are with corroded surrounds and require replacement.

Corrosion night lights

Ceiling light to repaint

*Suggestion : The exterior night lights are with corroded surrounds and require replacement.*

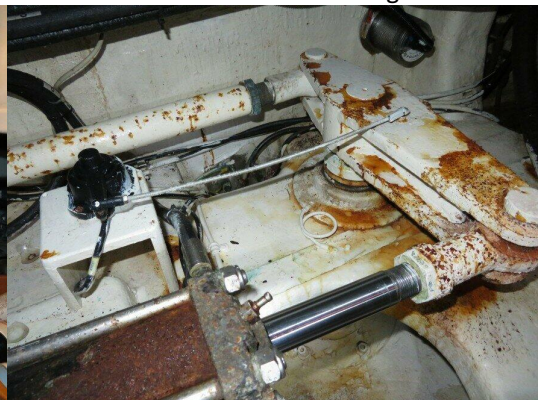
Steering gear corroded

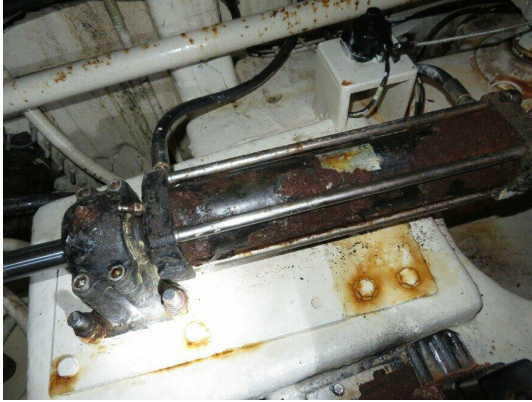
Cylinder corroded

*Suggestion : The steering hydraulic cylinders are corroded and require gritblast and repaint.*

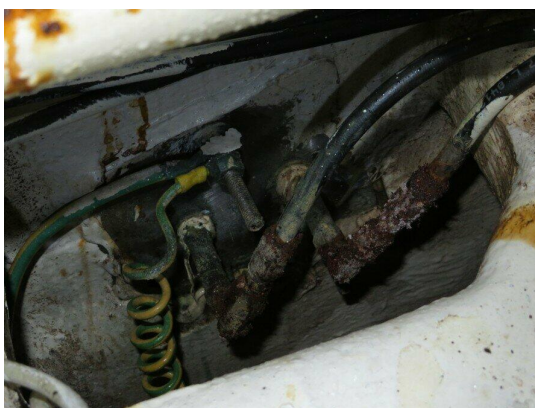
The trim tabs hydraulic connections at the steering area are corroded and require renewal of the hoses and connections.

Trim tabs through hull connections corroded

*Suggestion : The trim tabs hydraulic connections at the steering area are corroded and require renewal of the hoses and connections.*

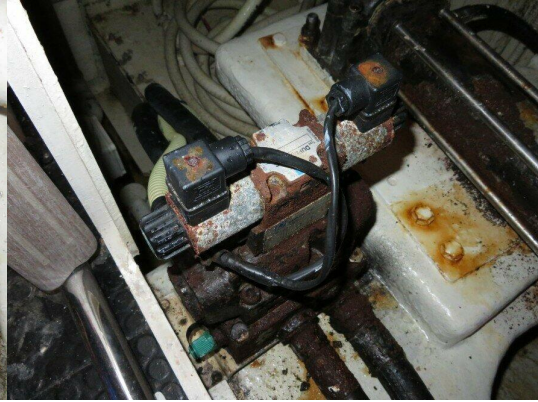
Trim tabs electronic valves with corrosion

*Suggestion : Stern thruster casing to be repainted and hoses with corroded connections renewed. Electronic valves also to be refurbished as corroded.*

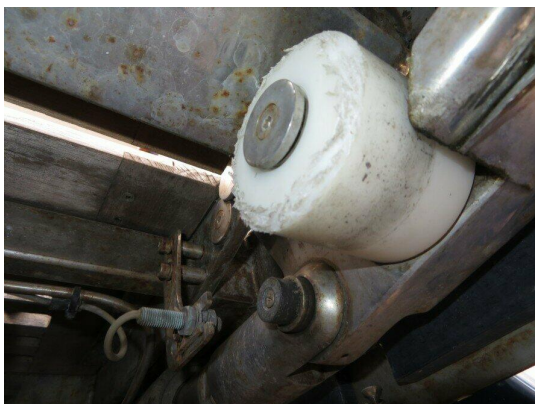
The passerelle was working. The railings are fitted manually which is inconvenient. The passerelle squeaks terribly in operation. It requires removal to workshop and refurbishment as the wheels are worn at least. The passerelle handrail ropes require replacement as with various chafe. The passerelle last section is disconnected and manually extended. The passerelle door wires are disconnected.

Passerelle wheels worn

*Suggestion : The passerelle requires full servicing (removal to workshop) due to terrible squeaks in operation from the wheels.*

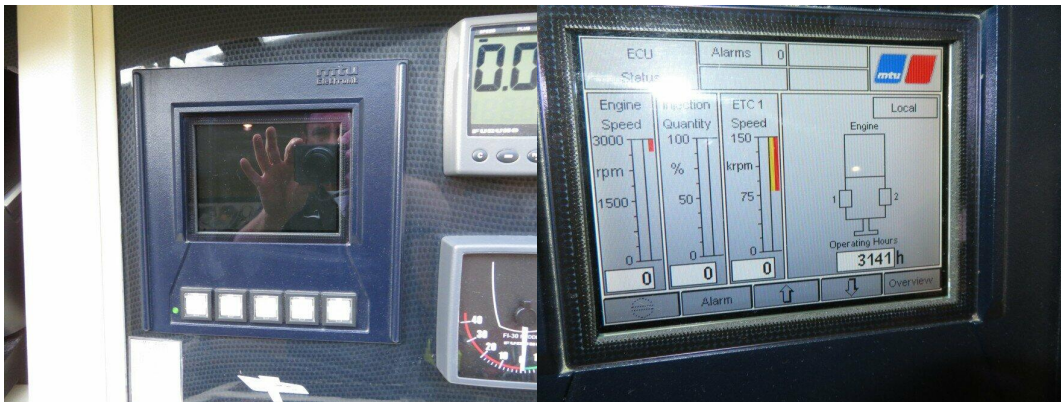
The port engine panel at the wheelhouse requires replacement as it does not work.

Port engine panel broken

*Recommendation : The port engine panel at the wheelhouse requires replacement as it does not work.*

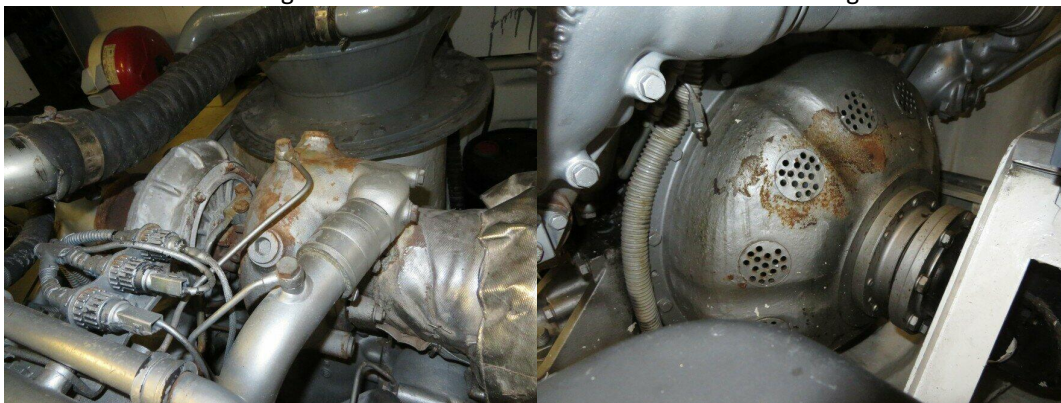
The engines require repaint in the small areas with broken coatings.

Engines some small corrosion areas

*Suggestion : The engines require repaint in the small areas with broken coatings.*

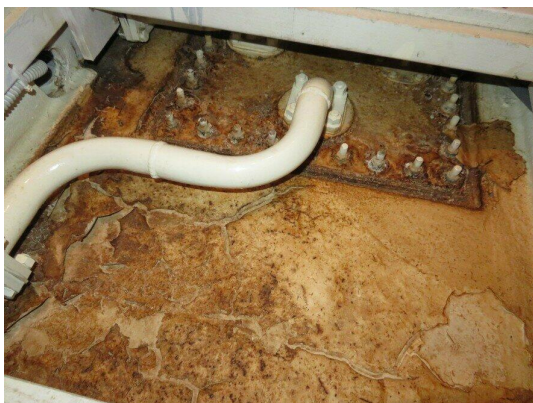
The fuel tank top in the accommodation passageway bilge requires repainting. The fuel transfer pump was checked working.

Fuel tank top to repaint

*Suggestion : The fuel tank top in the accommodation passageway bilge requires repainting.*

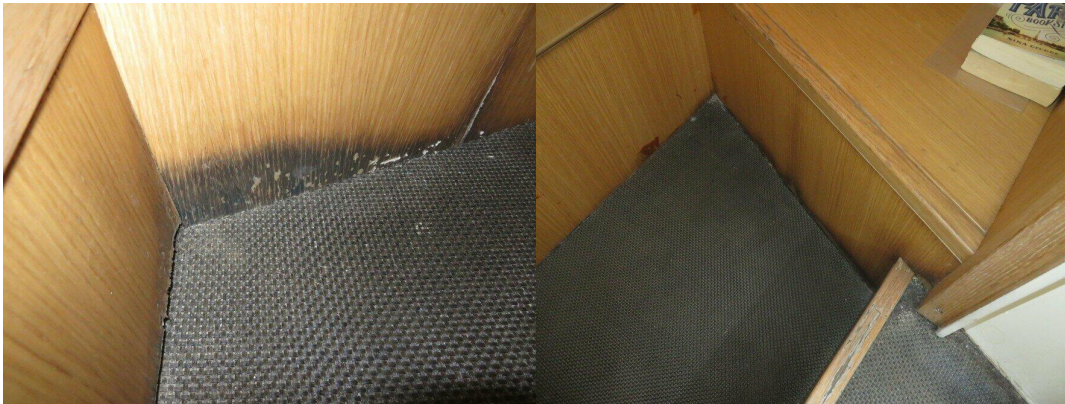
The crew accommodation was with various wet damage (blackening) to the woodwork near floor level.

Crew accommodation some blackening to panelling at floor level

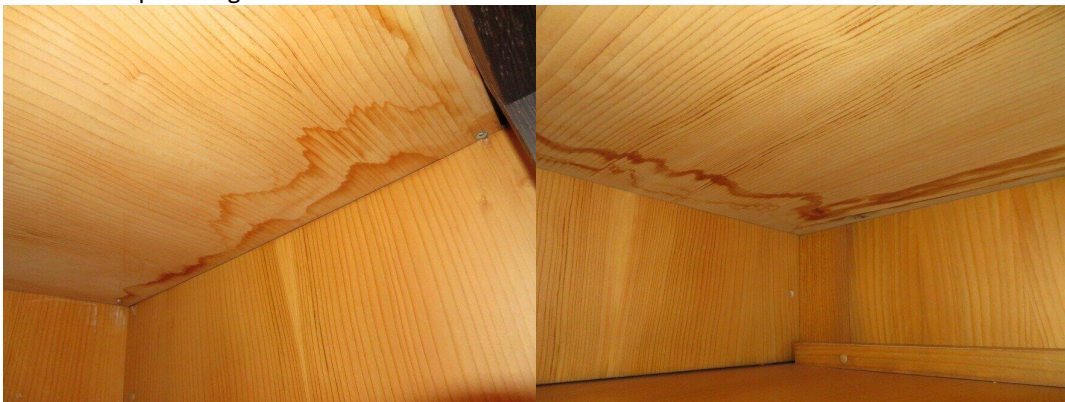
There were various previous leaks which had occurred into the double cabins cupboards. These were cosmetic and do not persist.

Old leaks in cabin cupboards

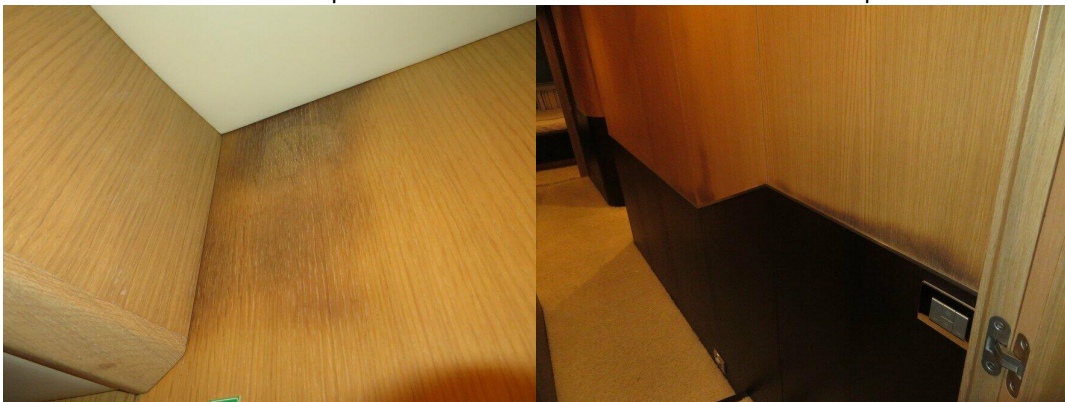
Blackening in guest passageway

*Suggestion : Several panels of accommodation passageway panelling could be replaced due to previous minor wet damage.*

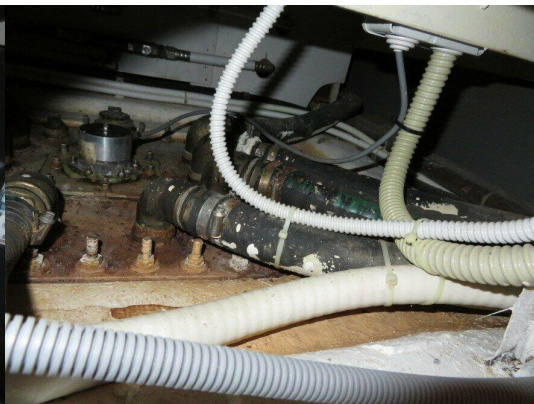
Top of black water tank requires painting

*Suggestion : Top of black water tank to paint.*

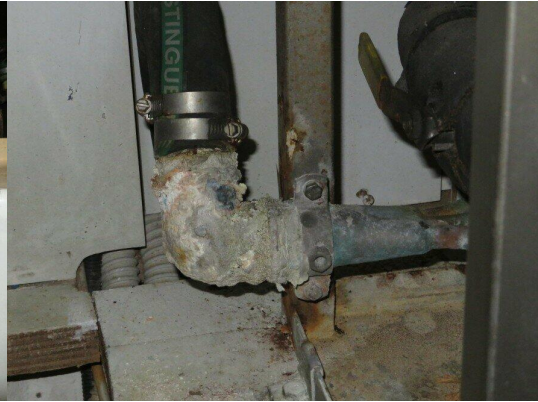
Airconditioning checked working on heat function. External condition of system satisfactory except for minor leak to circulating pump connection. Minor leak also at seawater elbow connection. Compressors with coatings intact.

Minor previous leak seawater elbow

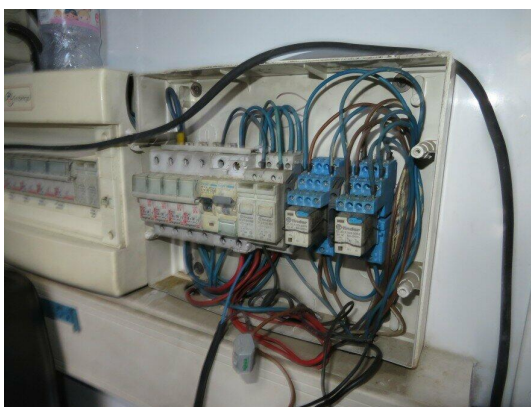
Electrical installation was generally working. One panel in lazarette requires the casing to be provided/fitted. One cable channel in lazarette was without cover. There were no burnt items or wet damage seen.

Electrical panel missing cover

*Recommendation : One electrical panel in lazarette requires the casing to be provided/fitted.*

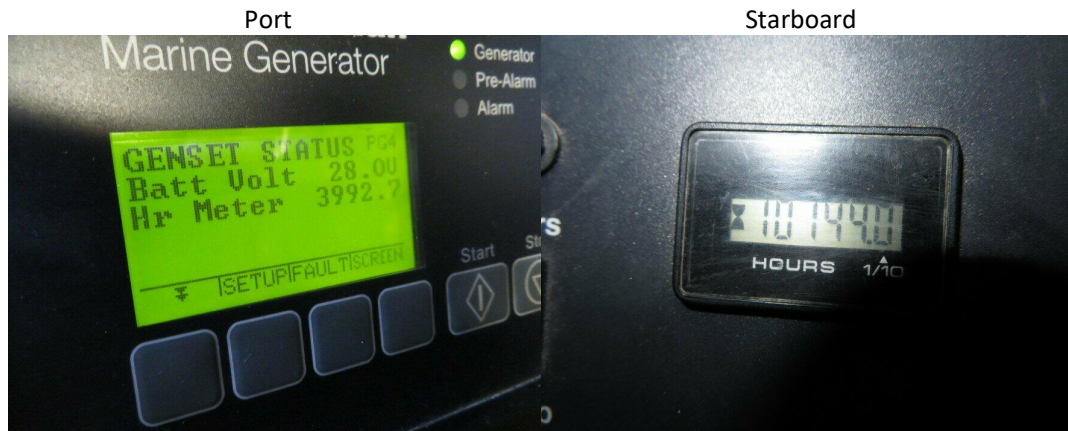
The Port generator is renewed and it is large capacity 35kW. The older Starboard 23kW is with excessive hours and requires replacement. It is still used at anchor because it is quieter.

The starboard generator requires repainting and the soundproofing requires replacement. The generators were otherwise in good running condition without abnormal sound or vibration and there were no leaks of fuel, oil, coolant or seawater. Lubricating oil looked normal.

Port generator 3992 hours

Starboard generator 10144 excessive hours

*Suggestion : The starboard generator soundproofing requires replacement.*

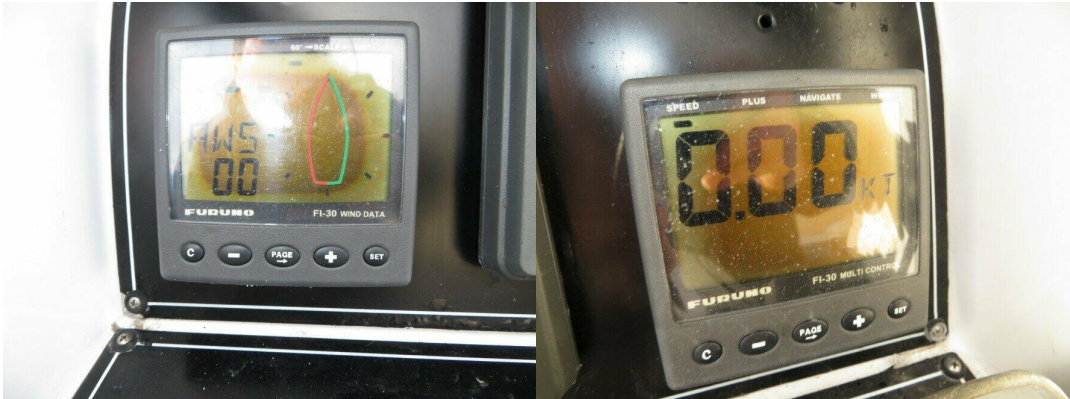
Flybridge small instruments with sun damage    Flybridge small instruments with sun damage

*Suggestion : The flybridge wind indicator and speed log are with sun damage and replacement could be considered.*

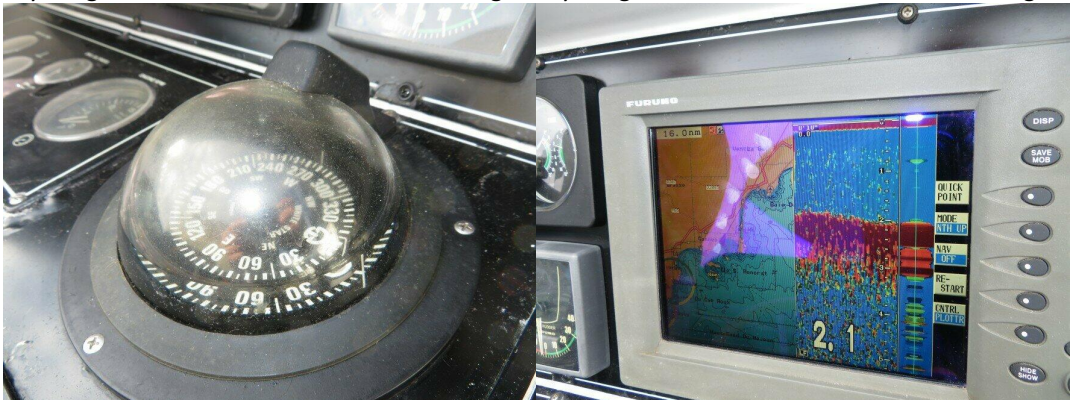
Magnetic compasses with bubble    Flybridge chartplotters working

*Recommendation : The magnetic compasses require refilling as they are with bubble.*

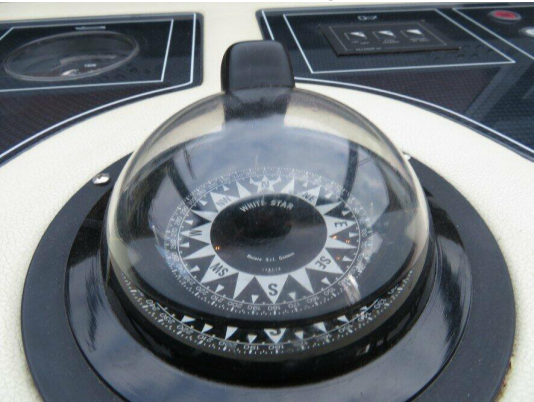
Compass with bubble
