Oref : 19002/BR(en0713xr)

PRE-PURCHASE CONDITION SURVEY REPORT

S/Y ENJOY

At Aghios Nikolaos Jul/19

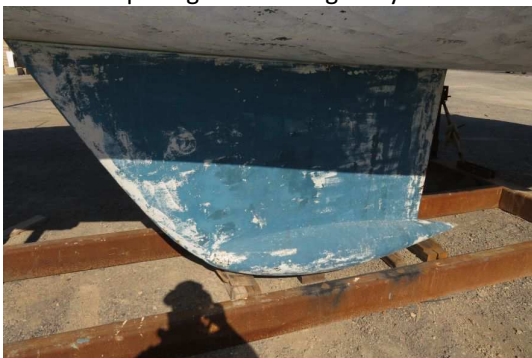
Iron keel bolted to the hull. The keel was without wastage but has small chips of the coating that require filler and priming. The hull to keel join was without spacing when lifting the yacht. The keel was square to the hull. There were no damages to the leading or trailing edges. The hull around the hull to keel join was without cracks or deflection.

Keel without wastage

Suggestion : Keel has small chips of the coating that require filler and priming.

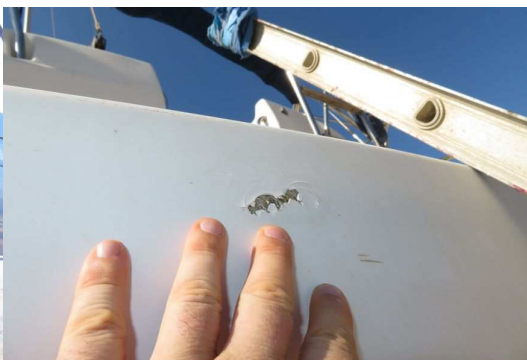
Topsides gelcoat is part painted over 2.0m x 0.60m at starboard side after previous contact with the dock (damage said to be only a scrape). There were no damages seen. The stern requires a small gelcoat repair.

Small gelcoat repair required at stern

Suggestion : The stern requires a small gelcoat repair.

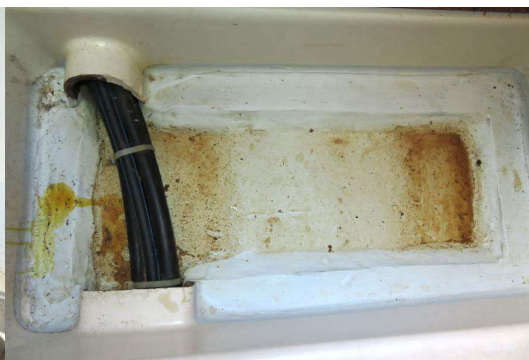
No cracks at interface of liner and hull

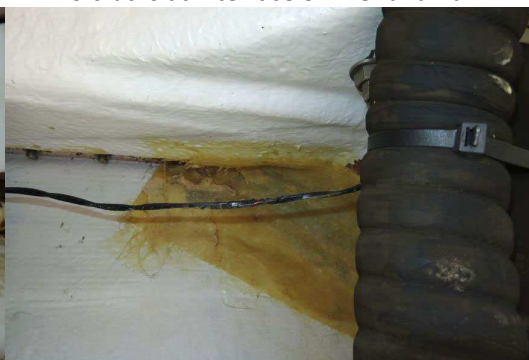
At the interior side under the stern cleats there were fiberglass repairs.

Fiberglass repairs under stern cleats

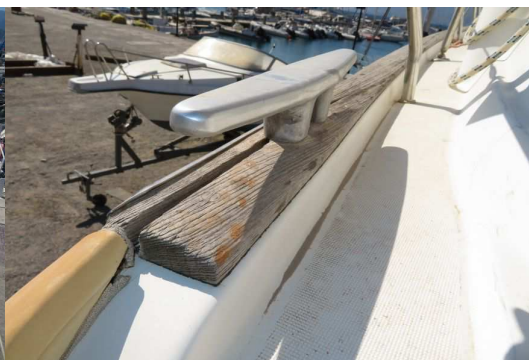
The wooden caprail is cracked/split at both stern cleats. At the interior side there are fiberglass repairs.

Caprail split at stern cleats

Suggestion : The wooden caprail is cracked at both stern cleats. The cracked section could be replaced for cosmetic improvement.

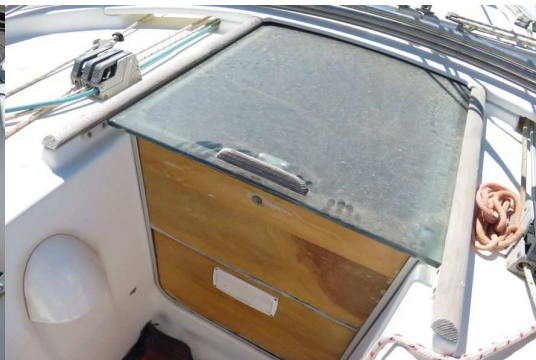
Companionway weathertight

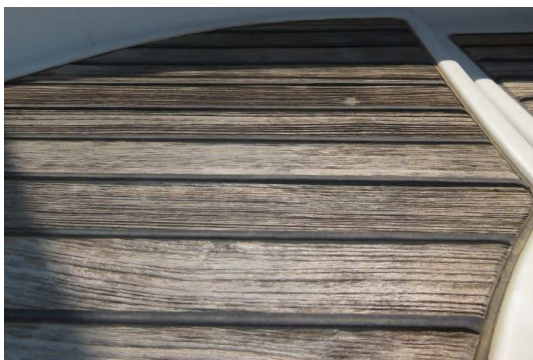
Cockpit teak caulking is raised. Stern platform caulking partly missing. Requires recaulking.

Cockpit teak
caulking raised

Suggestion : Cockpit teak caulking is raised. Stern platform caulking partly missing. Requires recaulking.

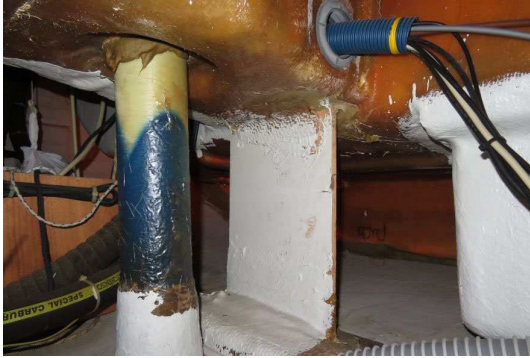
Rudder tube secure

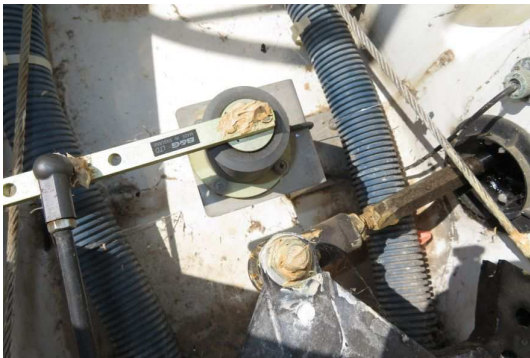
Rudder angle indicator secure

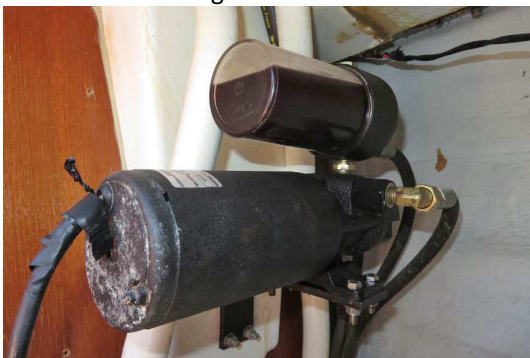
No leaks at hydraulic power pack

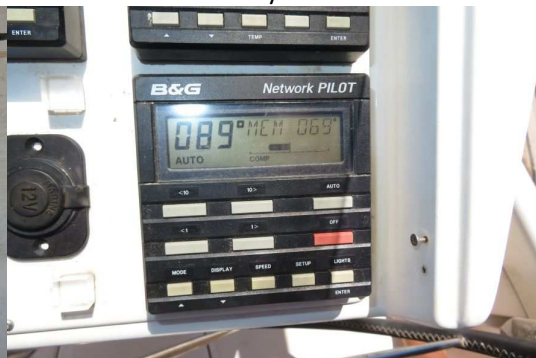
Hydraulic autopilot. Hydraulic power pack and cylinder without leaks. Connections at cylinder with typical minor corrosion. Autopilot was checked working on sea trial.

Checking autopilot

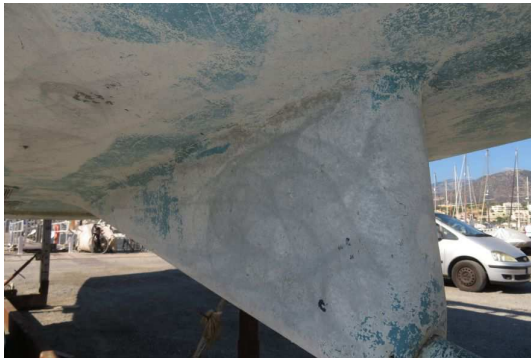
Skeg secure to the hull

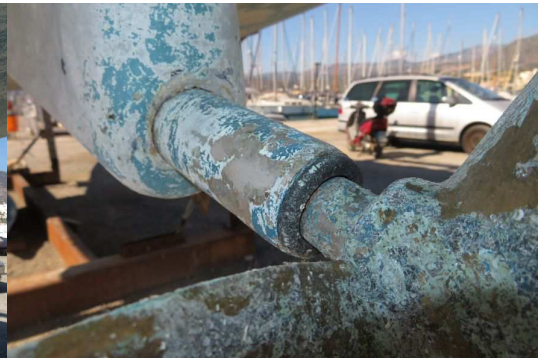
No excessive play at cutlass bearing

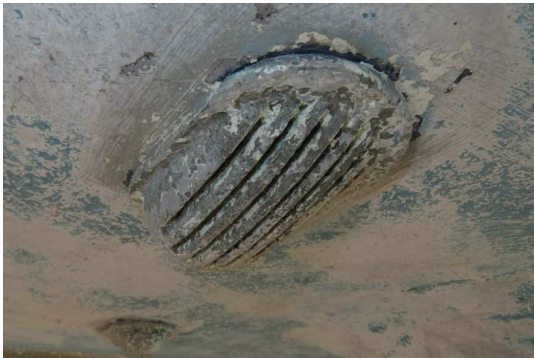
Grating without wastage

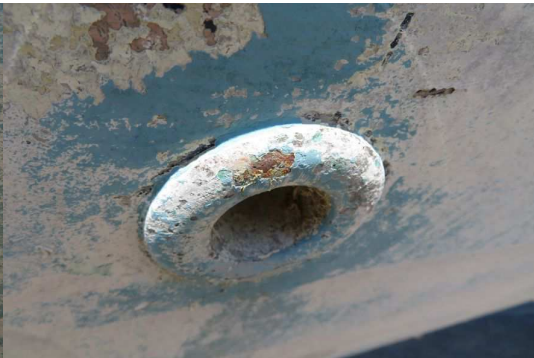
Through hull neck without wastage

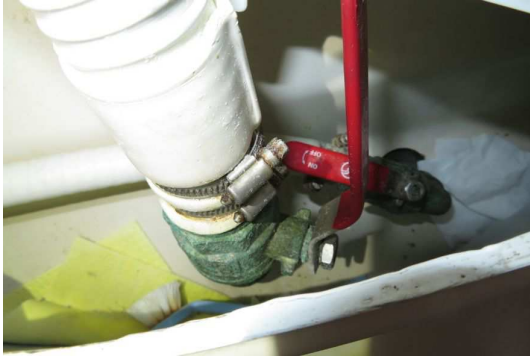
No leaks

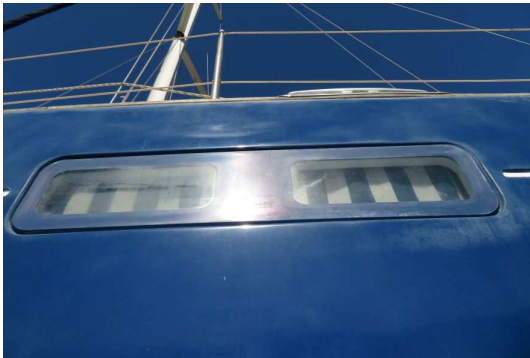
Hull windows intact

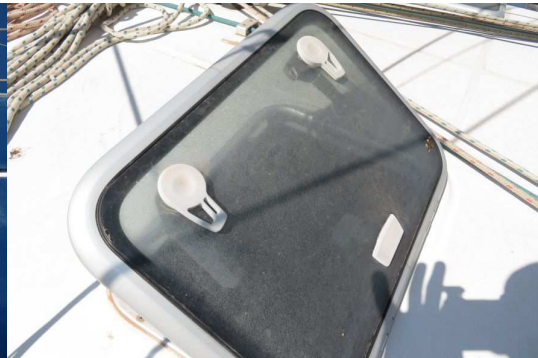
Hatch window framing not separating

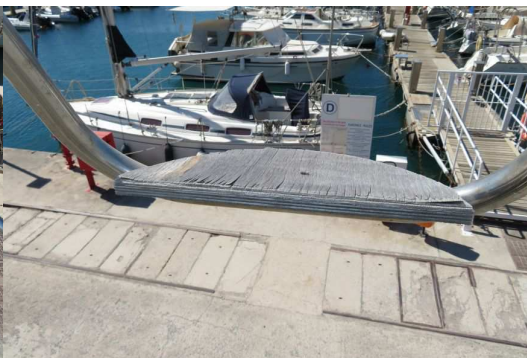
Step deteriorated

Suggestion : Bow pulpit wooden step is deteriorated and could be replaced.

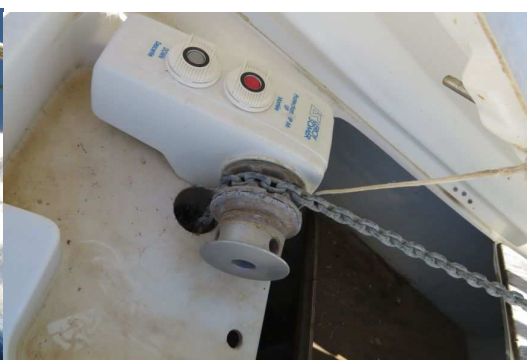
Anchor windlass secure

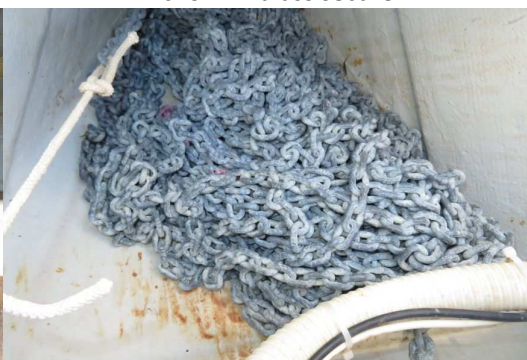
Chain with galvanising intact

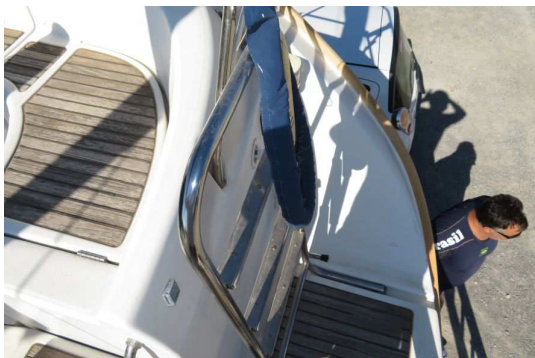
Boarding ladder secure and without damages.

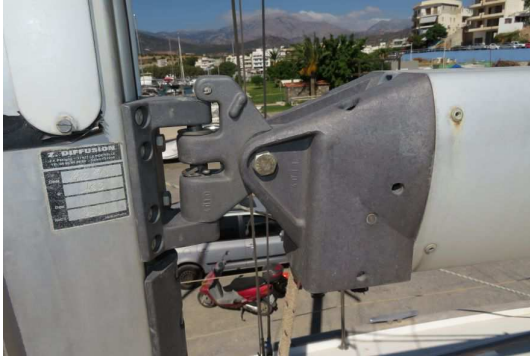
Boom gooseneck secure

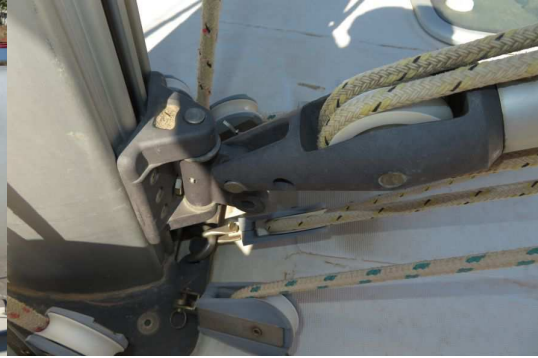
Boom vang fittings secure

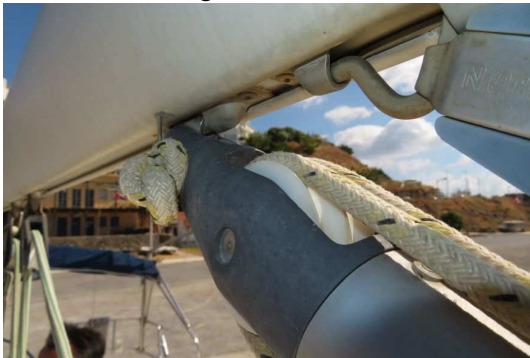
Boom vang fittings secure

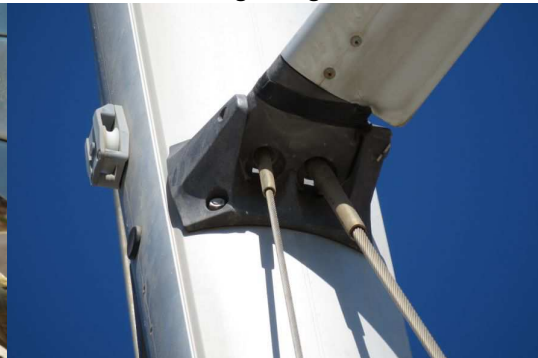
Spreaders secure

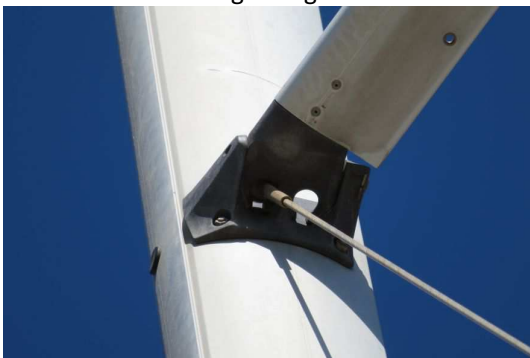
Spreaders secure

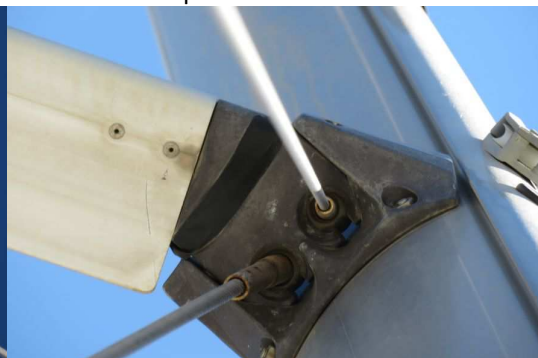
Spreaders secure

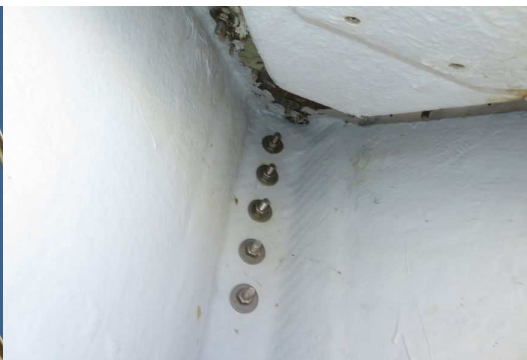
Stemhead bolts without corrosion

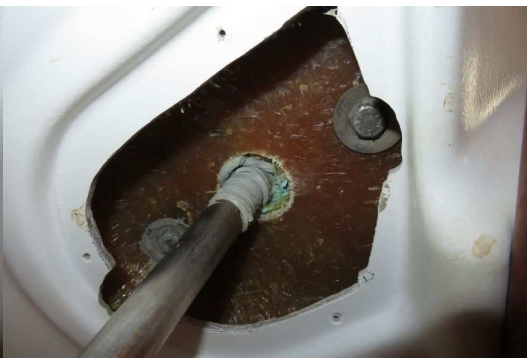
No cracks below shroud deck plates

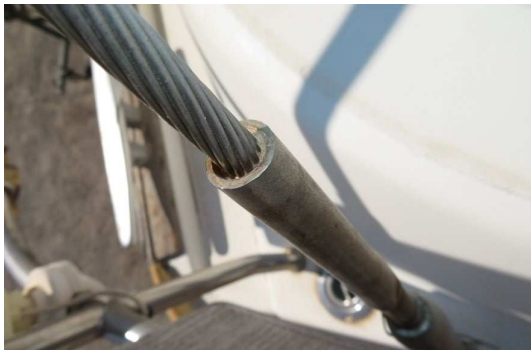
No broken wires at entry to swage terminals

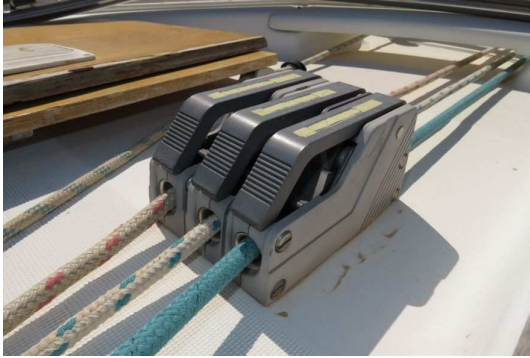
Rope jammer

The rope jammers and deck organisers were secure and without damage.

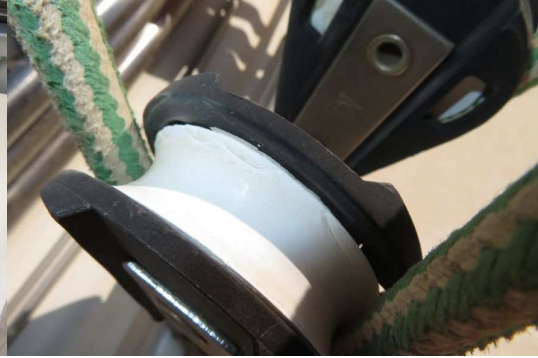
The sheave blocks were with deterioration and chipping from UV deterioration. They require renewal.

Chipped sheave block

Suggestion : The sheave blocks of the running rigging were with deterioration and chipping. They require renewal.

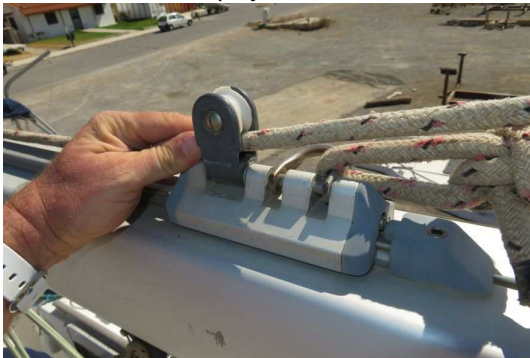
Outhaul requires replacement.
Sheave block chipped

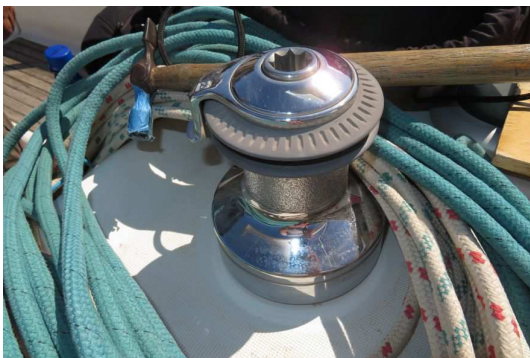
Winch

Starboard cockpit winch is very stiff it requires service.

Recommendation : Starboard cockpit winch is very stiff it requires service.

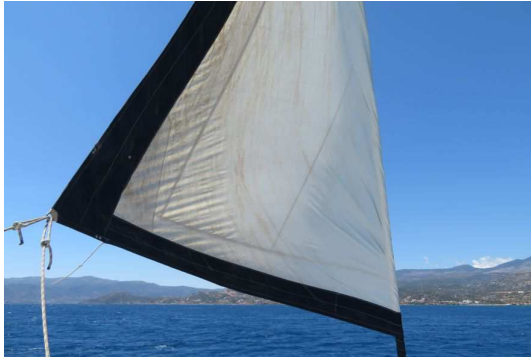
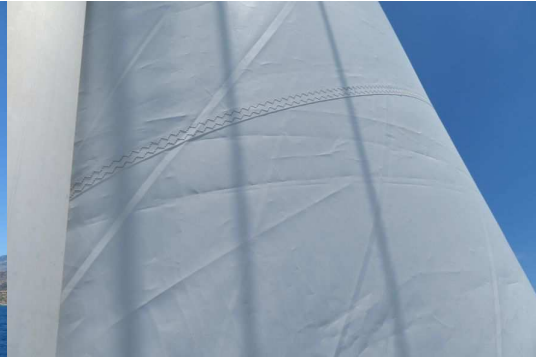
Genoa

Sails of 2011-2012. They were without damage and in satisfactory condition.

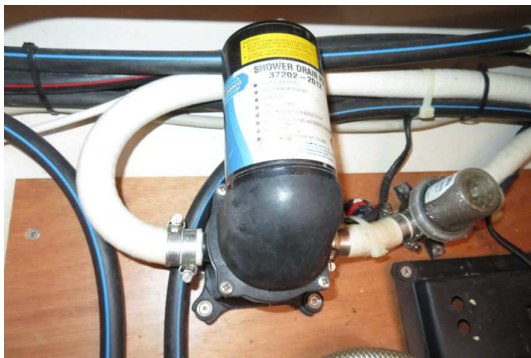
Manual bilge pump at the cockpit. Manually activated electric bilge pump. Both serving the saloon common bilge. Checked working.

Electric bilge pump no leaks

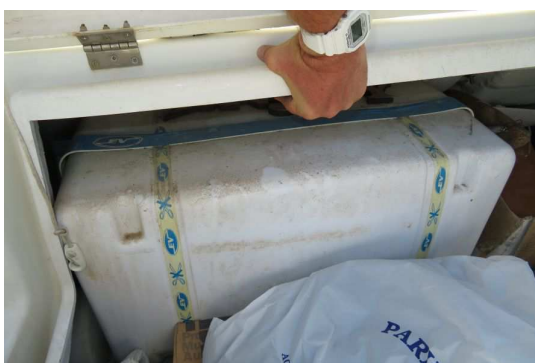
Liferaft casing intact

Recommendation : Liferaft requires service.

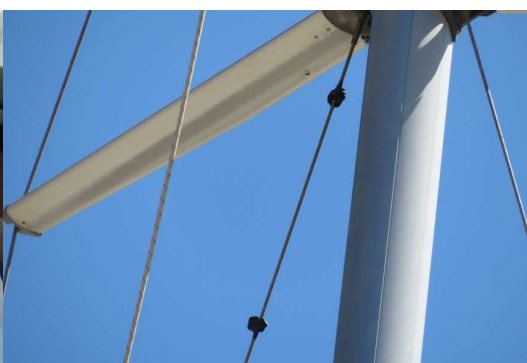
The radar reflector is detached and missing from the standing rigging (tube type).

Radar reflector detached

Recommendation : Radar reflector is required to be installed.

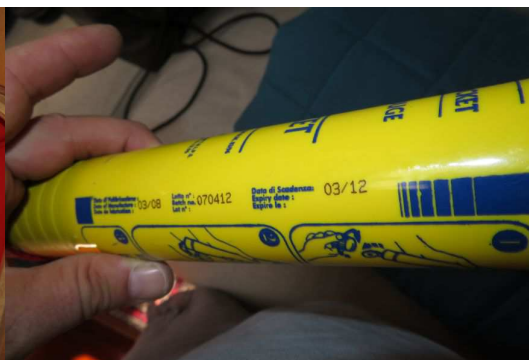
The pyrotechnic flares have expired.

Pyrotechnics expired

Recommendation : Pyrotechnic flares to be provided at least Greek kit (3 x Red Parachute, 3 x Red Hand Flare, 2 x Orange Smoke.

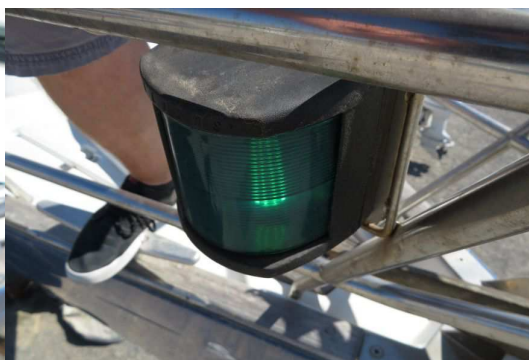
Side lights working

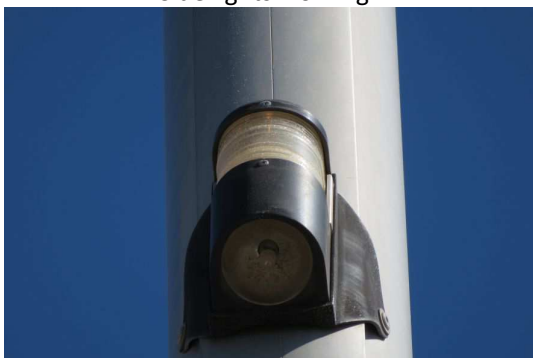
Deck light bulb requires replacement. The remainder of lights were working. Anchor light could not see.

Steaming light working.
Deck light not working

Suggestion : Deck light bulb requires replacement.

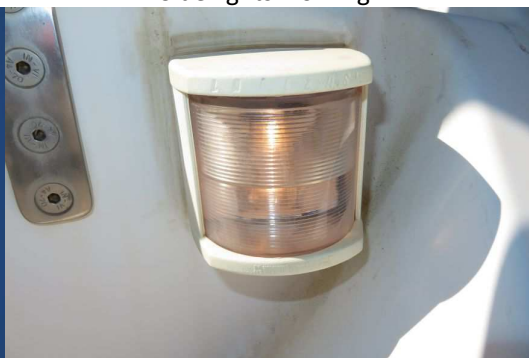
Stern light working

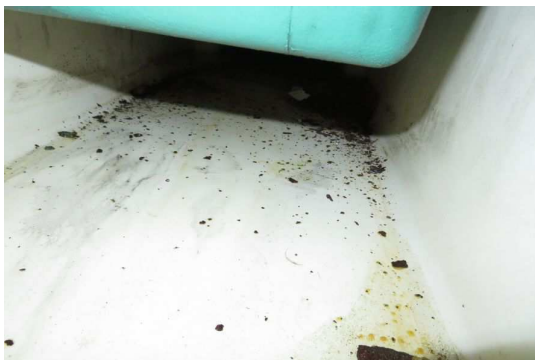
Enclosed centreline engine compartment. Bilges clean of oils and water.

Engine bearer bilges clean

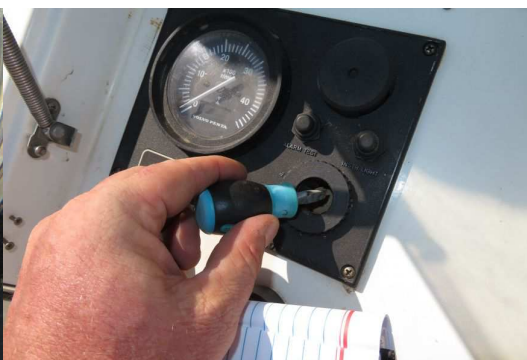
Engine key socket is broken and modified so that screwdriver is used to turn key.

Engine start with screwdriver

Suggestion : Engine key socket is broken and modified so that screwdriver is used to turn key. A new key socket could be installed.

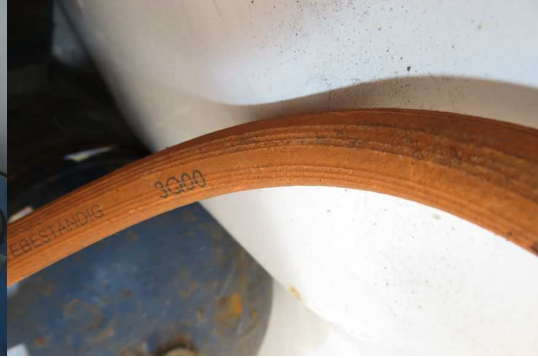
Dedicated gas locker with drain. Single cylinder installation. Gas flexible hoses have time expired since 2006. Gas regulator has time expired since 2010. Gas cooker was without corrosion. Gimbal lock was working.

Gas flexible hoses expired

Recommendation : Gas flexible hoses have time expired since 2006 and requires replacement.

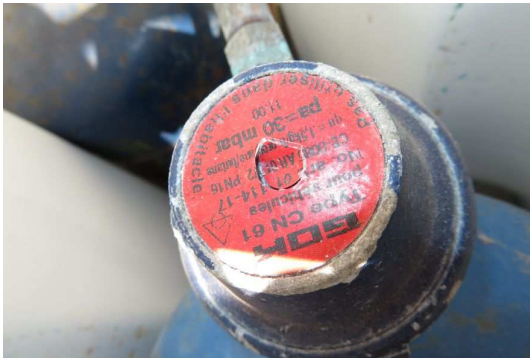
Regulator expired

Recommendation : Gas regulator has time expired since 2010 and requires replacement.

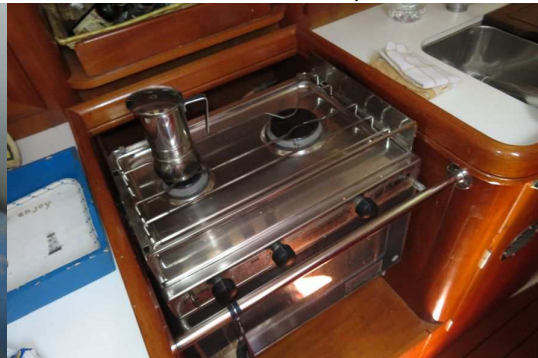
Cooker sits flat

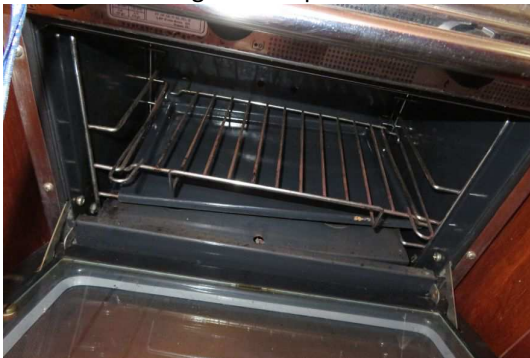
Oven was clean

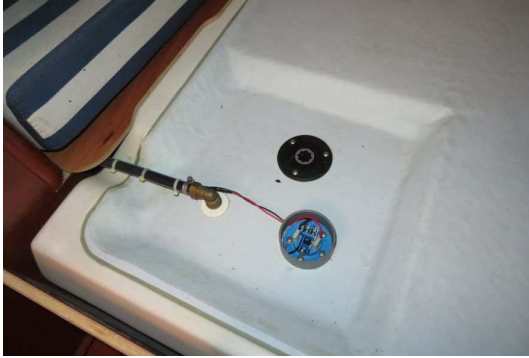
Fresh water tank externally intact

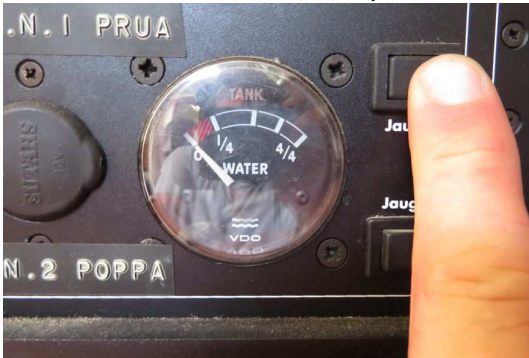
Level gauge working

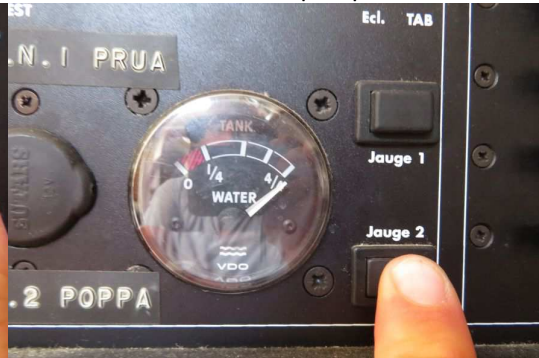
Level gauge working

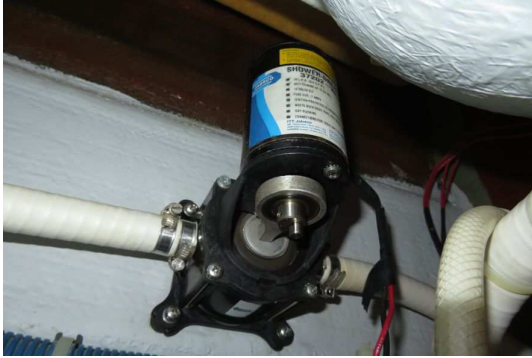
Shower drain pump without leak

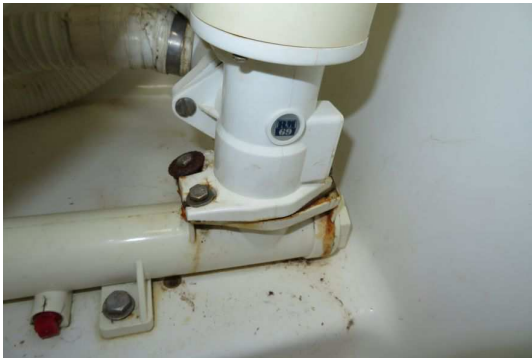
The forward toilet electric pump is broken and requires replacement. The previous manual pump is on board. The manual pump was without sign of leak.

Electric pump not working

Suggestion : The forward toilet electric pump is broken and requires replacement. The previous manual pump is on board.

- 47.23. The fresh water pump requires to be secured down properly.
- 47.24. The forward toilet electric pump is broken and requires replacement. The previous manual pump is on board.

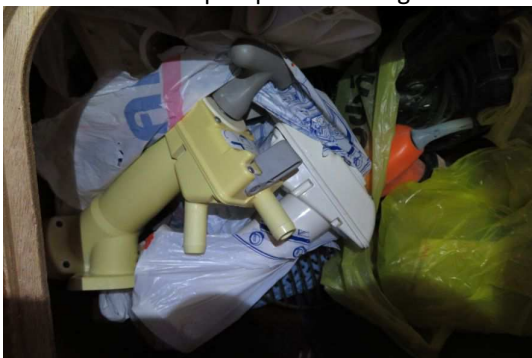
Spare old manual pumps

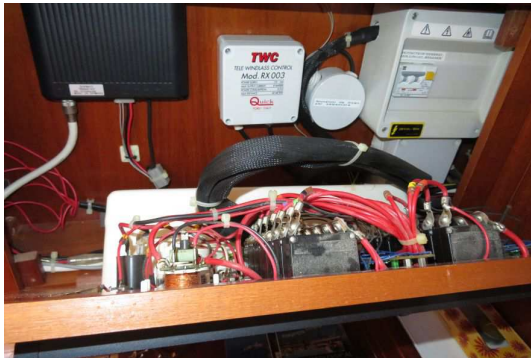
No wet damage or burnt items

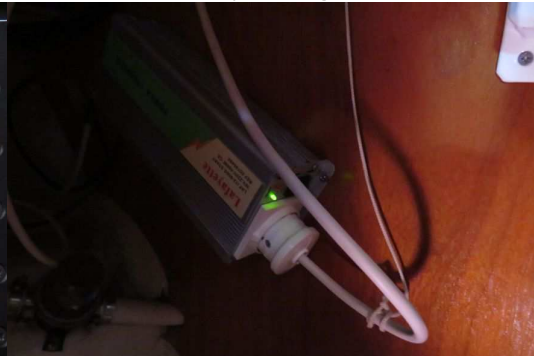
Inverter working

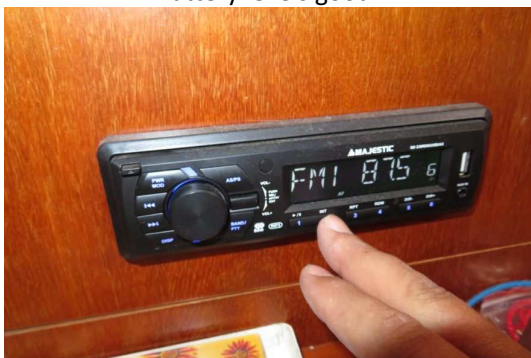
Stereo working

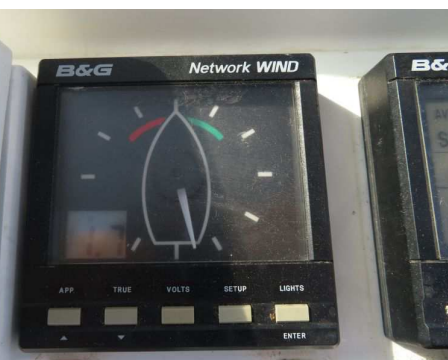
Wind direction working

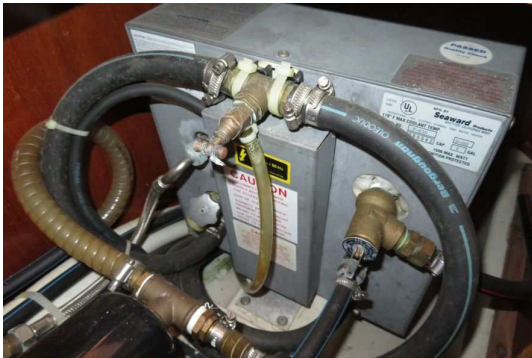
Water heater no leaks from connections

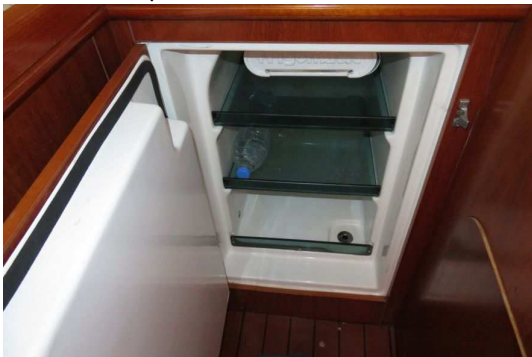
Refrigerator internals intact

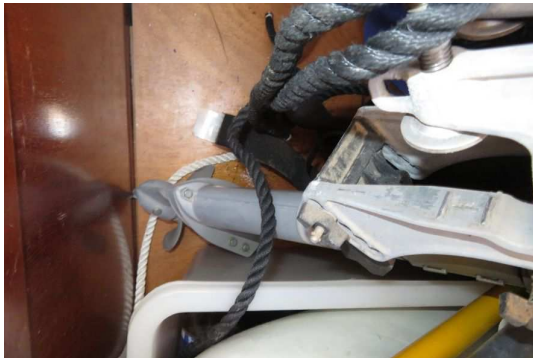
Outboard

Honda BF2DX 2hp 4 stroke outboard of 1998. Serial No. BZBF-1029566. Inflatable tender looked old.

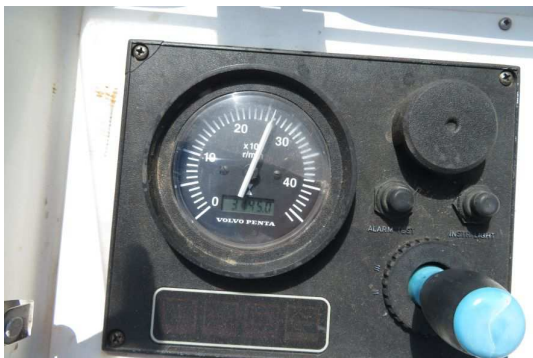
Checking engine

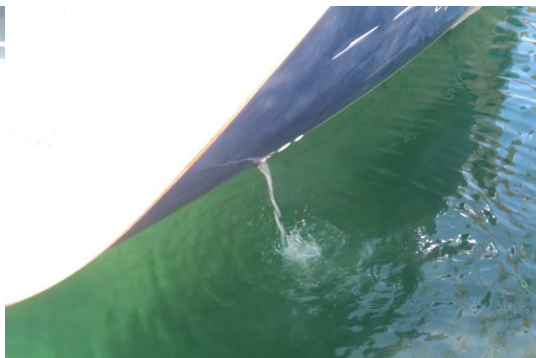
Exhaust clean
