Date : 25 January 2021

PRE-PURCHASE CONDITION SURVEY REPORT

S/Y LAGOON 420 At Poros-Koilada Jan/20

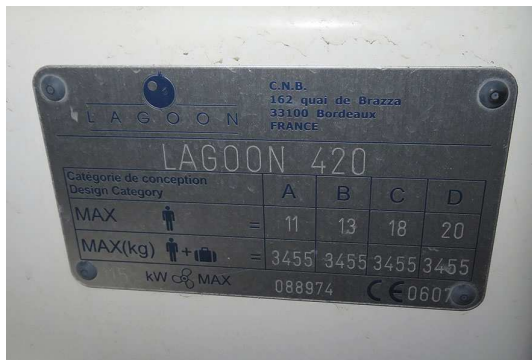
CE Plate

According to CE plate at the cockpit, the yacht is CE marked for Category A 11 Persons. The HIN No. FR-CNB420000000 indicates a 2008 model built in 05/2007.

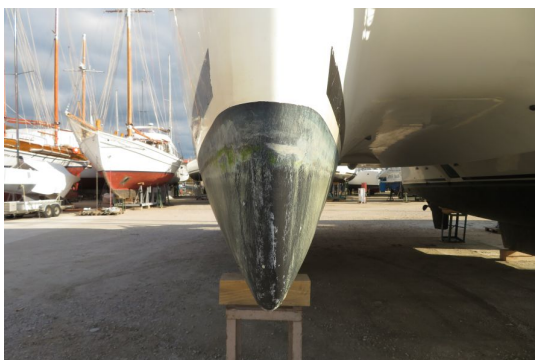
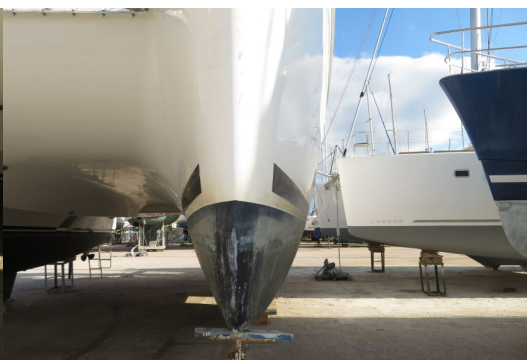
No damages at bow

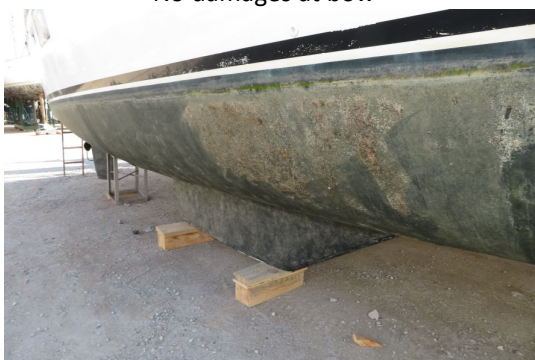
Hull surfaces fair

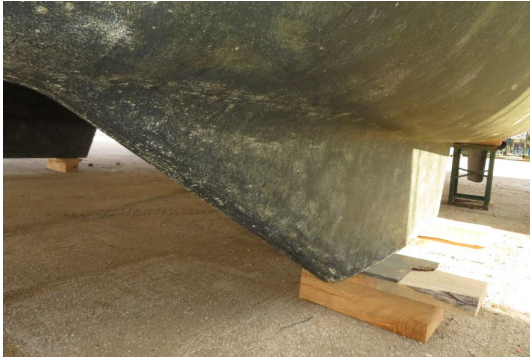
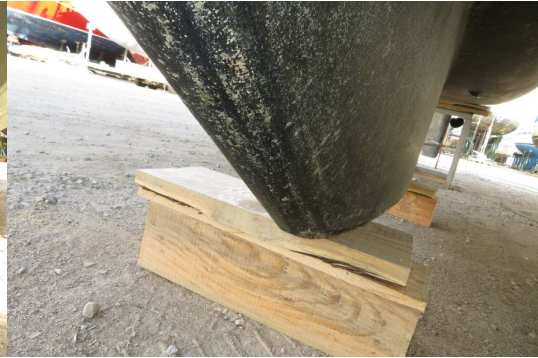
No damages to hull at leading edge

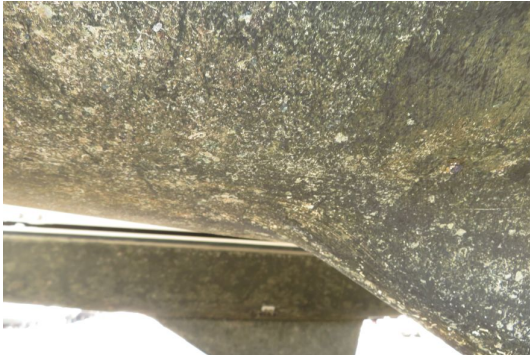
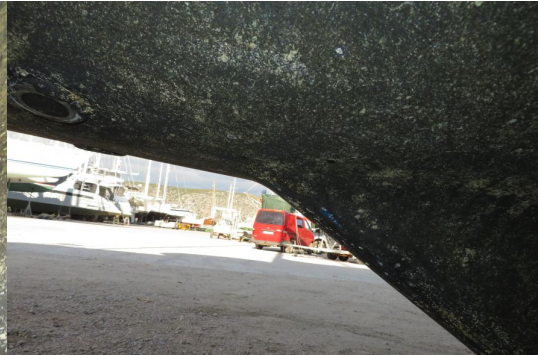
No cracks to hull around leading edge

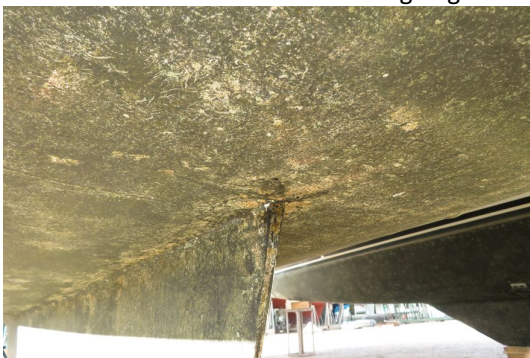
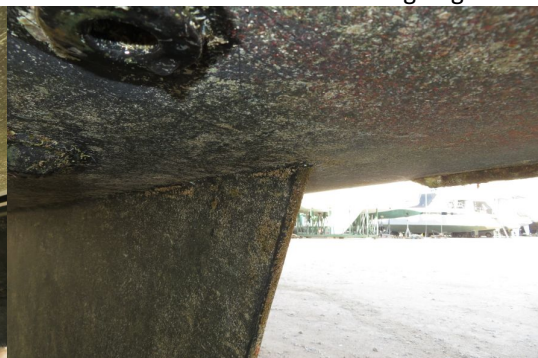
No cracks to hull around trailing edge

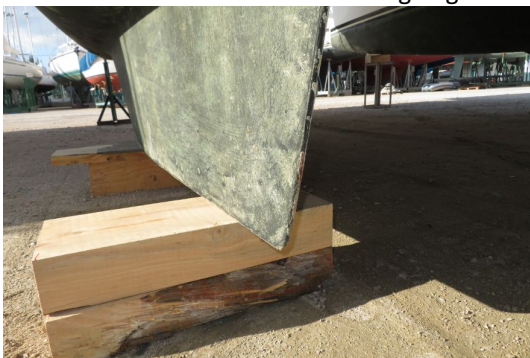
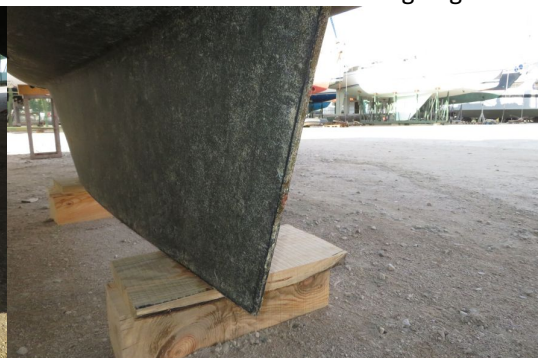
No damages at trailing edge

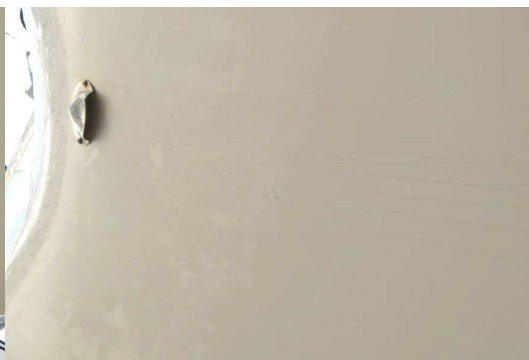
Bridge deck underside near starboard forward edge. There is crazing in this location which requires grinding and gelcoat minor repair. There was no delamination detected by hammer sounding there however which means it is cosmetic.

Crazing at bridge deck underside

Suggestion : Bridge deck underside near starboard forward edge. There is crazing in this location which requires grinding and gelcoat minor repair. There was no delamination detected by hammer sounding there however.

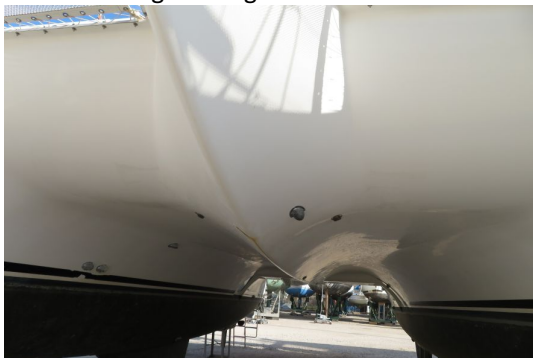
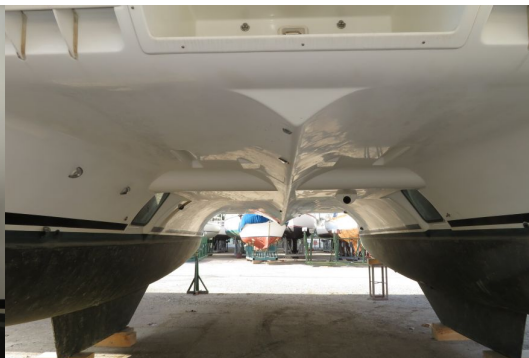
Bridge deck underside generally fair

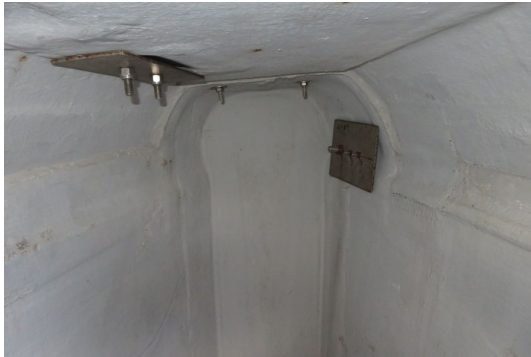
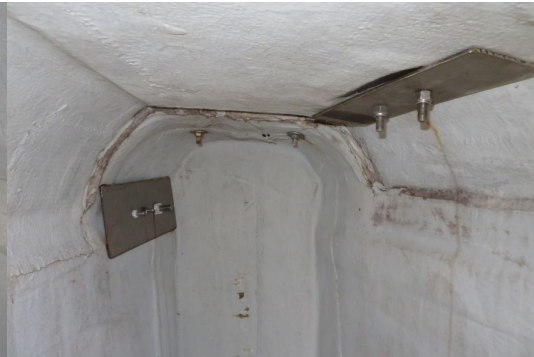
Bow internals intact

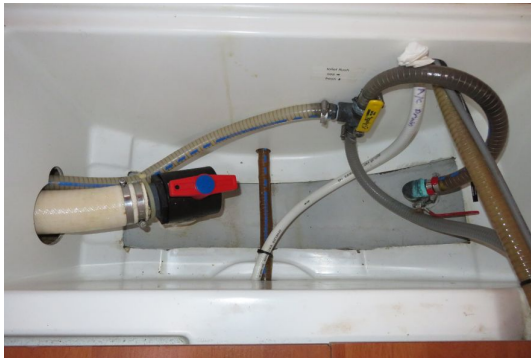
Bilge internals intact

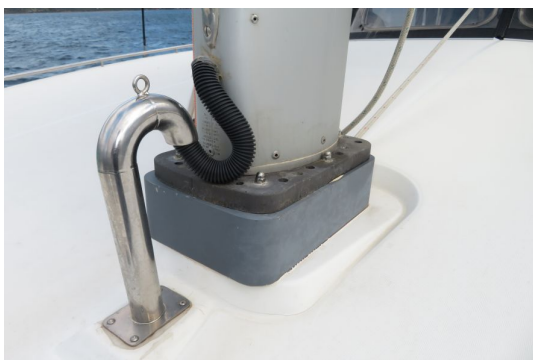
No compression at mast step

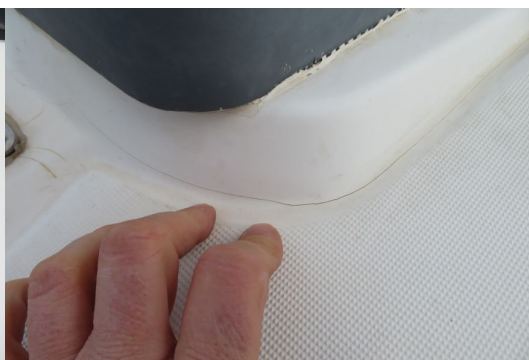
There was no compression at mast deck step. There was only cosmetic crazing at mast step. The coachroof was without delamination detected during hammer sounding.

Cosmetic crazing at mast step

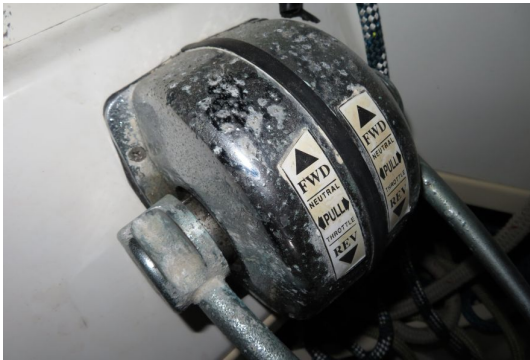
Engine controls with cosmetic deterioration of the chrome plating

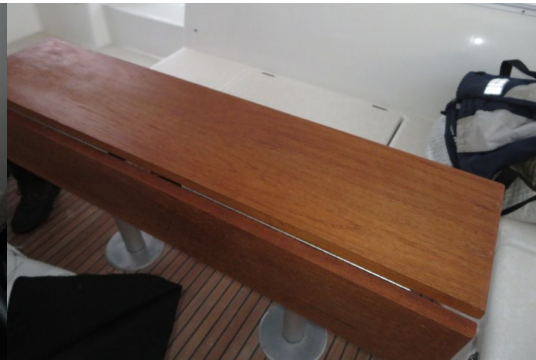
The cockpit table is replaced with nice folding version. The original blocks the generator hatch.

Table in good condition

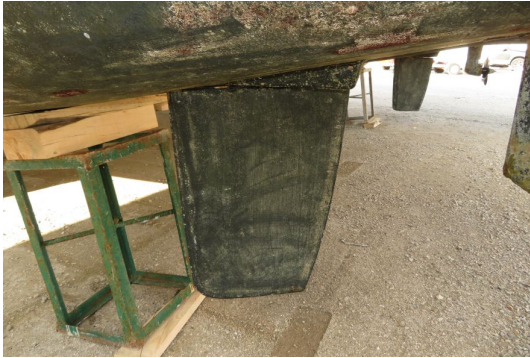
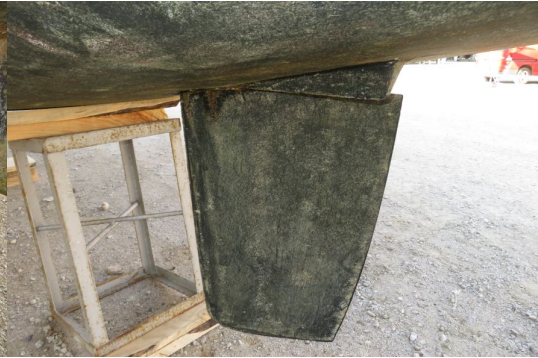
Rudder intact

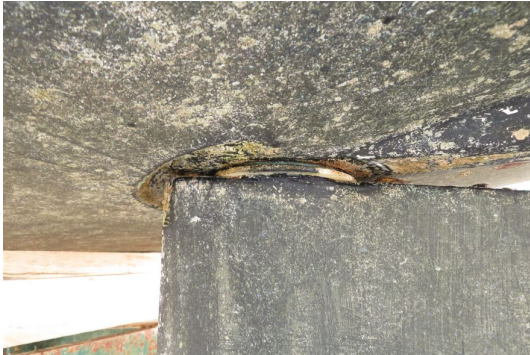
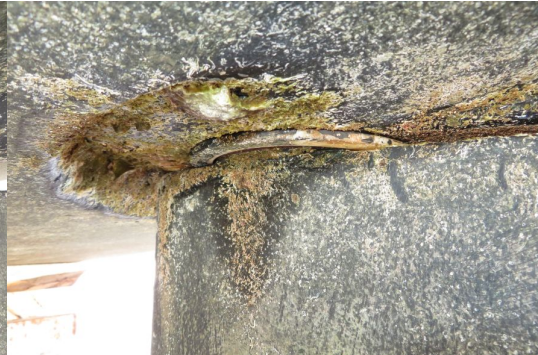
No cracks at top of rudder

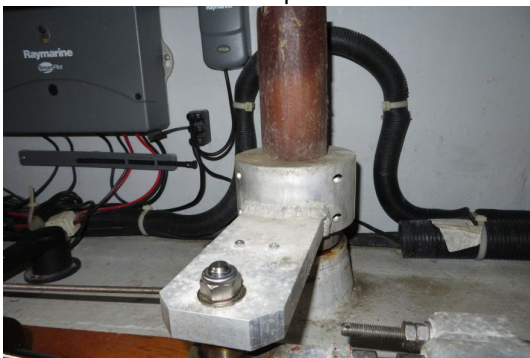
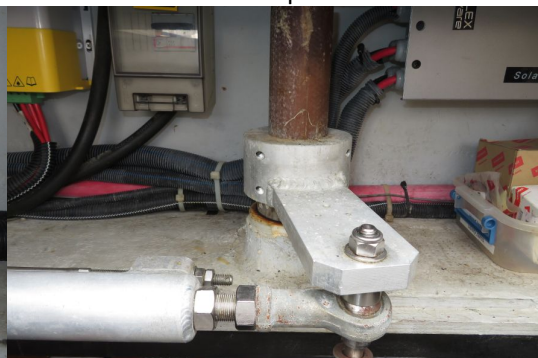
Steering gear without corrosion

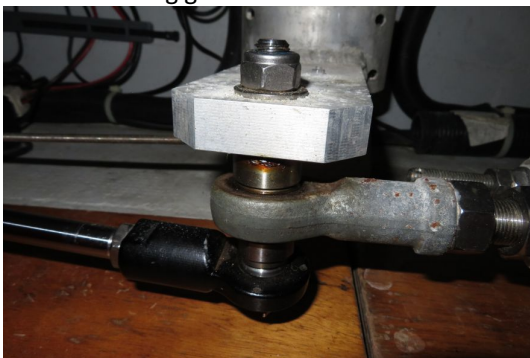
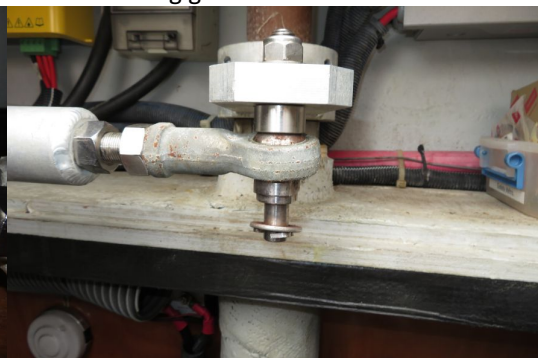
Drag links intact

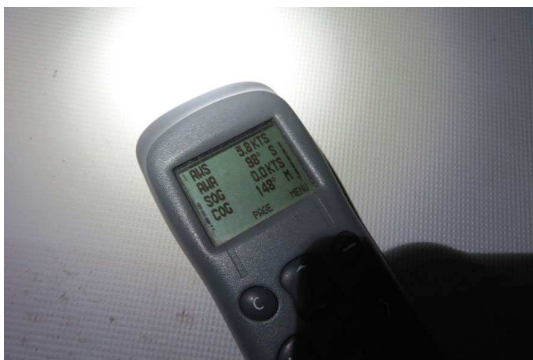
Autopilot control at the cockpit Raymarine ST6002 Smart. It is not connected with any wires (data or power). The chartplotter has autopilot display/control but it is not really useful. The autopilot remote was working but is without holder and power cable at the cockpit. The cockpit autopilot control requires to be provided and may not be working.

Autopilot remote working

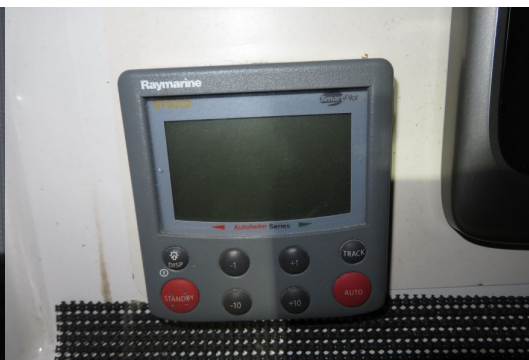
Autopilot control not working

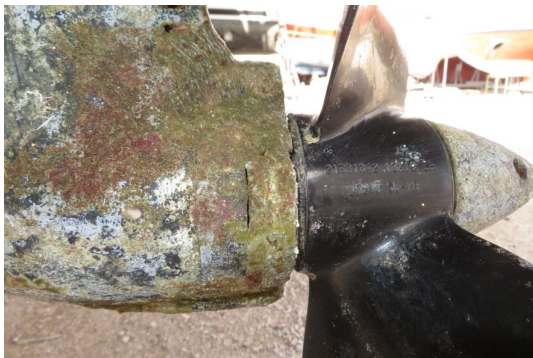
Saildrive leg anodes were secure and suitable for further use. No abnormal galvanic action was seen during the survey.

Saildrive anode secure

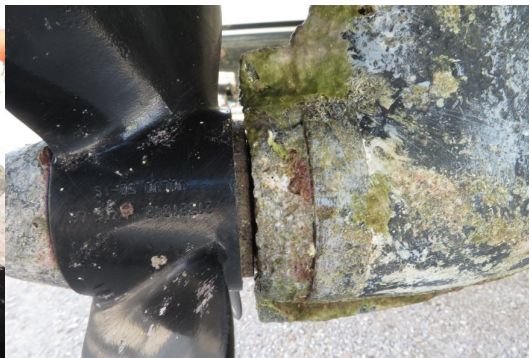
Saildrive anode secure

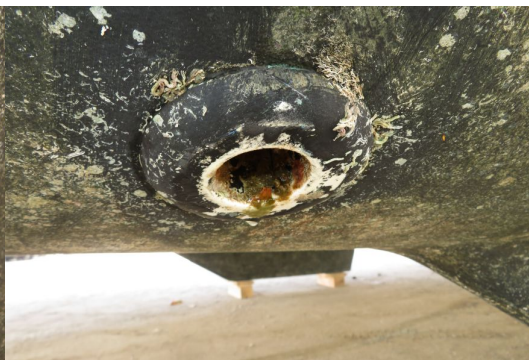
Plastic through hull without cracks

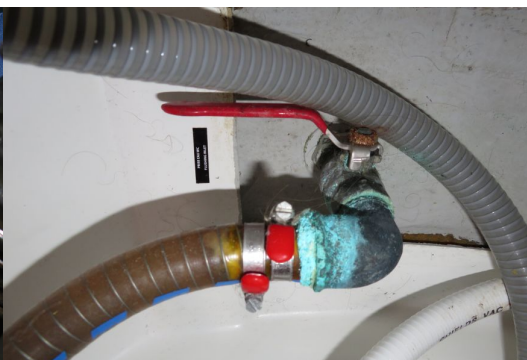
Owner toilet seawater inlet valve has a small leak at the elbow. Requires hose to be reseated and the barb checked for corrosion. Owner sink outlet valve has a small leak. The remainder of valves were in satisfactory external condition.

Small leak at owner toilet inlet valve

Recommendation : Owner toilet seawater inlet valve has a small leak at the elbow. Requires hose to be reseated and the barb checked for corrosion.

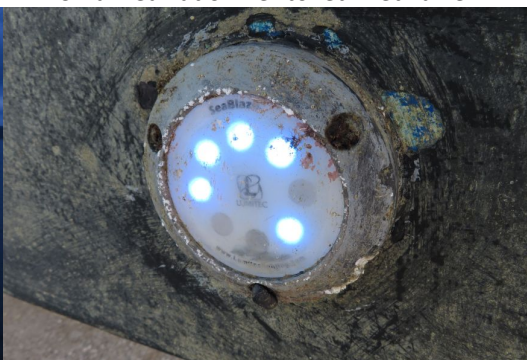
Underwater inner light for each hull do not work.
Underwater stern light starboard is partly defective.

Starboard underwater light partly failed

Suggestion : Underwater stern light starboard is partly defective and requires replacement.

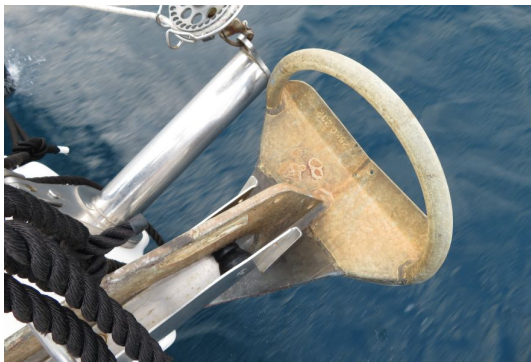
25Kg. Rocna anchor without wastage. Electric anchor windlass secure and working. Chain with galvanising reasonably intact. Brittany kedge provided.

Rocna main anchor

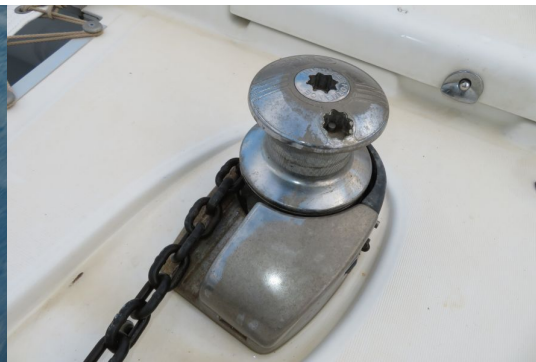
Windlass secure

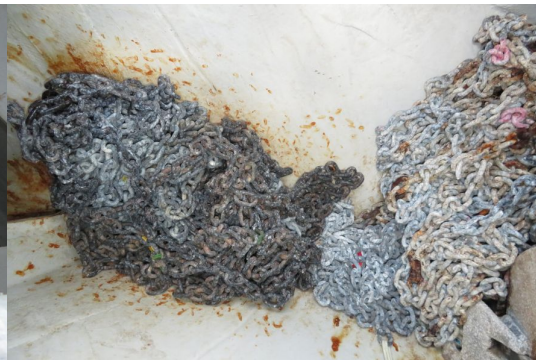
Chain with galvanising reasonably intact

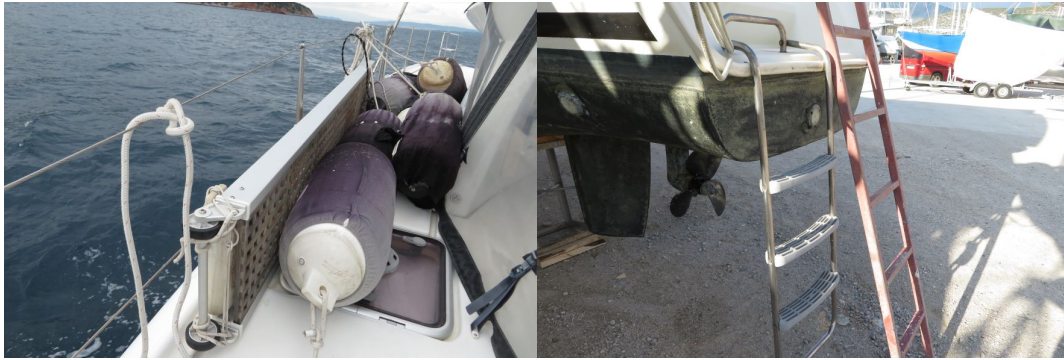
Manual passerelle looked intact.

Boarding ladder secure and without damages.

Passerelle

Boarding ladder without damages

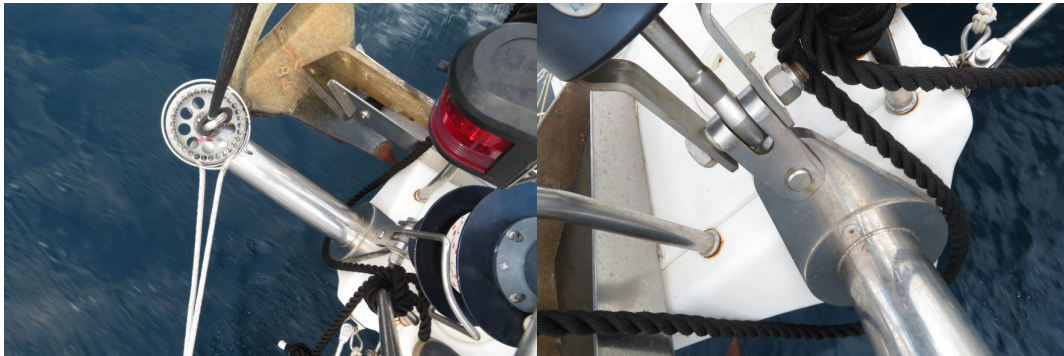
Gennaker bowsprit secure

Furler fork secure and without damages

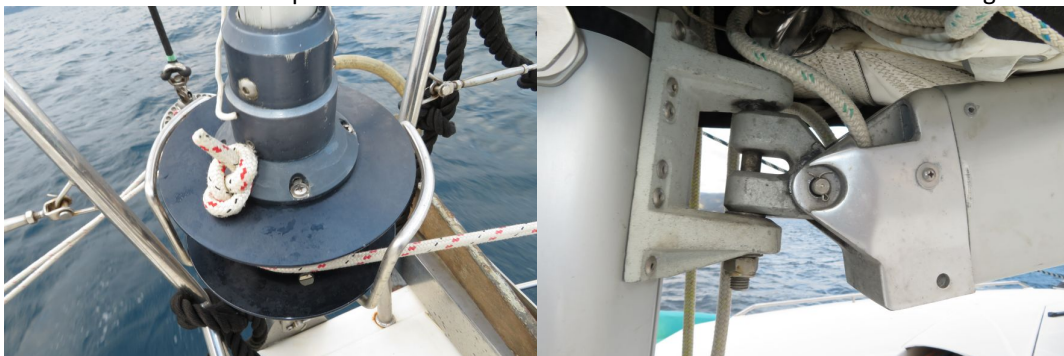
Furler drum intact
and with free movementBoom gooseneck secure
and without fracture

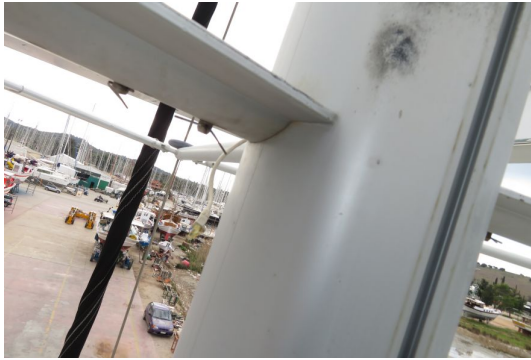
Spreader secure

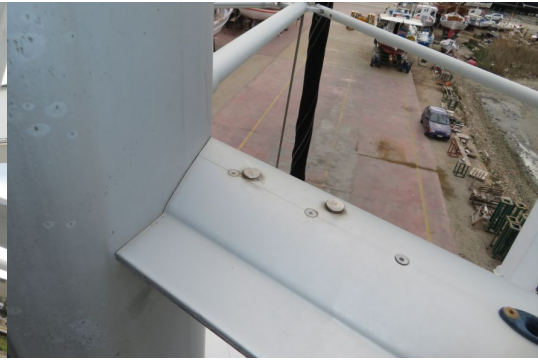
Spreader secure

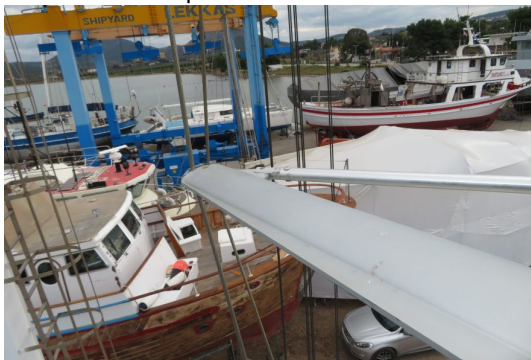
Spreader intact

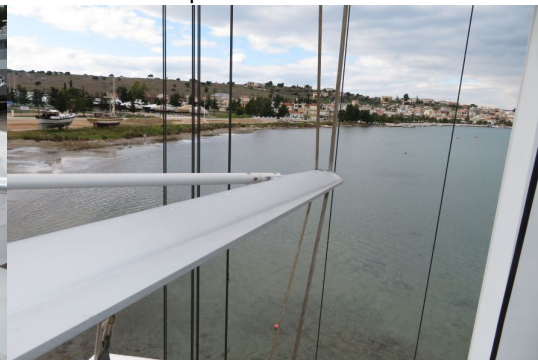
Spreader intact

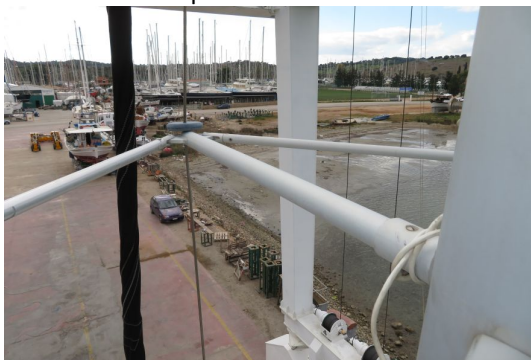
Jumper strut secure

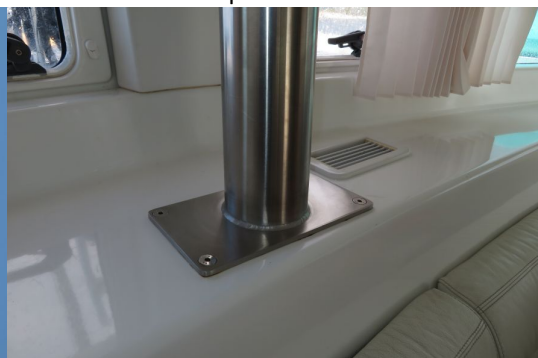
At the interior side the compression post without movement.

Compression post secure

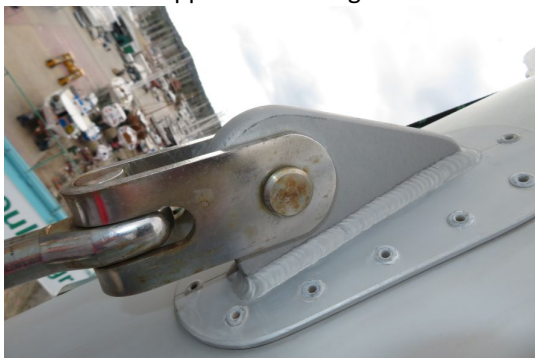
Shroud upper fittings secure

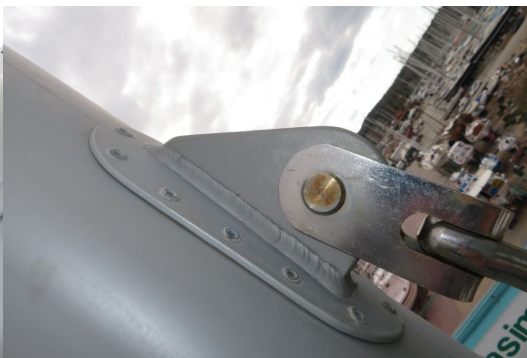
Shroud upper fittings secure

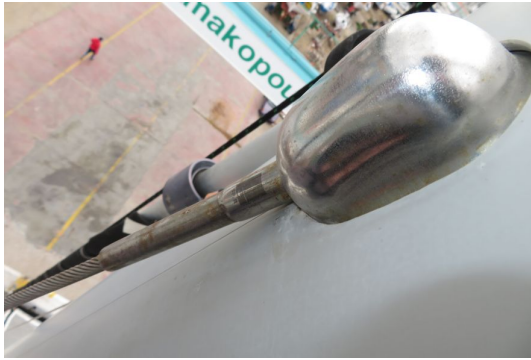
Diamond upper swages without broken wire

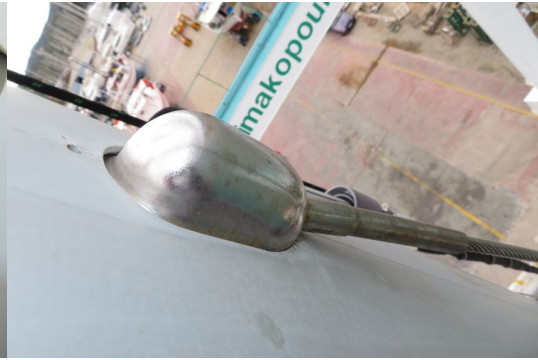
Diamond upper swages without broken wire

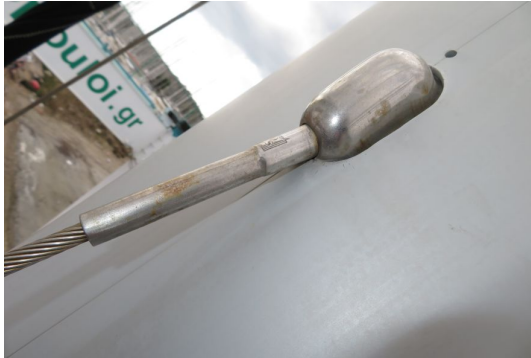
Intermediate upper swages without broken wire

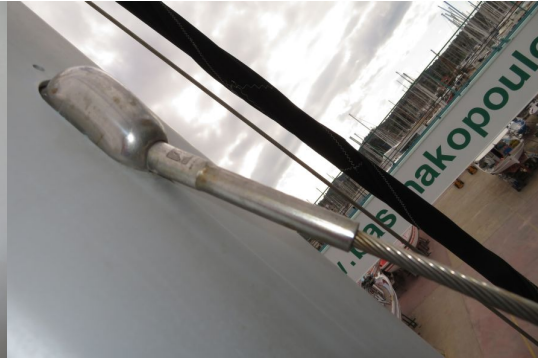
Intermediate upper swages without broken wire

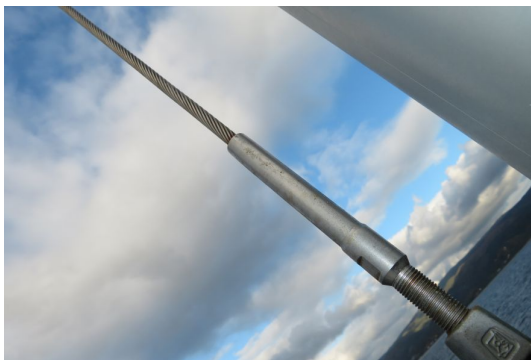
Diamond lower swages without broken wire

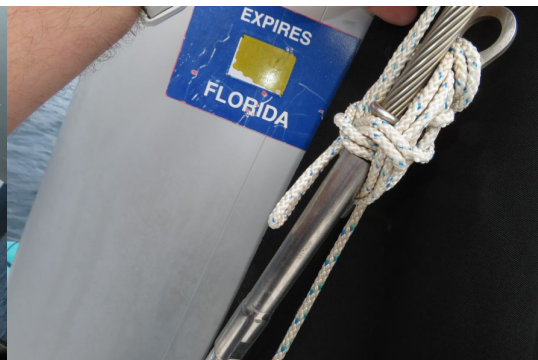
Diamond lower swages without broken wire

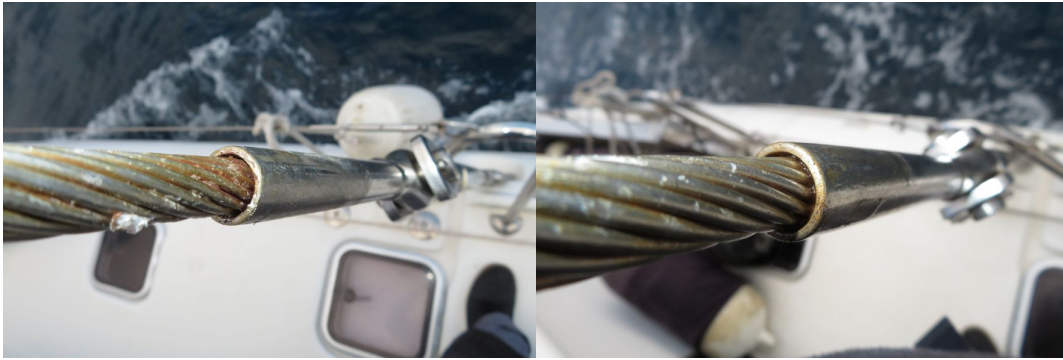
Shroud lower swages without broken wire

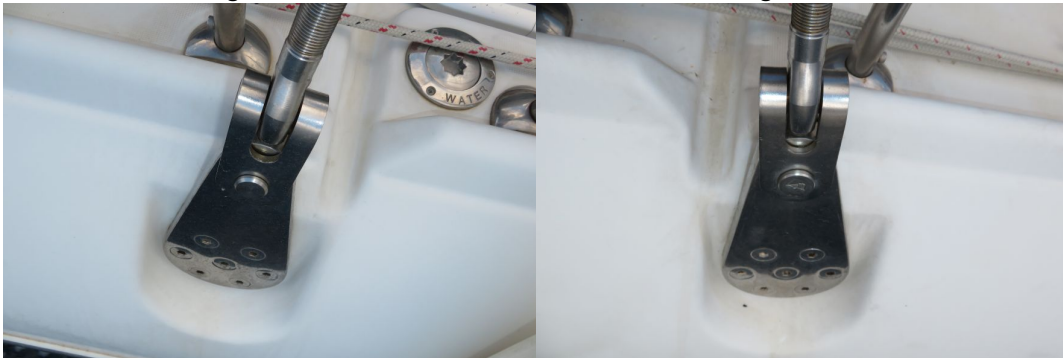
No gelcoat crazing
around shroud chainplatesNo gelcoat crazing
around shroud chainplates

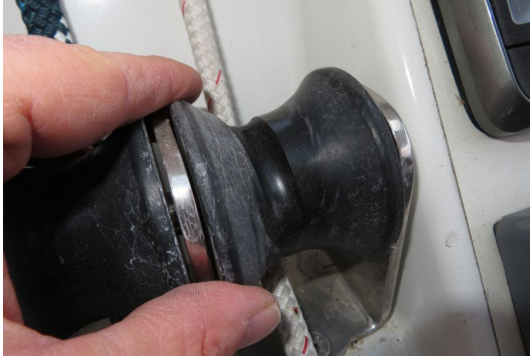
Mainsheet traveller sheave at the helm. Requires replacement due to heavy chafe wear.

Sheave with chafe

Suggestion : Mainsheet traveller sheave at the helm. Requires replacement due to heavy chafe wear.

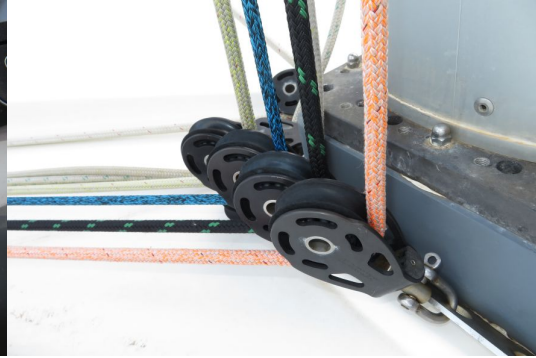
Sheaves without deterioration

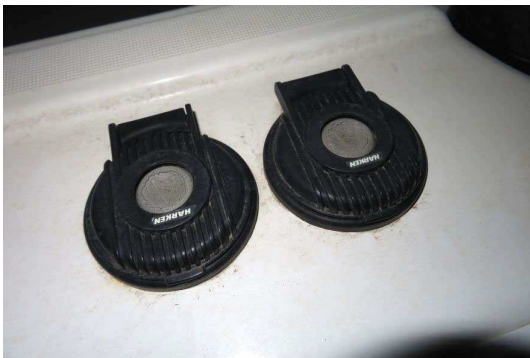
Aft cockpit winch footswitch type buttons require replacement because they are deteriorated. All electric winches were working and the motors externally without corrosion.

Aft cockpit winch footswitches to replace

Suggestion : Aft cockpit winch footswitch type buttons require replacement because they are deteriorated.

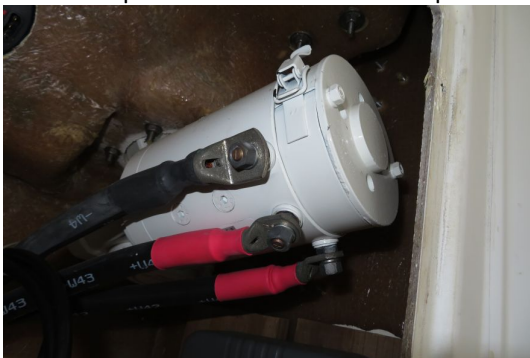
Winch motor without corrosion

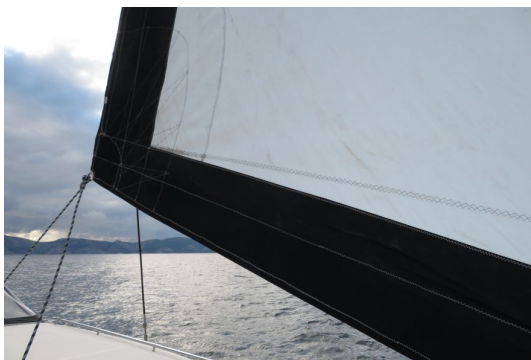
Genoa without damages

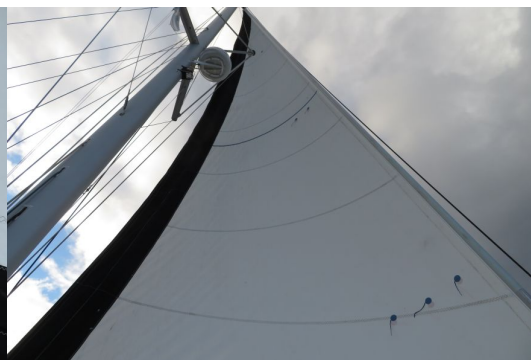
Genoa without damages

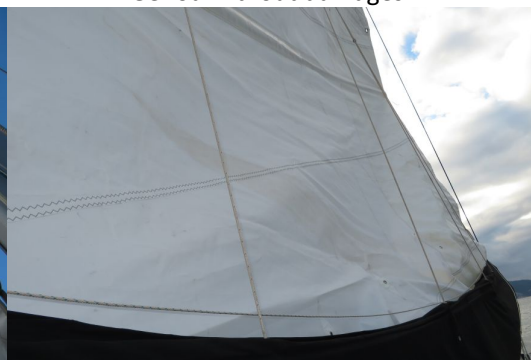
Main without damages

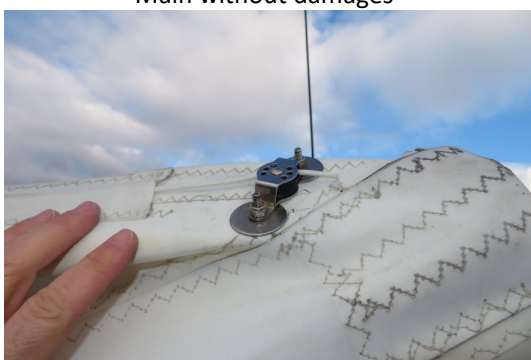
Mainsail has a small sheave attached with excessively long bolts. It is possible to damage something. The lazy bag has small tear from this.

Main sheave bolts too long

Suggestion : Mainsail has a small sheave attached with excessively long bolts. It is possible to damage something. The lazy bag has small tear from this. The bolts to be cut down.

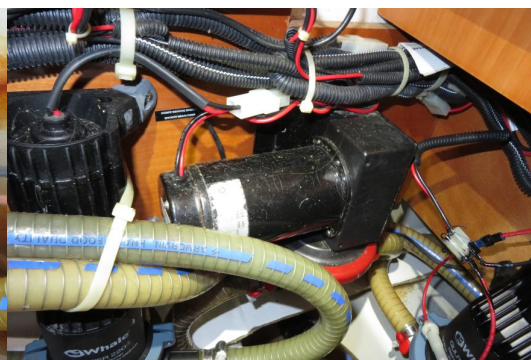
Diaphragm bilge pump no leaks

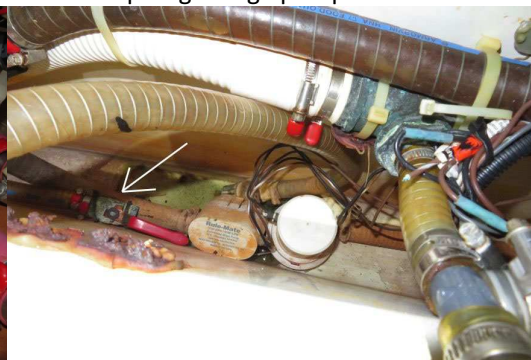
Hoses to drain the bow and engine room watertight compartments to the keel sumps. The hose end valves to be resecured at convenient height for usage as they have fallen to the bottom of the keel sumps.

Drain hose fallen into bilge
where the valve cannot be closed

Recommendation : Hoses to drain the bow and engine room compartments to the keel sumps. The hose end valves to be resecured at convenient height for usage as they have fallen to the bottom of the keel sumps.

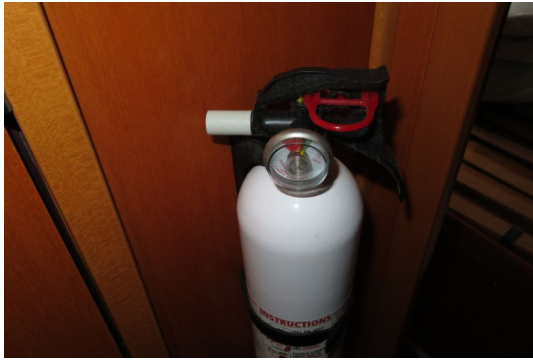
Portable fire extinguisher

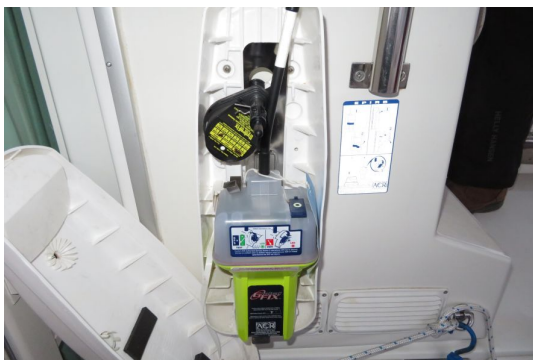
EPIRB Hydrostatic Release expires 05/2020. EPIRB battery expiry not found.

EPIRB

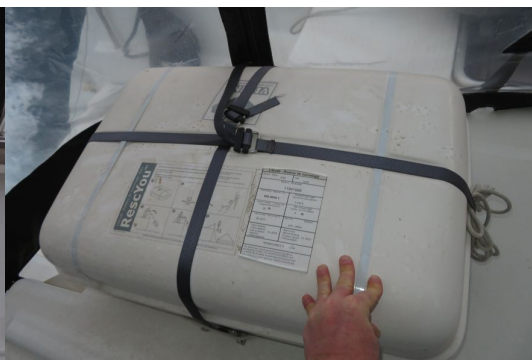
Liferaft casing intact

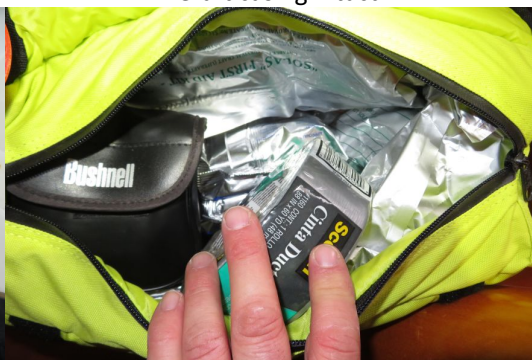
Grab bag

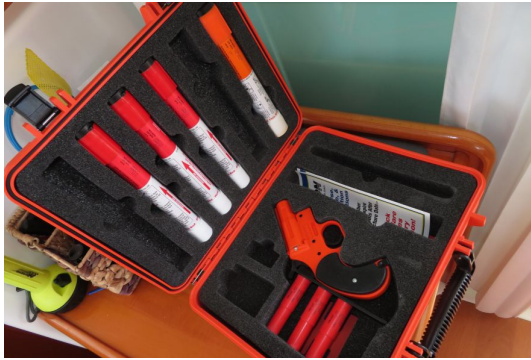
Pyrotechnics

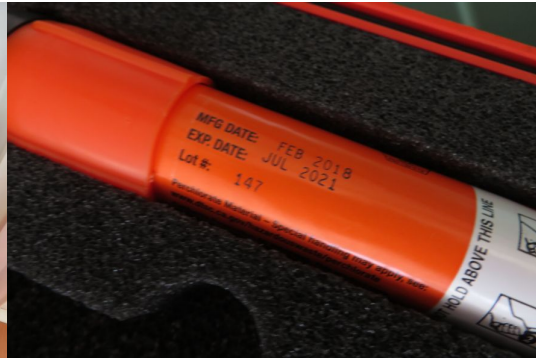
In date

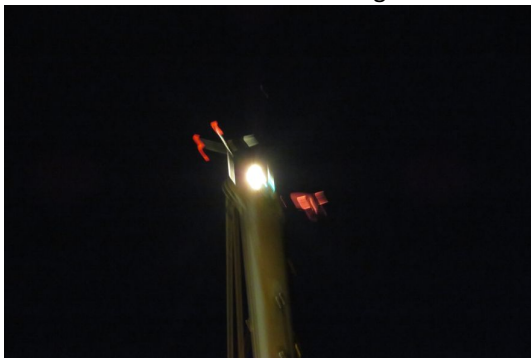
Anchor light working

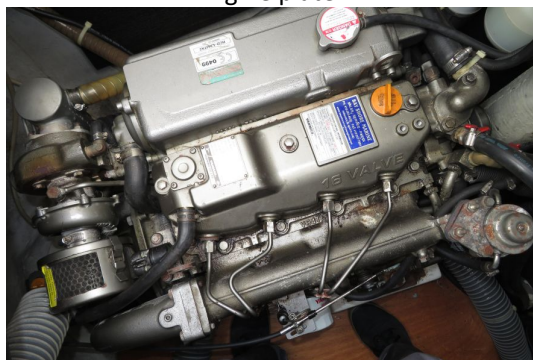
Engine with minor corrosion

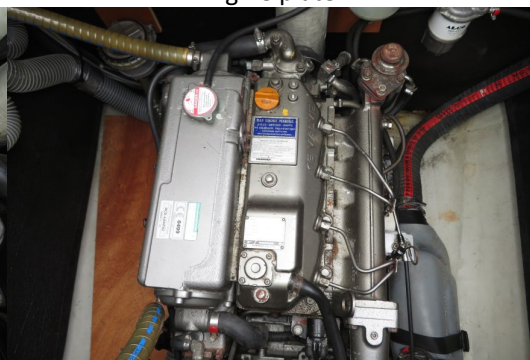
Engine with minor corrosion

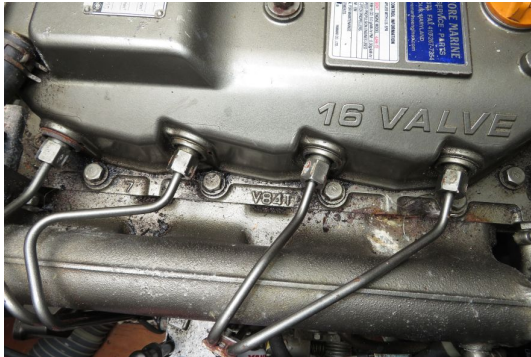
No leaks at injectors

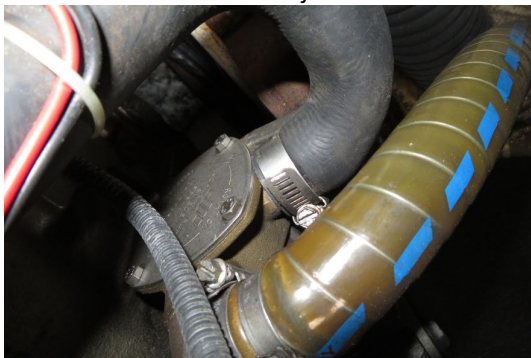
No leaks at seawater pump

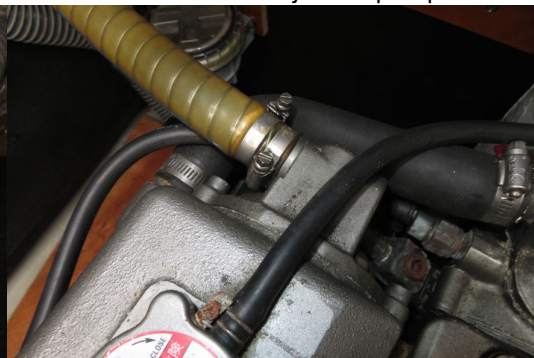
No leaks at heat exchanger ends

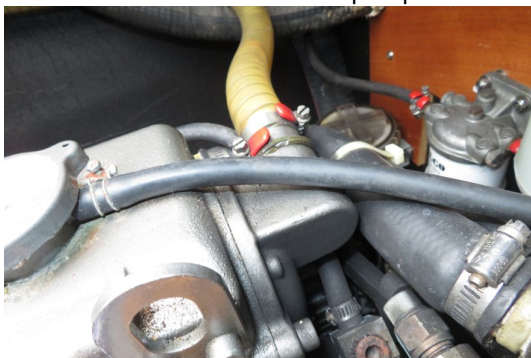
No leaks at heat exchanger ends

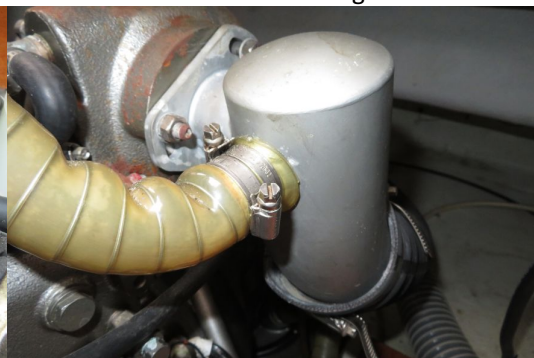
No leaks at exhaust mixing elbow

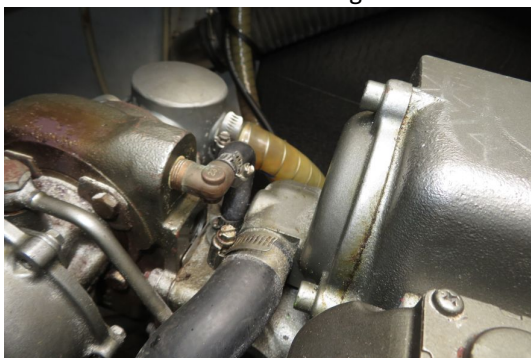
No leaks at heat exchanger ends

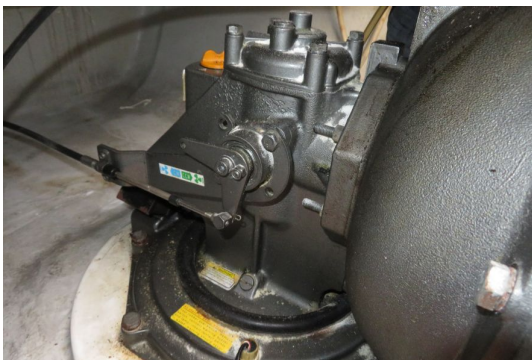
No leaks at seal

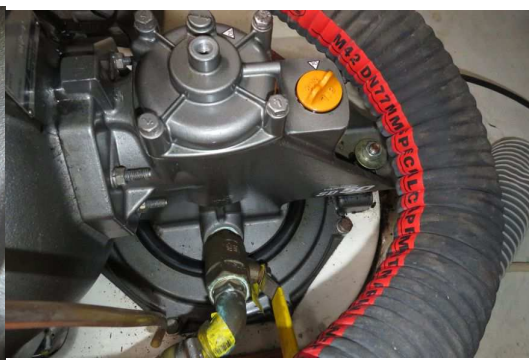
No leaks at seal

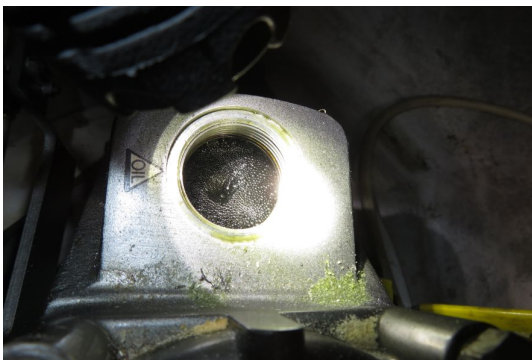
Oil without sign of water contamination

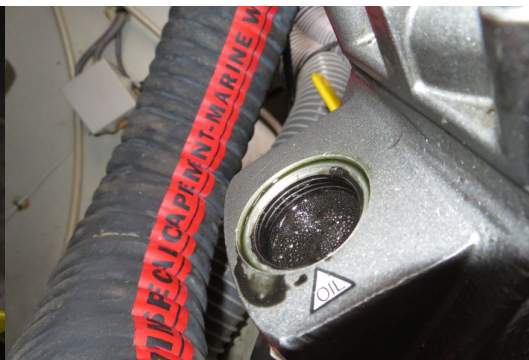
Oil without sign of water contamination

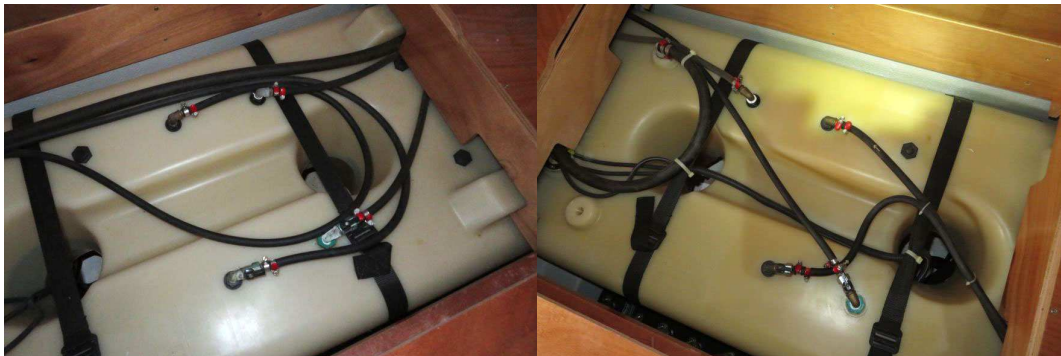
Fuel tank no leaks from connections

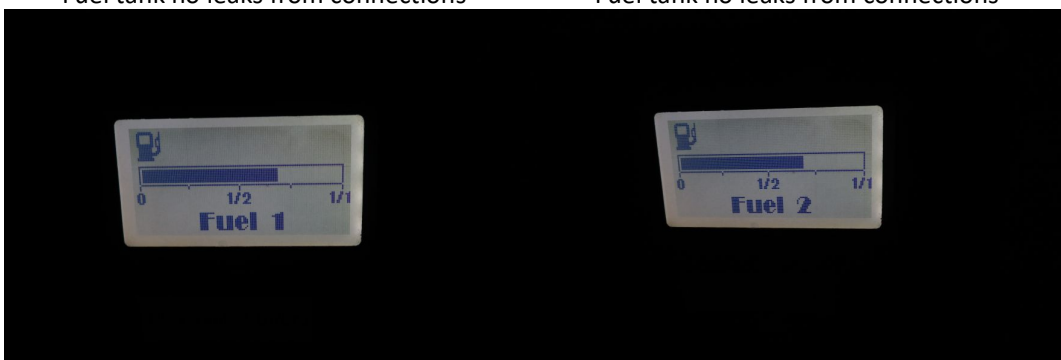
Level gauge working

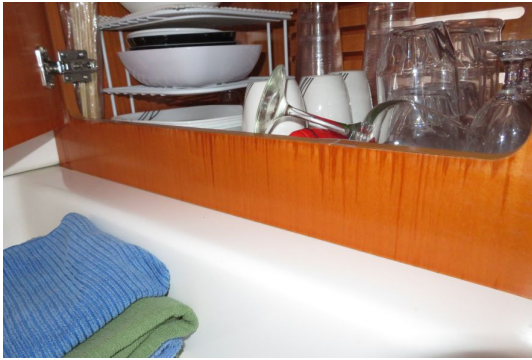
Cupboard above cooker is with discoloration and detachment of the veneer from previous wetting.

Minor wetting at galley

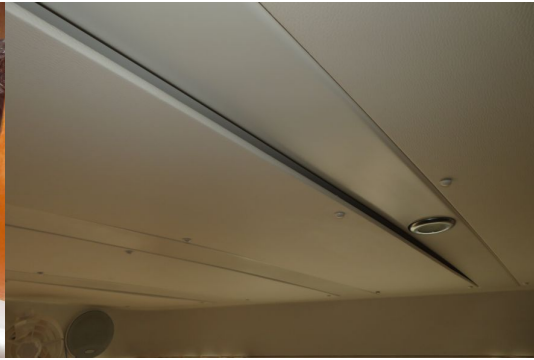
Ceiling panels to be screwed

Suggestion : Several saloon ceiling panels require to be secured with larger screws as they are drooping.

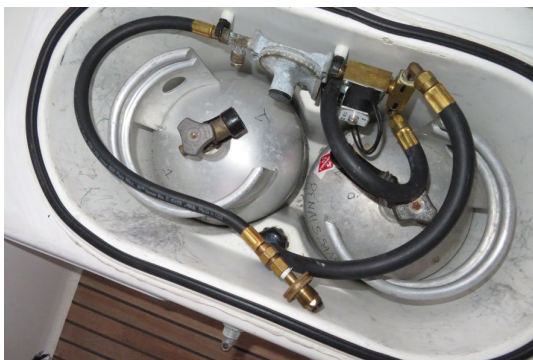
Gas locker

Dedicated gas locker with drain. The connections leak slightly and require checking/tightening. The gas cooker was without corrosion and working. The electronic valve at the cylinders was working.

Recommendation : Gas locker. The connections leak slightly and require checking/tightening.

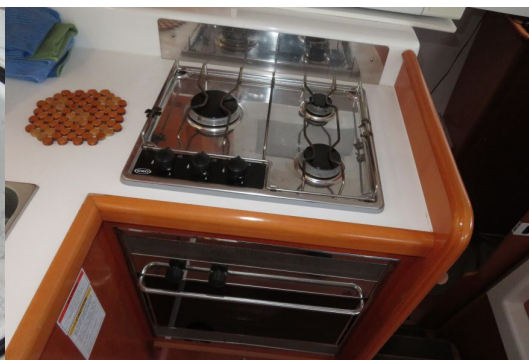
Cooker without corrosion

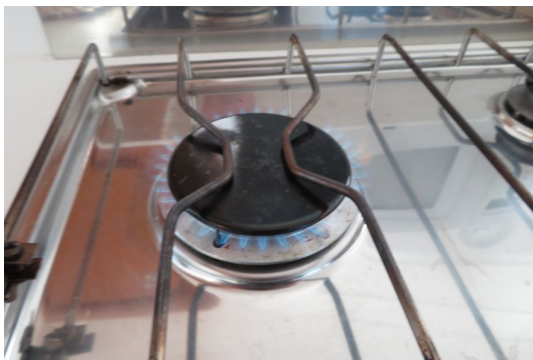
Gas working

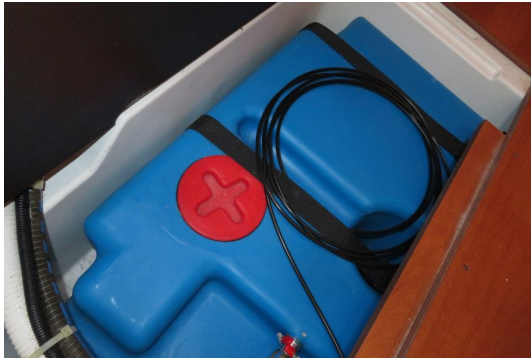
Fresh water tank externally intact

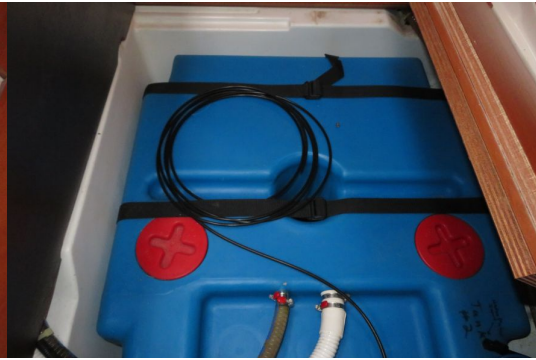
Fresh water tank externally intact

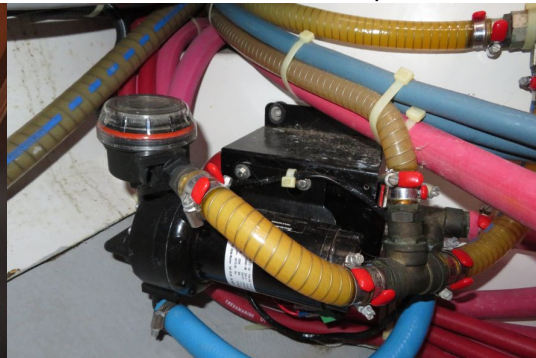
No leaks at pump

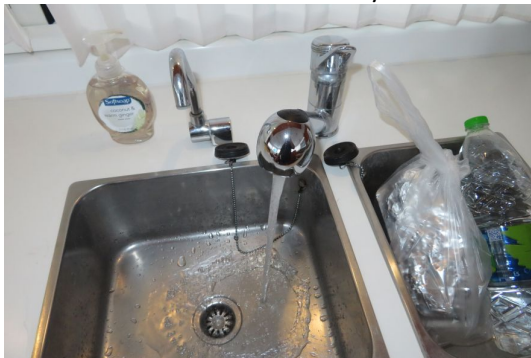
Water pressure good

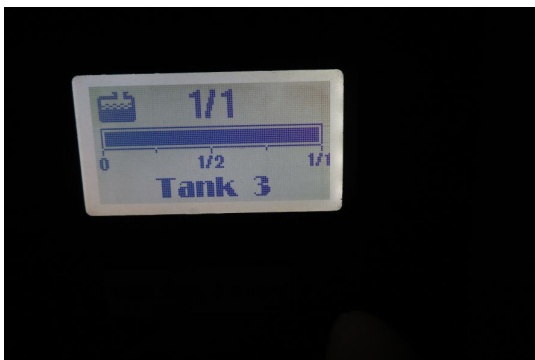
Tank 3 level gauge working

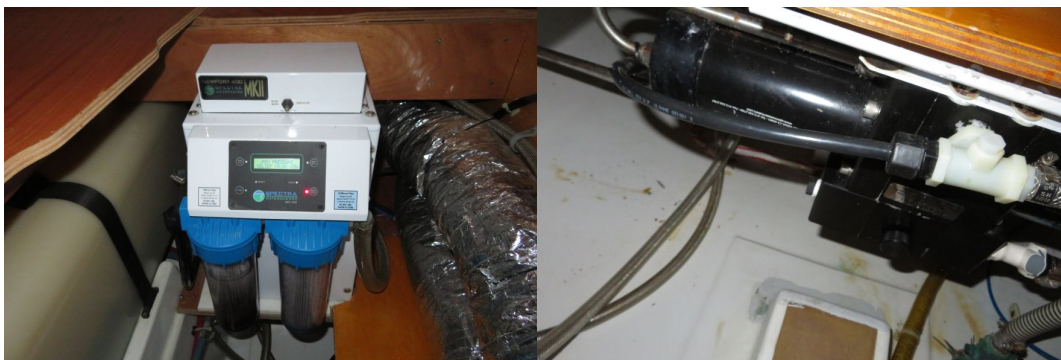
Watermaker

The watermaker was not tested because there was placed nearby directives regarding dewinterising it therefore it was probably full of chemicals for winter. The external condition was satisfactory and the unit was with power.

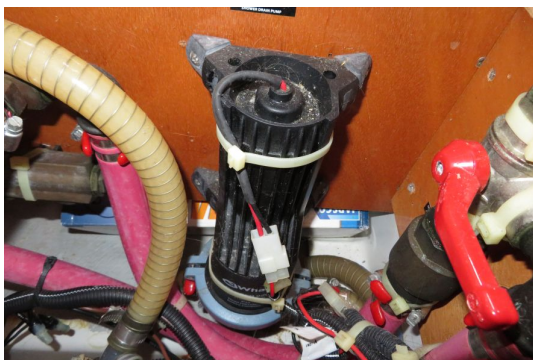
Grey water pump no leaks

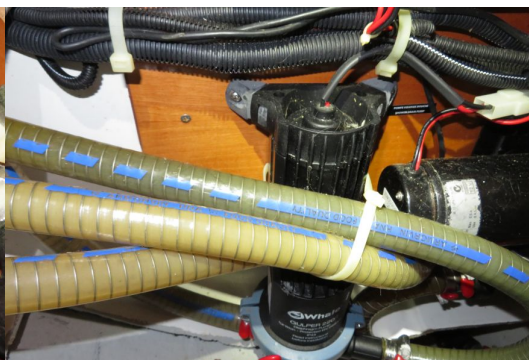
Grey water pump no leaks
