Date : 25 January 2021

PRE-PURCHASE CONDITION SURVEY REPORT

S/Y LAGOON 420 At Poros-Koilada Jan/20

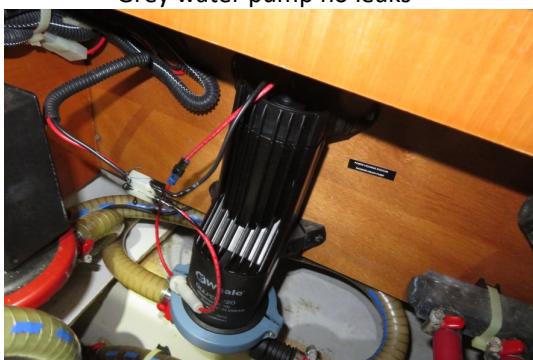
Grey water pump no leaks

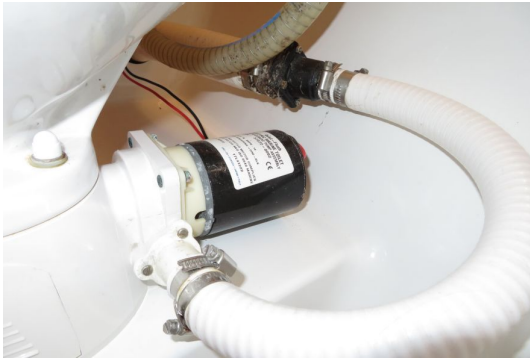
No leaks at toilet discharge pump

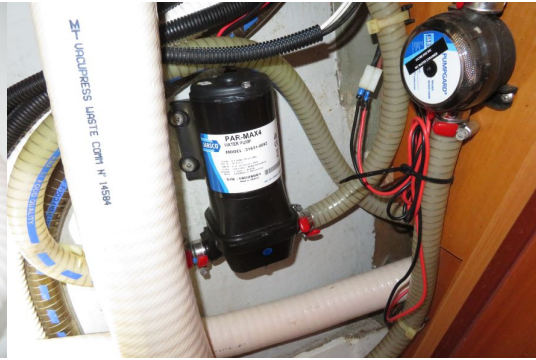
No leaks at toilet flushing water pump

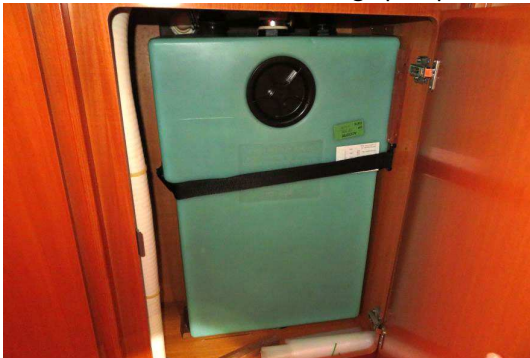
No leaks at owners holding tank

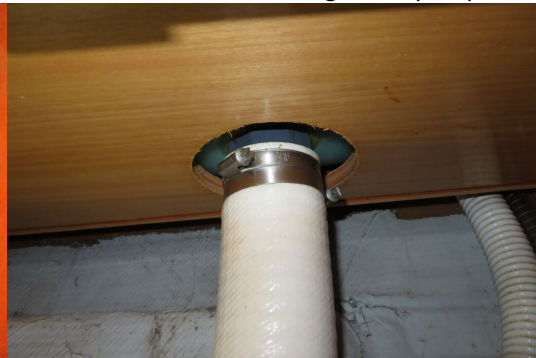
No leaks at owners holding tank

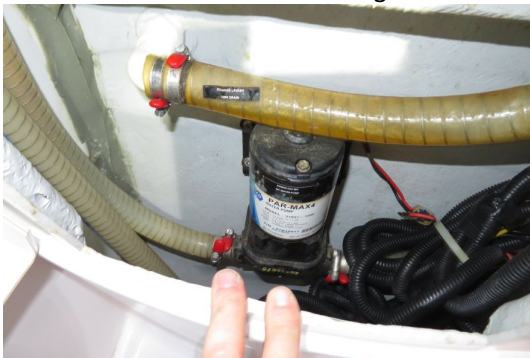
No leaks at toilet flushing water pump

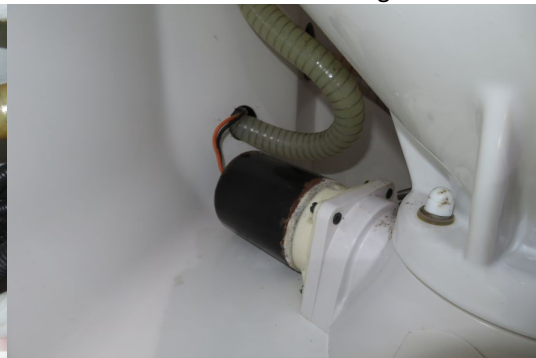
No leaks at toilet discharge pump

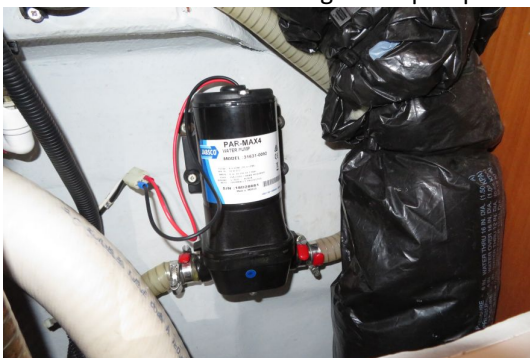
No leaks at toilet flushing water pump

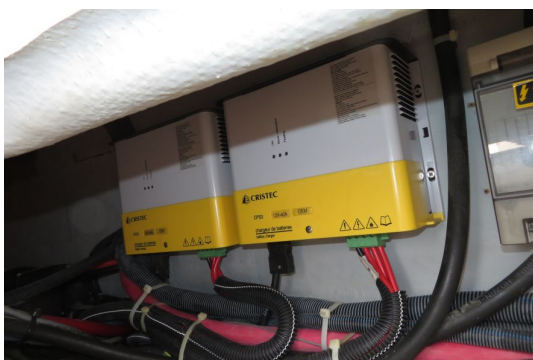
Chargers not tested

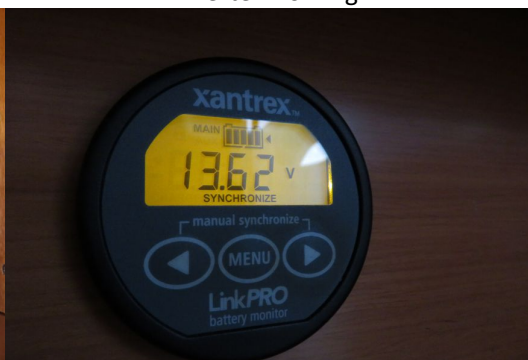
Battery monitor working

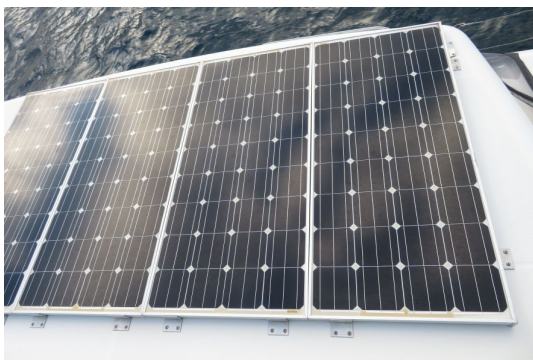
Solar panels intact

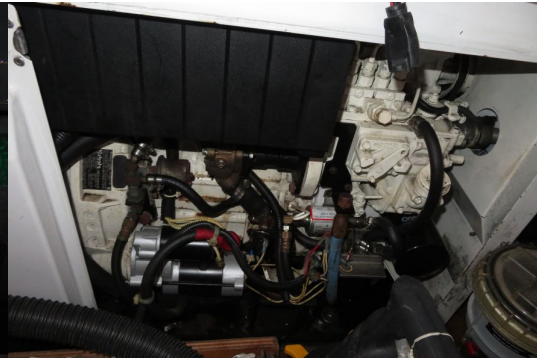
Generator with coatings intact

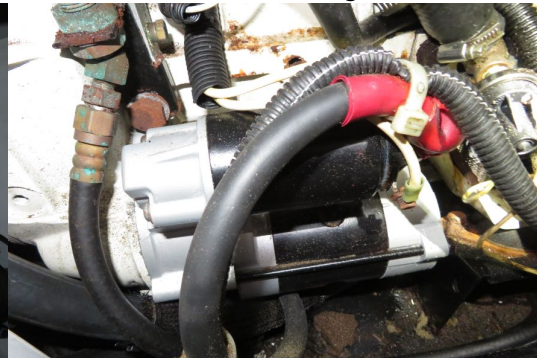
Starter and solenoid renewed in recent past

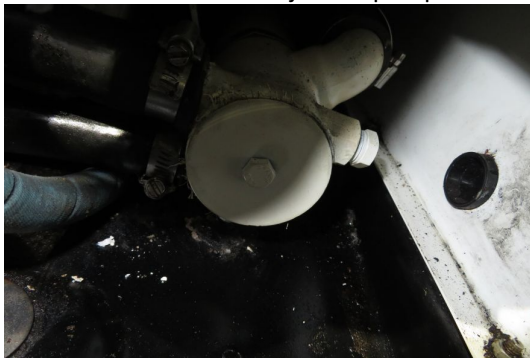
Only minor leak at heat exchanger

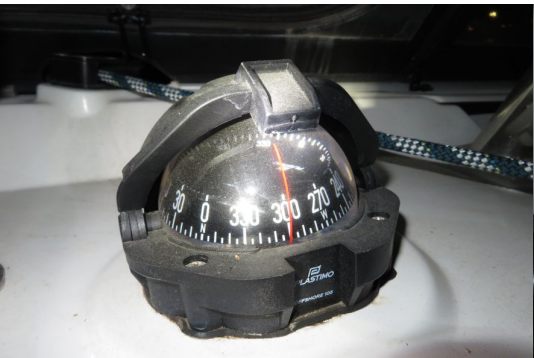
Magnetic compass no bubble

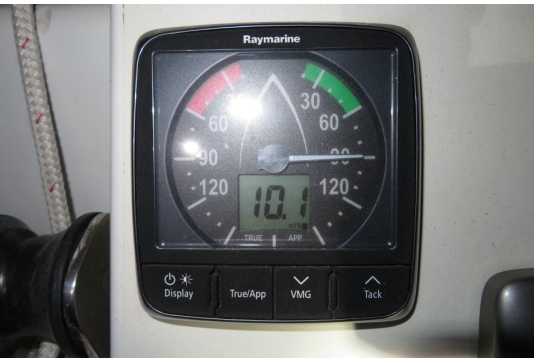
Wind Indicator working

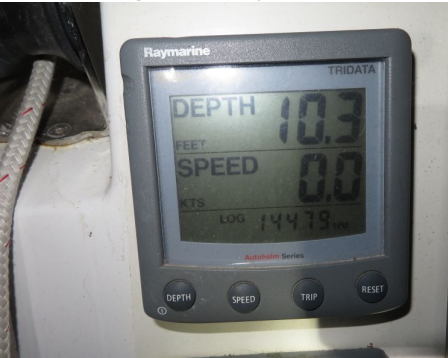
Depth working

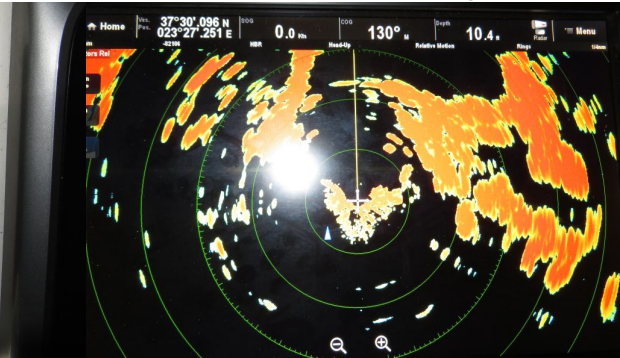
Chartplotter radar working

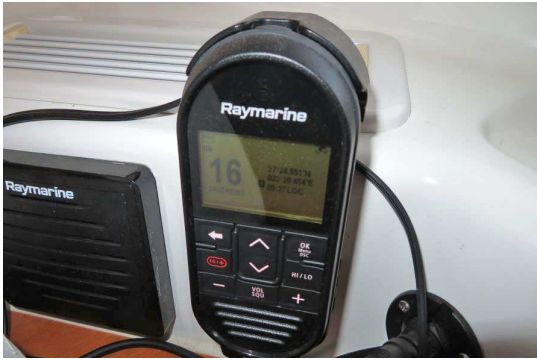
VHF working

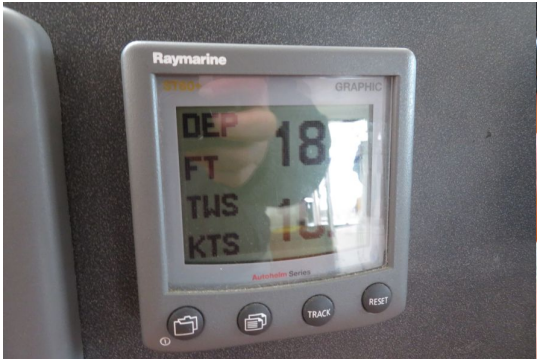
Multifunction display working

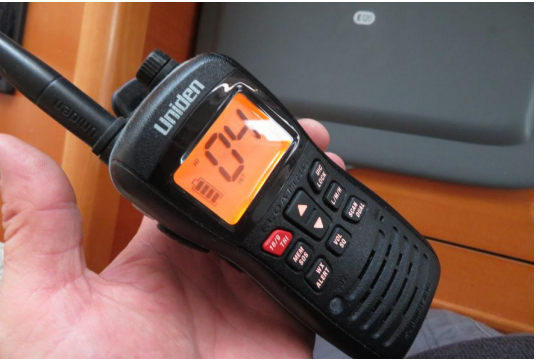
VHF working

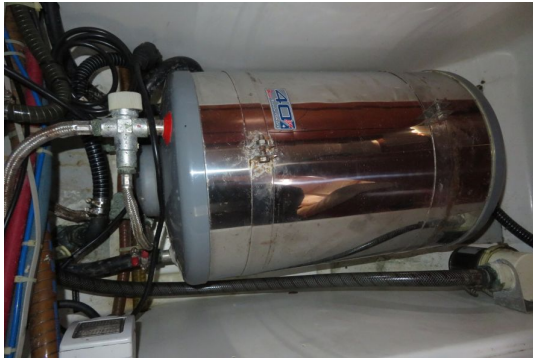
Water heater powered by shore power or engine heater connection. It was working on engine heater connection and was without leak.

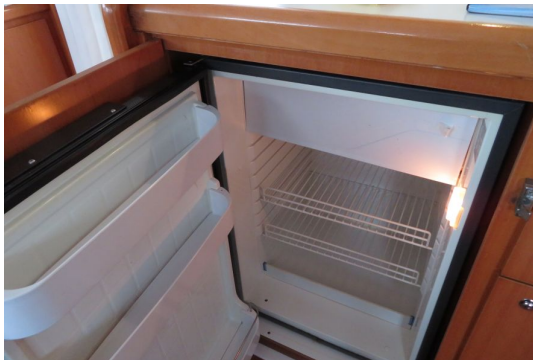
Refrigerator working

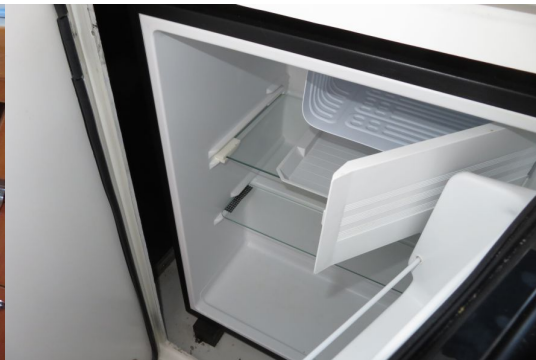
Refrigerator working

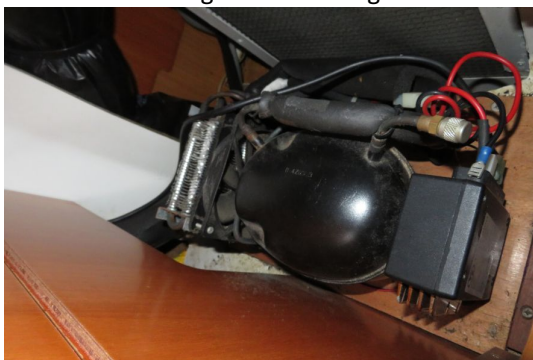
Compressor with coatings intact

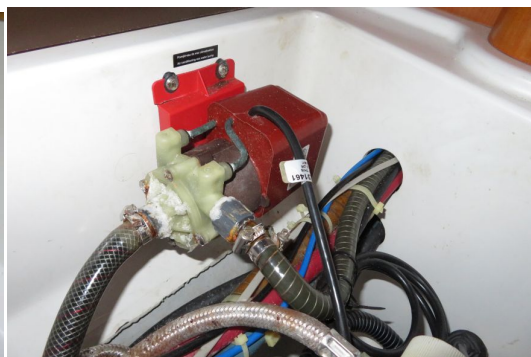
Airconditioning pump at owner cabin bilge. There is a small leak at the pump which requires attention. The remainder of seawater pumps were without leak.

Small leak at seawater pump

Suggestion : Airconditioning pump at owner cabin bilge. There is a small leak at the pump which requires attention.

47.28. Airconditioning pump at owner cabin bilge. There is a small leak at the pump which requires attention.

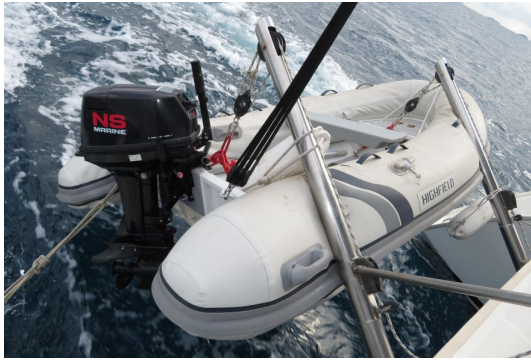
The tender was only slightly inflated and therefore could not be assessed for leak. The outboard motor propeller was without damage.

Tender partly inflated

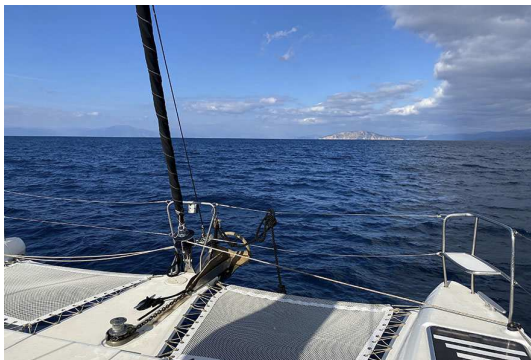
On sea trial

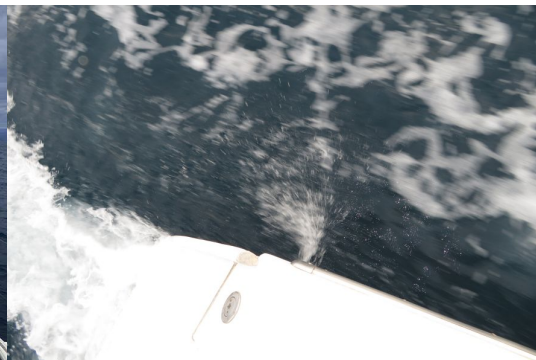
Exhaust clean

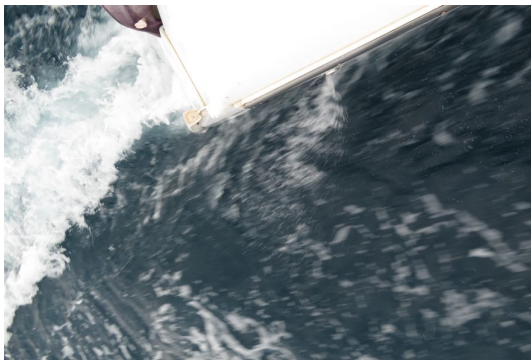
Exhaust clean
