Date : 13 January 2020

## PRE-PURCHASE CONDITION SURVEY REPORT

### S/Y BAVARIA 46

At Athens Jan/20

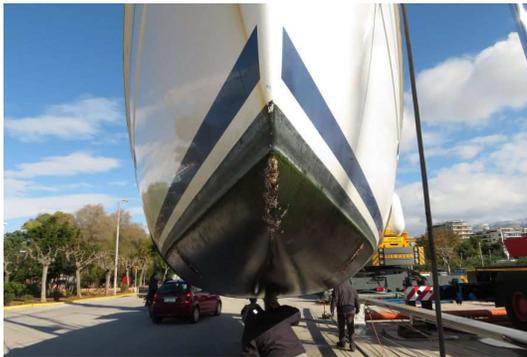
Hull below waterline surfaces were fair. Hammer sounding did not find any delamination or void. There were no unrepaired damages.

No damages at bow

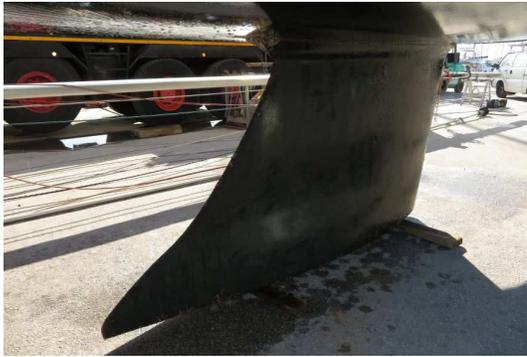
Keel generally intact

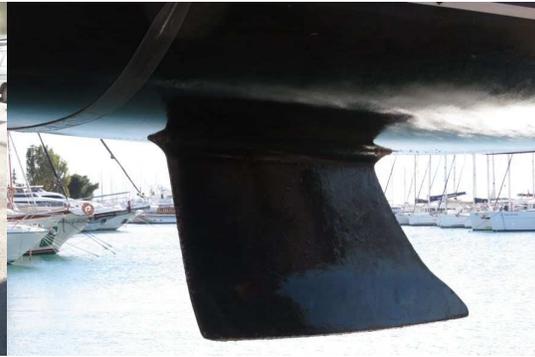
No spacing when lifting the yacht

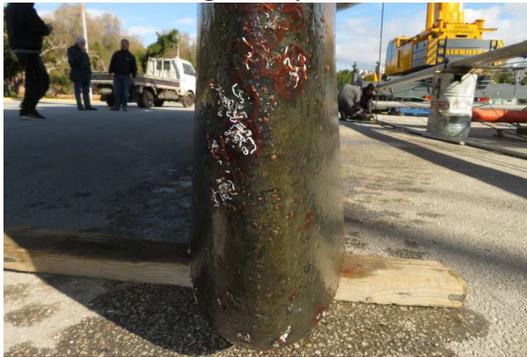
No damages at the leading edge

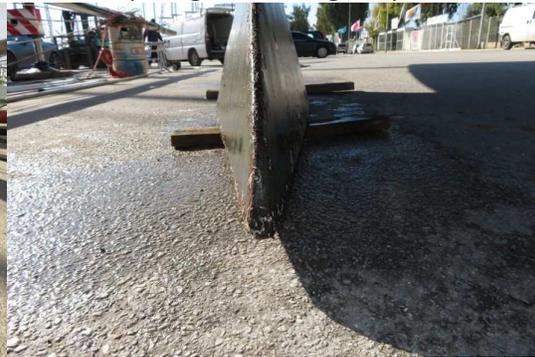
No damages at the trailing edge

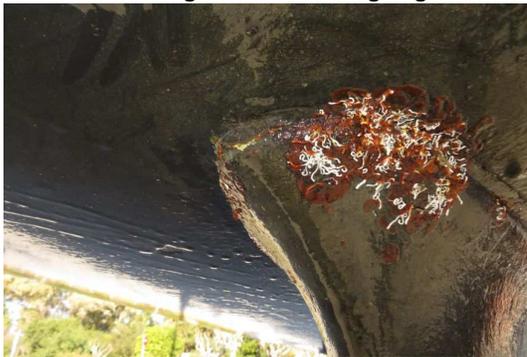
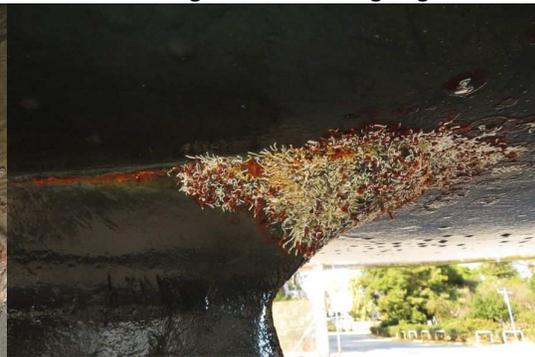
No cracks to hull around the join

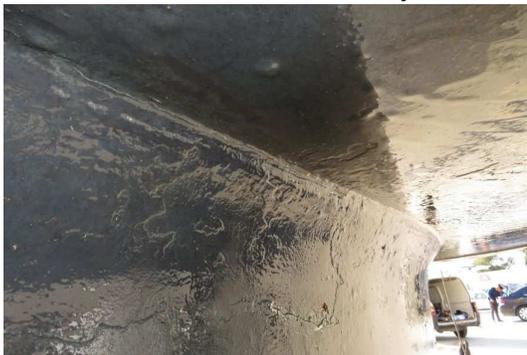
The stainless keelbolts were without corrosion or sign of leak. The keel attachment area was visually sound and checked with hammer sounding to not have any disbond.

Hull to keel join tight and without rust stains

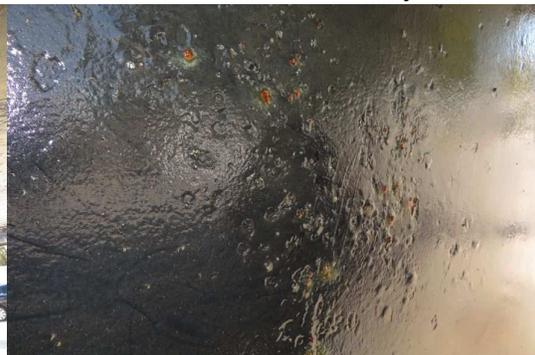
The keel is with some cosmetic corrosion and pitting under the paint. At some point before it becomes in a poor cosmetic condition the keel requires sandblast, fairing, prime and antifoul.

Keel with various minor corrosion under the paint

*Suggestion : The keel is with some cosmetic corrosion and pitting under the paint. At some point before it becomes in a poor cosmetic condition the keel requires sandblast, fairing, prime and antifoul.*

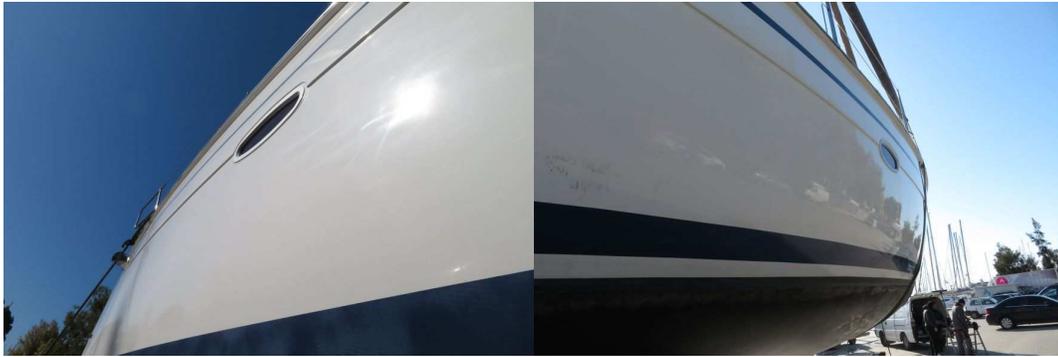
Topsides were fair and without stress crazing. Gelcoat chips at the bow in two locations, require cosmetic gelcoat repair.

Topsides fair

*Suggestion : Gelcoat chips at the bow in two locations, require cosmetic gelcoat repair.*

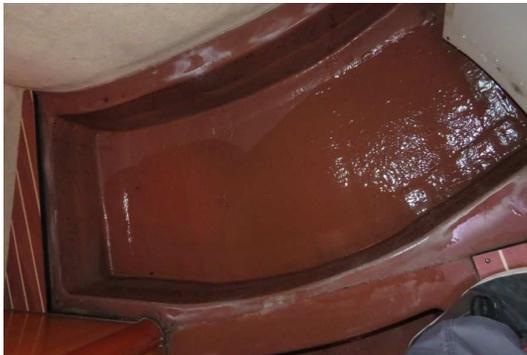
No detachment of liner overlaminations

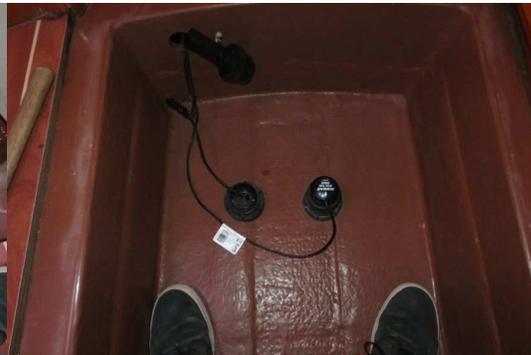
No cracks

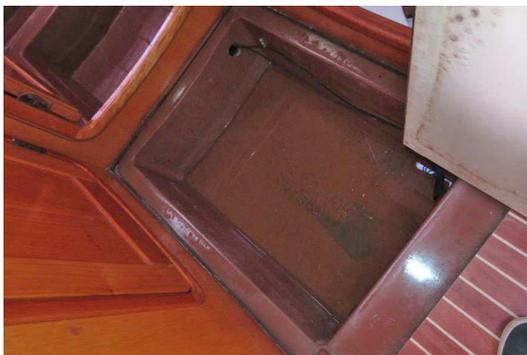
Water from deck window leak

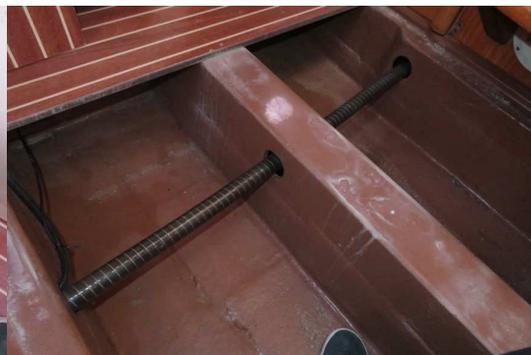
No cracks at stringers

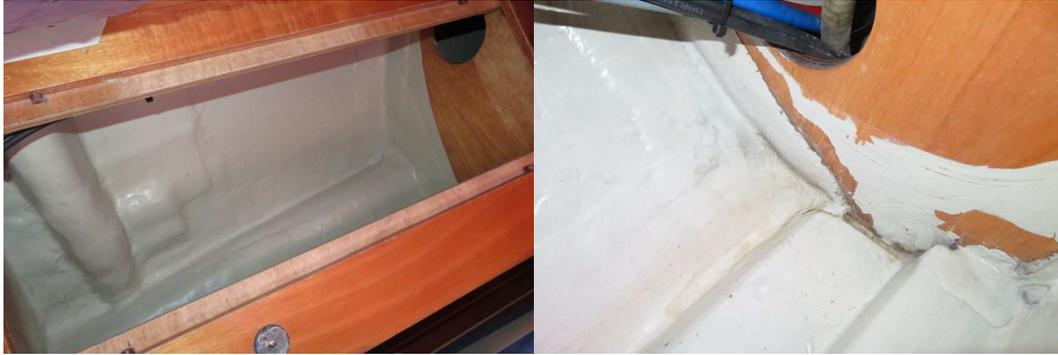
Intact structure around chainplates

Part detachment of minor tabbing

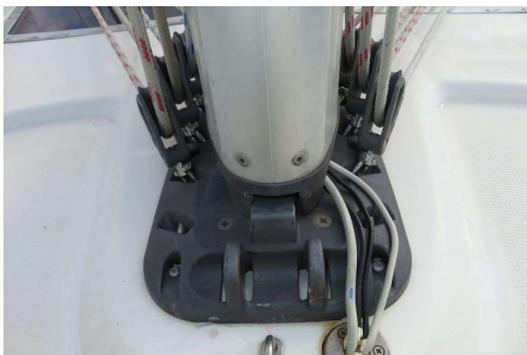
No compression or crazing  
at the mast deck step

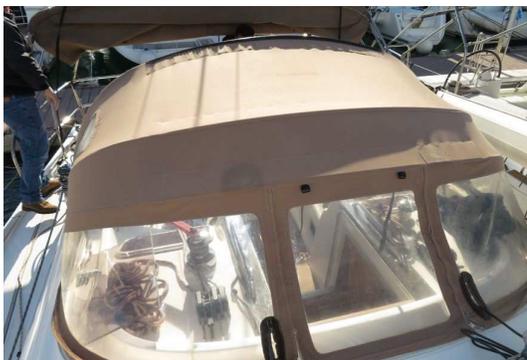
Sprayhood without damages

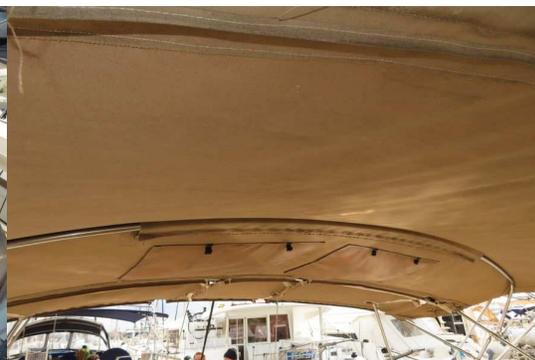
Bimini without damages

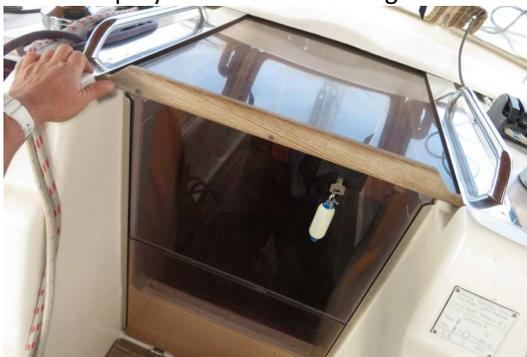
Companionway secure

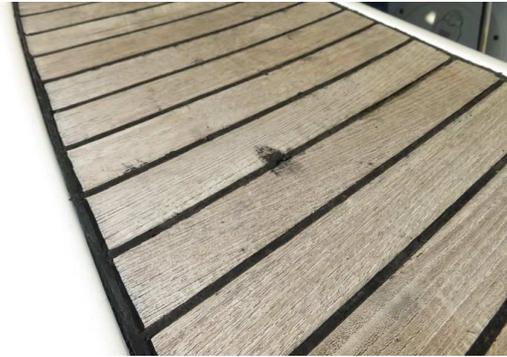
Cockpit aft port seat  
requires recaulking

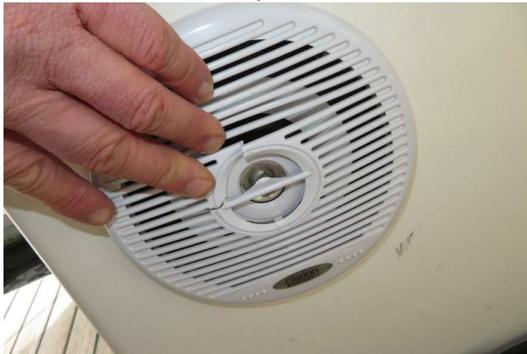
Both cockpit stereo speakers are with their grilles cracked and could be replaced.

Damaged stereo speaker grille

*Suggestion : Both cockpit stereo speakers are with their grilles cracked and could be replaced.*

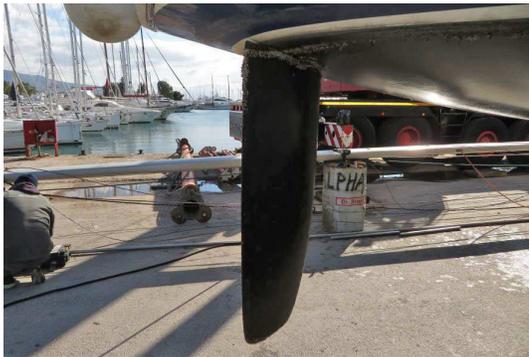
Fiberglass rudder generally intact. Rudder has a small abrasion on the bottom edge that requires repair.

Rudder generally intact

*Suggestion : Rudder has a small abrasion on the bottom edge that requires repair.*

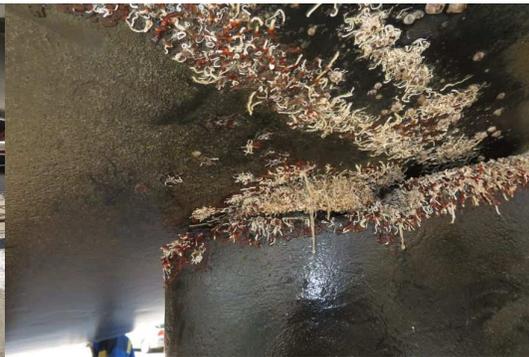
No cracks at top of rudder

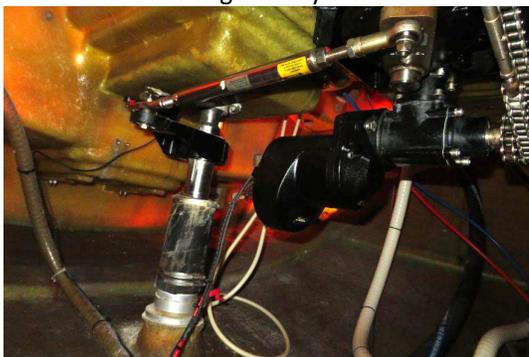
Steering gear is chain driven to a reduction gear which operates a draglink connected to the rudder post. The steering was without corrosion and with smooth operation. The steering range according to the rudder angle indicator was same both sides.

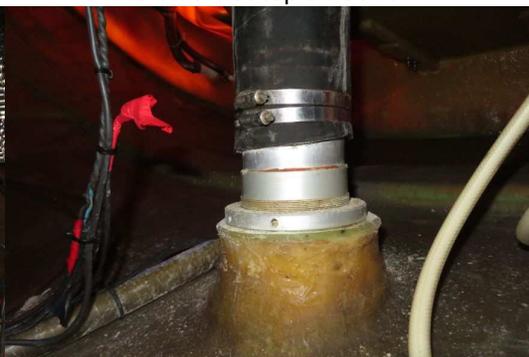
Rudder tube seal clips not corroded

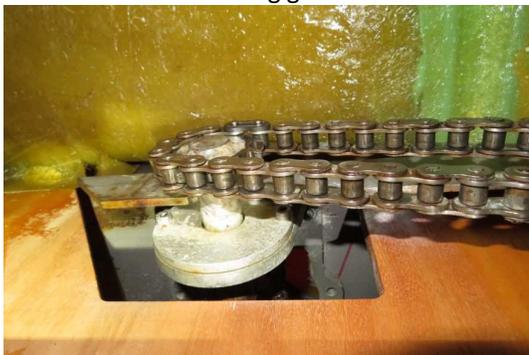
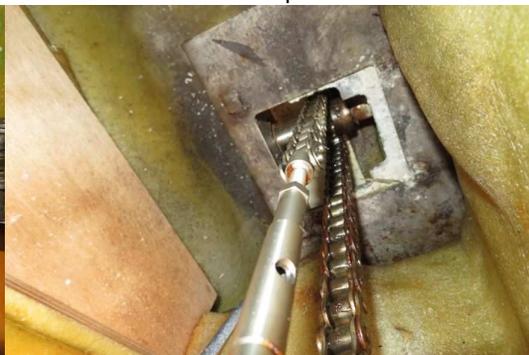
Chains without corrosion

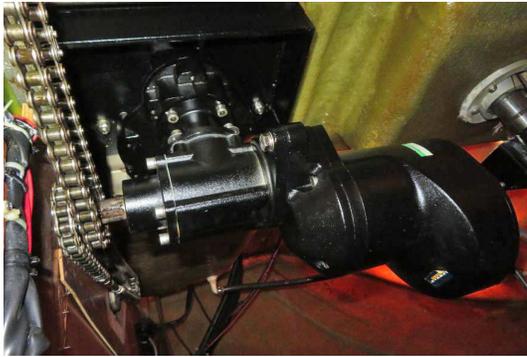
Autopilot

Electric autopilot which operates a motor attached to the steering gear reduction gear. The autopilot was checked working along with the angle indicator.

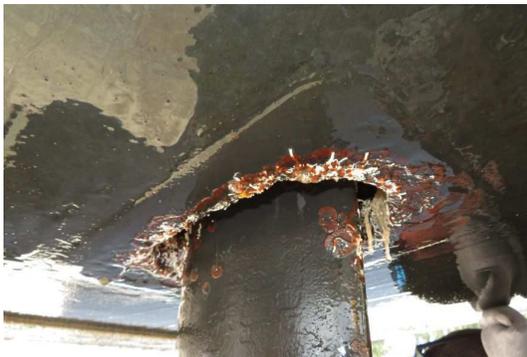
Saildrive rubber boot at the hull underside that fairs the opening is missing.

Fairing boot missing

*Suggestion : Saildrive rubber boot at the hull underside that fails the opening is missing and could be fitted.*

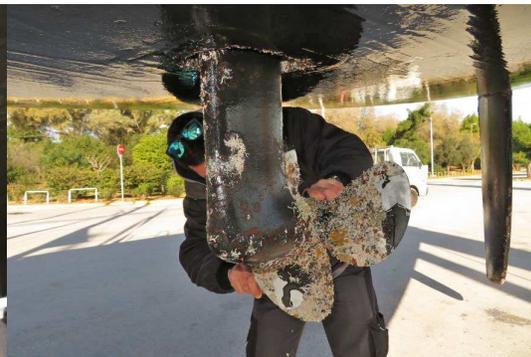
Saildrive leg without wastage

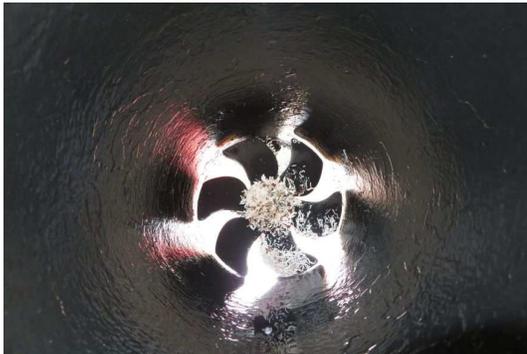
Propeller without damages

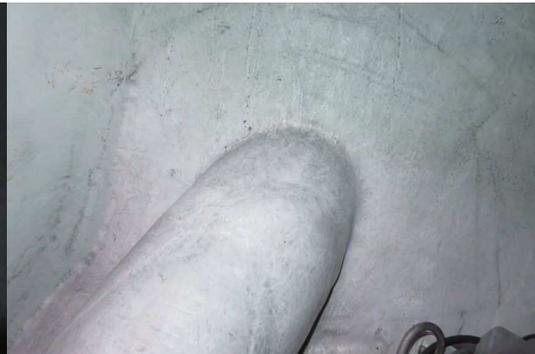
Tunnel overlaminations secure

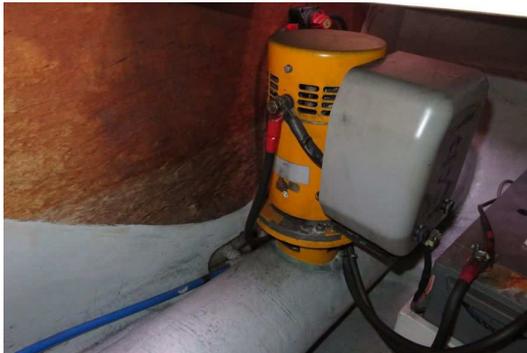
Motor casing without corrosion

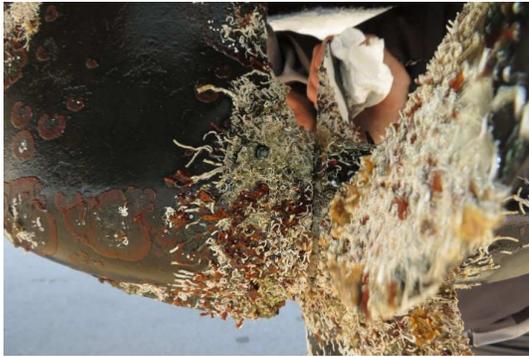
The saildrive leg anode was secure and suitable for further use.

Saildrive leg anode

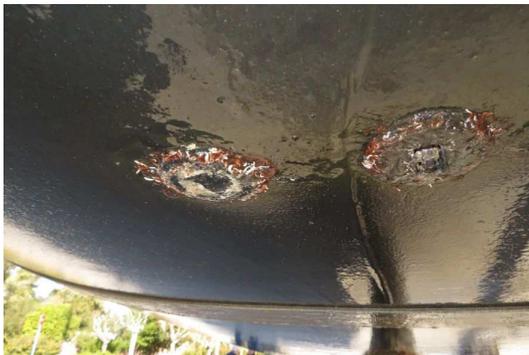
Transducer fittings intact

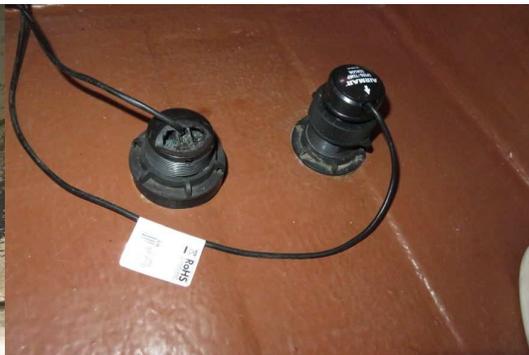
Transducer fittings intact

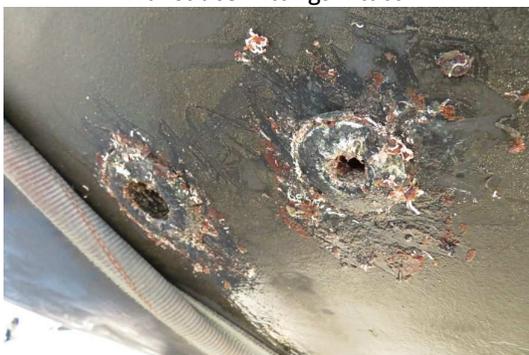
Through hull fittings without wastage

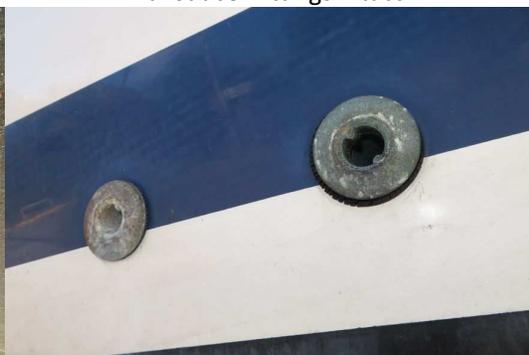
Through hull fittings without wastage

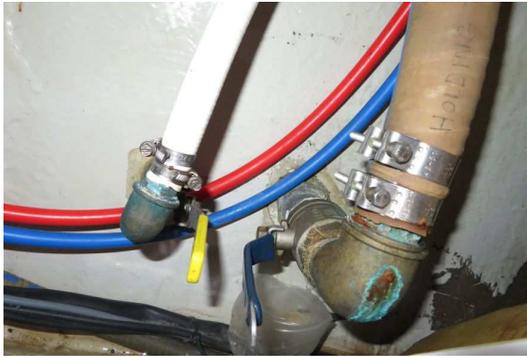
Ball valves without corrosion

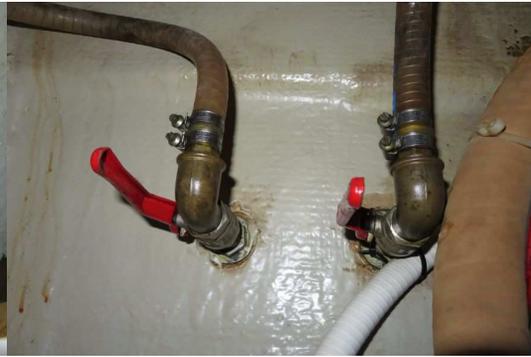
Ball valves without leak

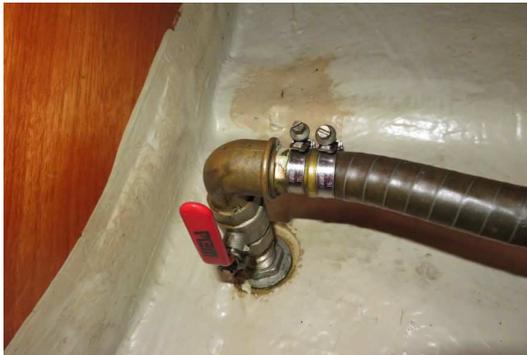
Hoses double clipped

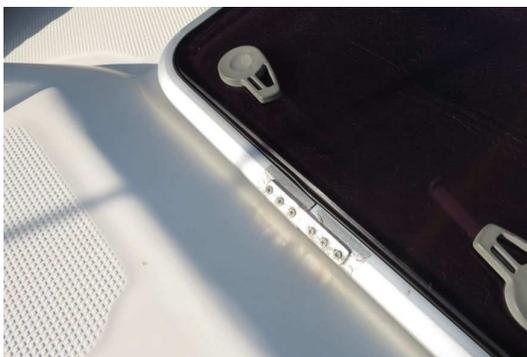
The bow storage hatch is with screwed on bracket which is cosmetically poor looking. Forward cabin hatch window plexiglass is crazed and could be replaced.

Cosmetically poor repair of hatch

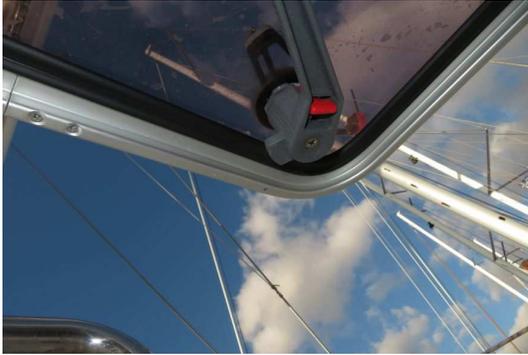
Seal without deterioration

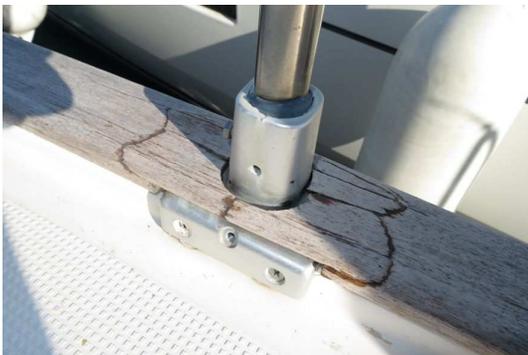
No. 4 (counting from bow) stanchion starboard is loose. The wooden caprail is cracked. The damaged section of caprail to be replaced and the stanchion secured properly. The caprail is part of the securing. The remainder of stanchions were secure. Lifelines were suitably tight.

Broken caprail  
and loose stanchion securing

*Recommendation : No. 4 (counting from bow) stanchion starboard. It is loose. The wooden caprail is cracked. The damaged section of caprail to be replaced and the stanchion secured properly.*

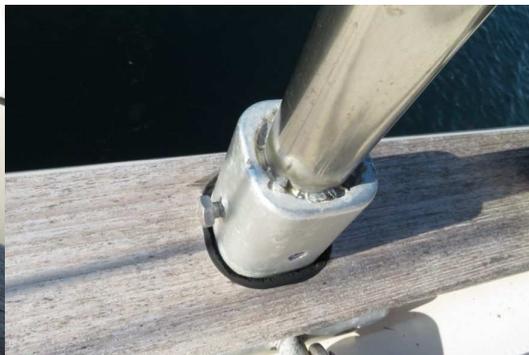
The aluminium stanchion bases are with galvanic corrosion with the stainless stanchions to a minor extent.

Galvanic corrosion between stainless  
stanchion and base

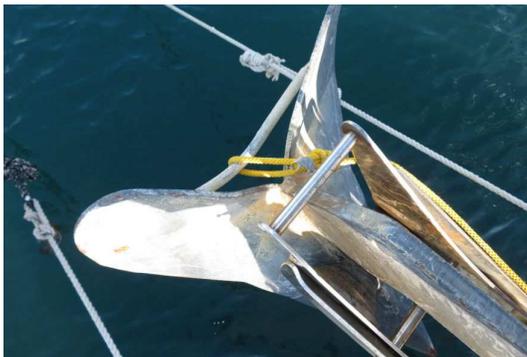
Anchor without wastage

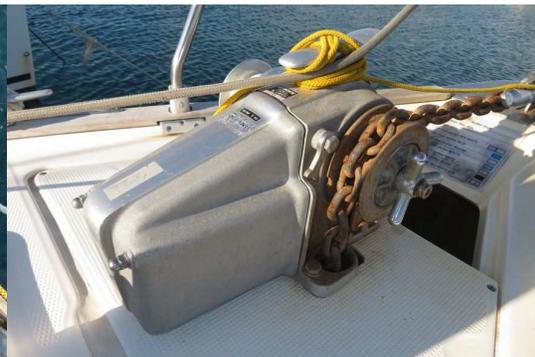
Anchor windlass secure

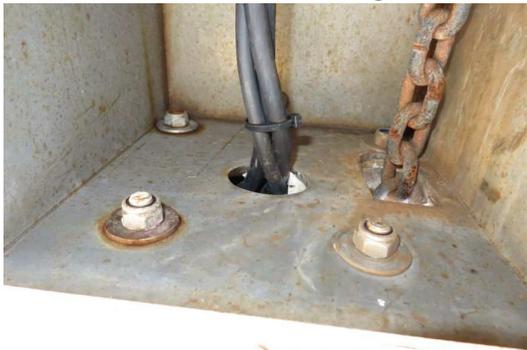
Windlass securing bolts not corroded

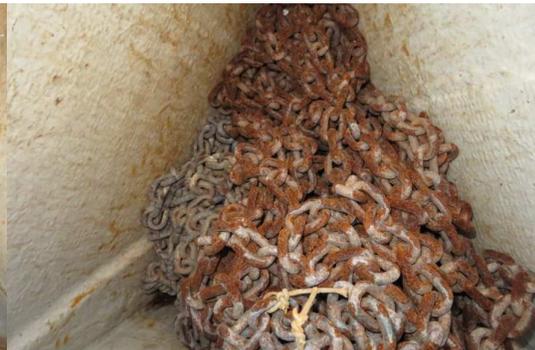
CQR galvanised main anchor without wastage. The anchor chain is corroded and could be replaced.

Chain with corrosion

*Suggestion : The anchor chain is corroded and could be replaced.*

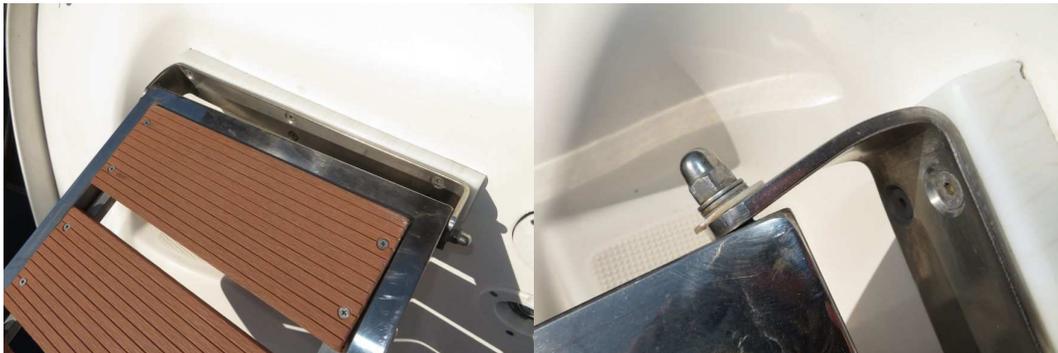
Passerelle securing bracket. It is bent on the port side and became also too big for the passerelle width. It requires repair.

Manual passerelle decking sound

Bent bracket

*Suggestion : Passerelle securing bracket. It is bent on the port side and became also too big for the passerelle width. It requires repair.*

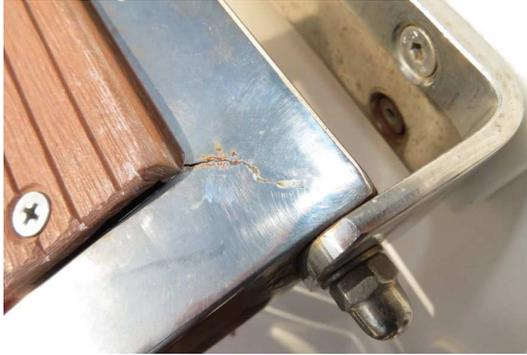
Manual passerelle is cracked at the starboard side next to the securing bracket. The crack requires grinding out and welding on the top and underside.

Cracked framing

*Suggestion : Passerelle is cracked at the starboard side next to the securing bracket. The crack requires grinding out and welding on the top and underside.*

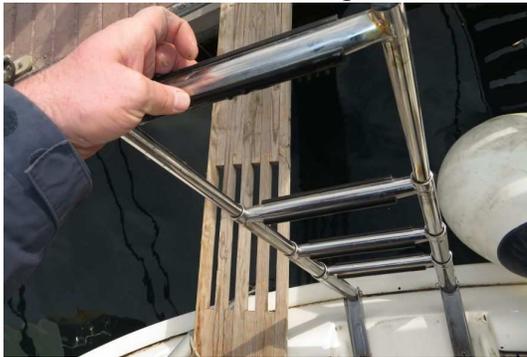
Boarding ladder without damages

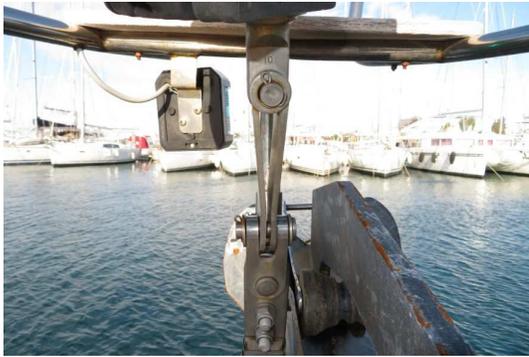
Furler fork secure and straight

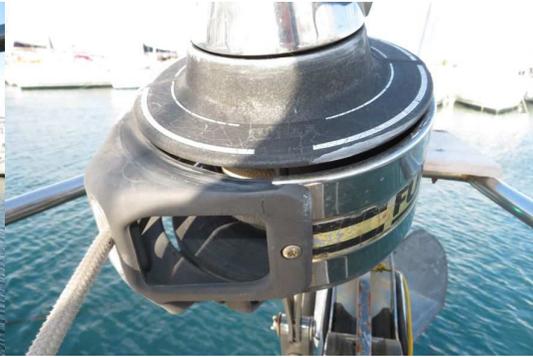
Furler drum without damages

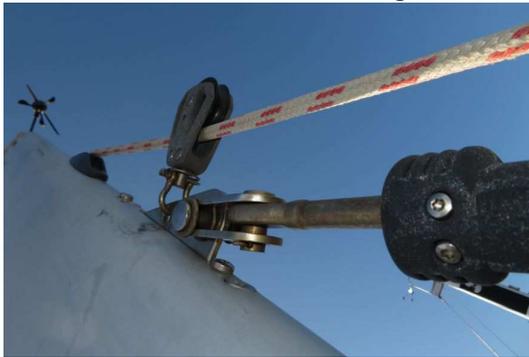
Furler secure at mast

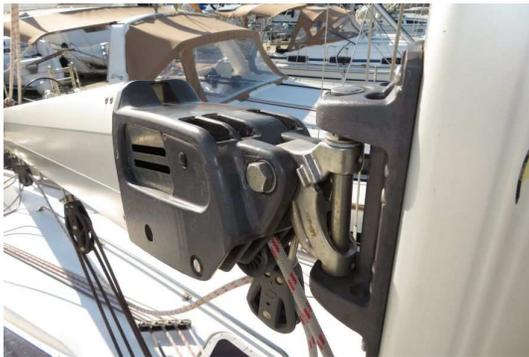
Boom gooseneck secure and without damages

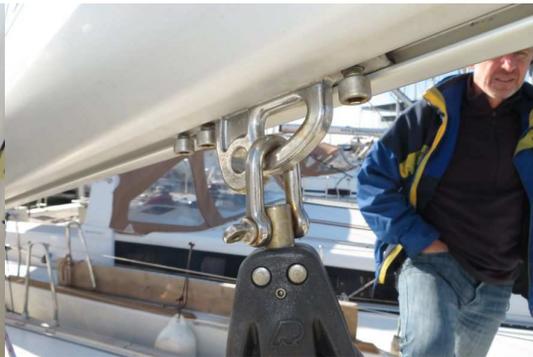
Rope boom vang sheaves secure

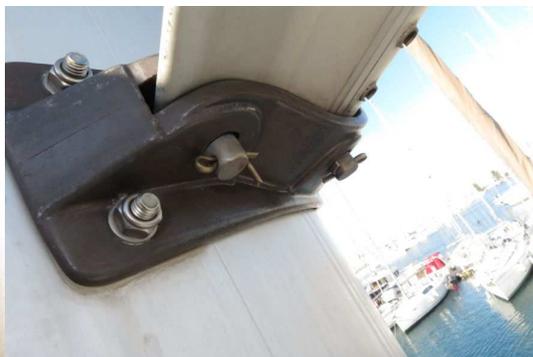
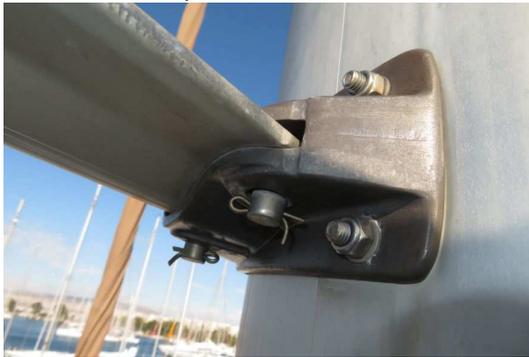
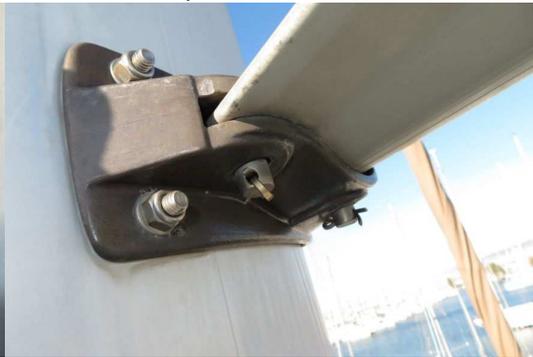
Spreaders secure

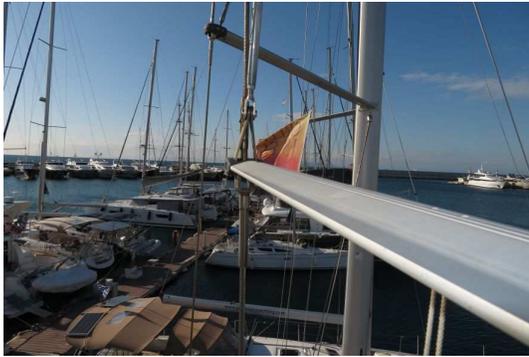
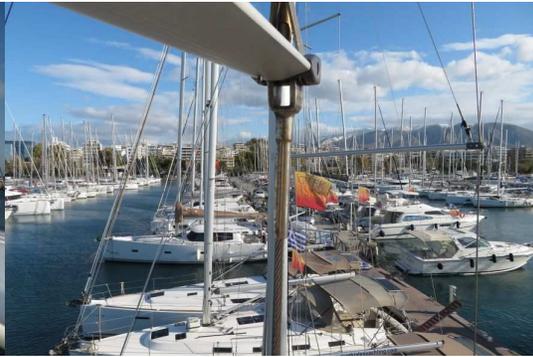
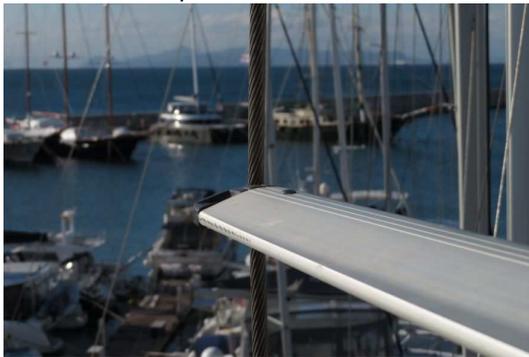
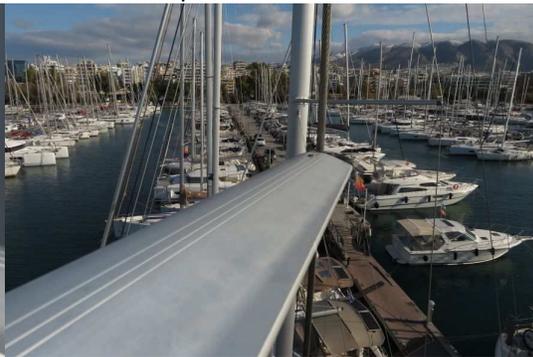
Spreaders intact

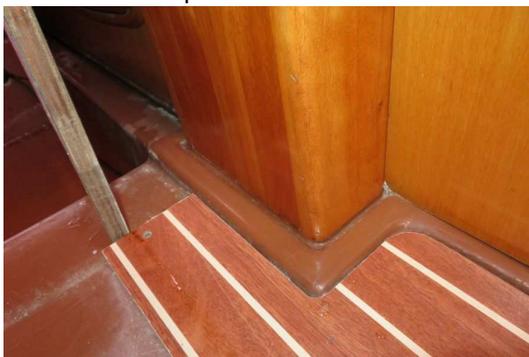
Compression post secure

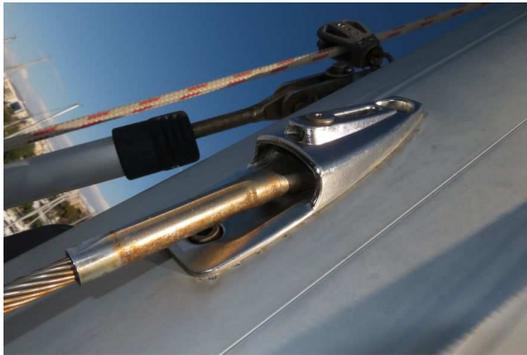
Cap shroud fittings secure

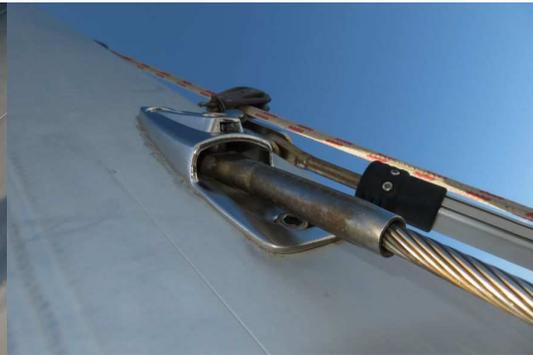
Cap shroud without broken wires

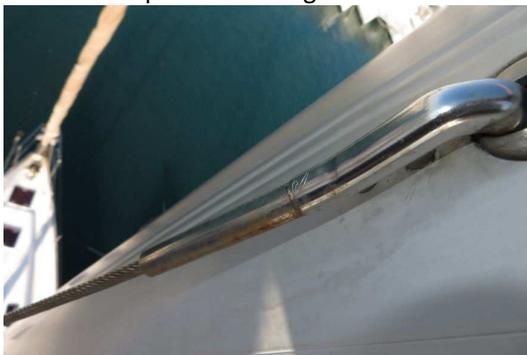
Intermediates fitting secure

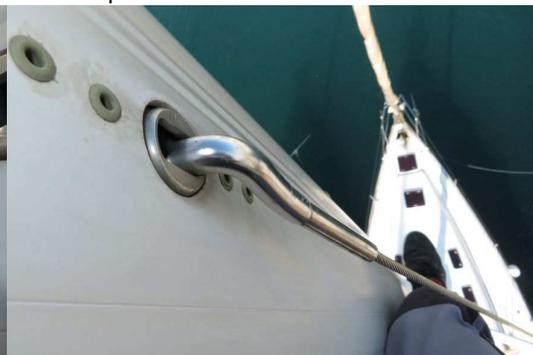
Intermediates no broken wires

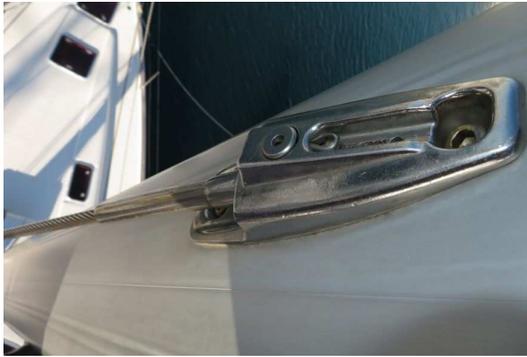
Lower fittings secure

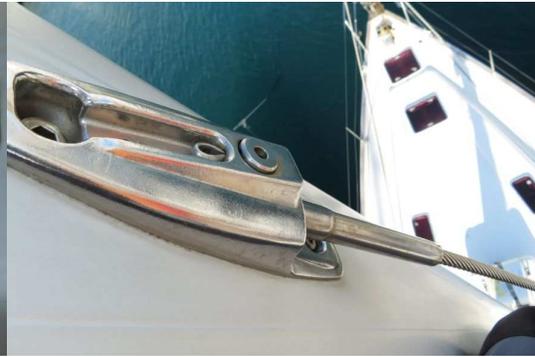
Lowers no broken wires

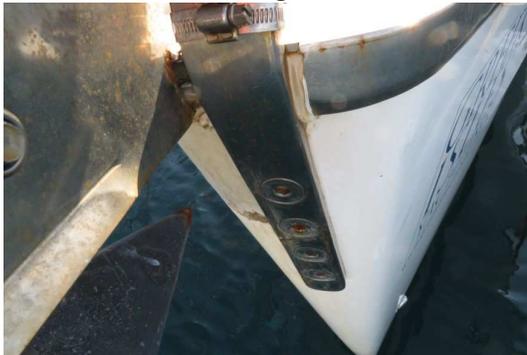
Stemhead fitting without fracture

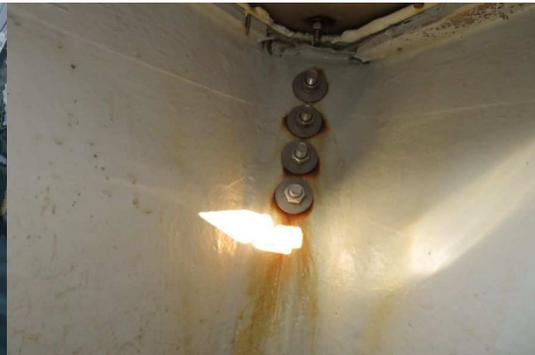
Stemhead fitting secure

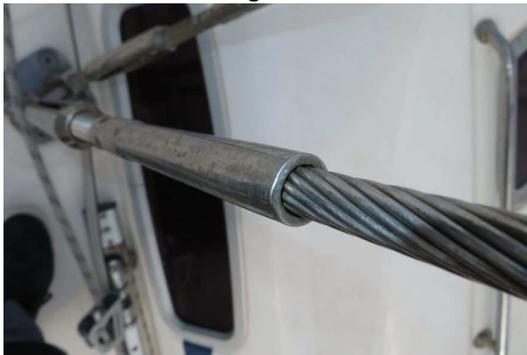
No broken wires at entry to swage terminals

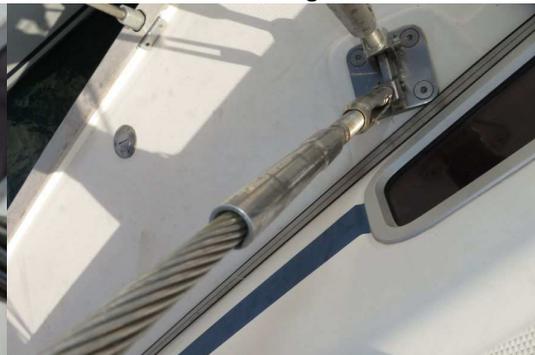
Swage terminals were straight and without cracks

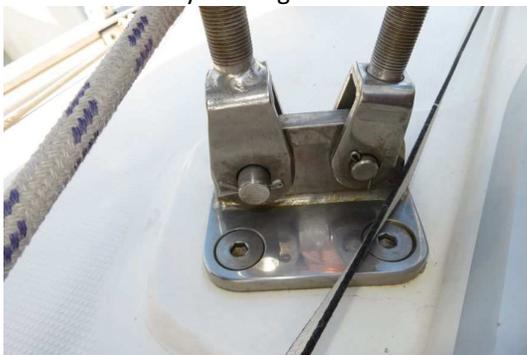
Shroud deck plate welds without cracks

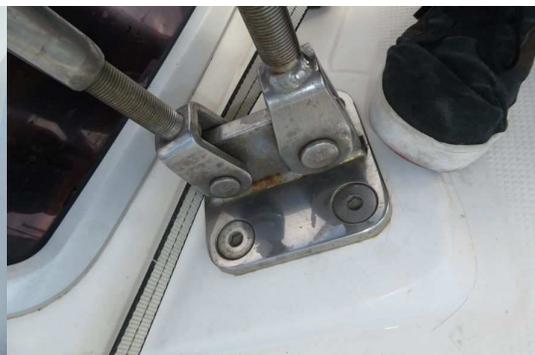
Not more than cosmetic crazing at shroud deckplates

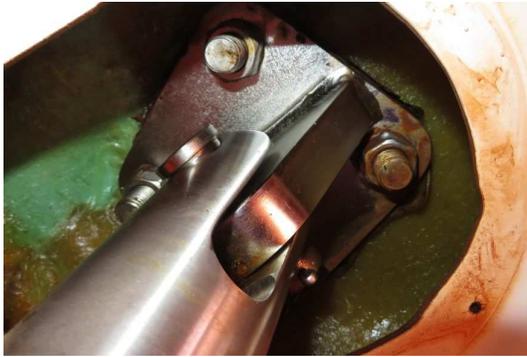
Deck under shroud deckplates without cracks

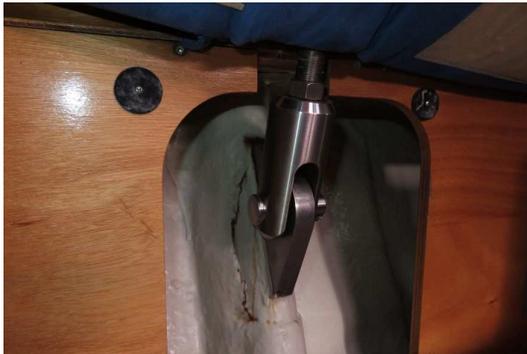
Shroud attachment structure intact

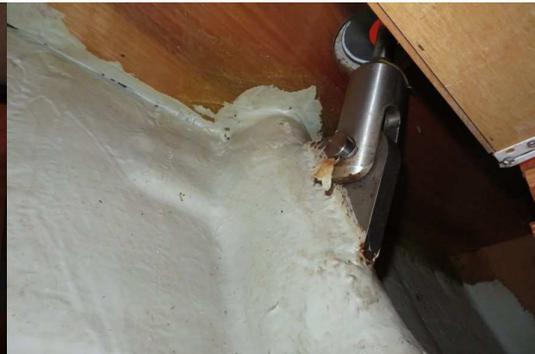
Shroud attachment structure intact

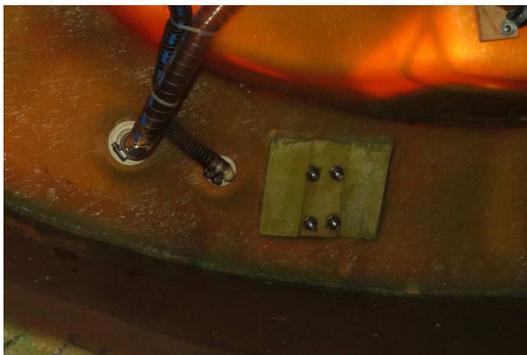
No corrosion at backstay chainplates

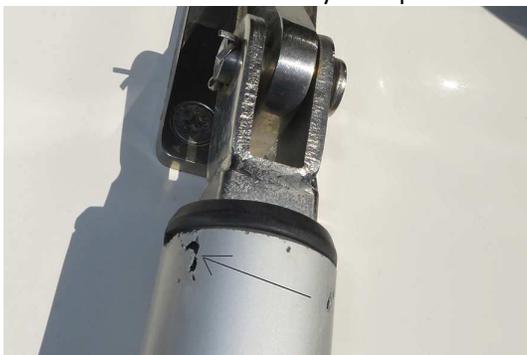
The adjustable backstay aluminium cylinder is with corrosion pitting but still of use.

Small areas of wastage at backstay cylinder

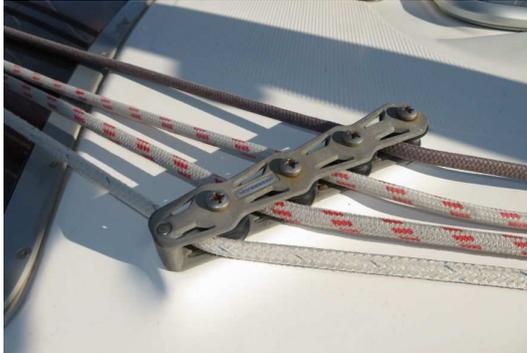
Deck organisers secure

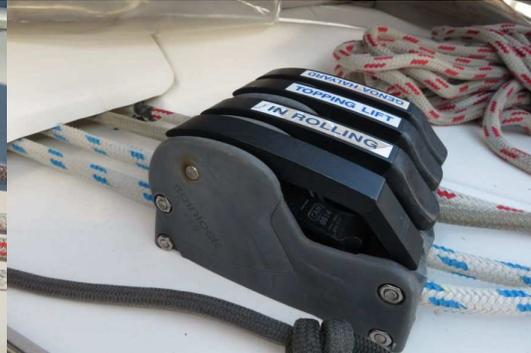
Rope jammers without damage

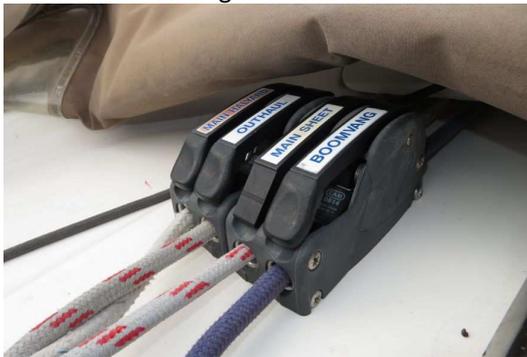
Rope jammers secure

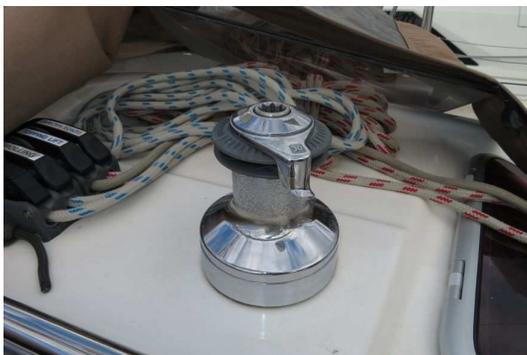
Manual winches were working. The starboard cockpit winch requires service because the stop is broken.

Winches secure

*Recommendation : The starboard cockpit winch requires service because the stop is broken.*

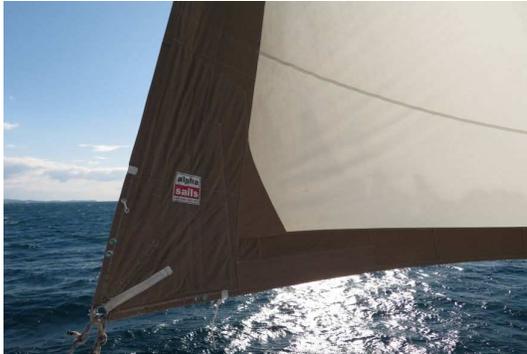
Genoa without damages

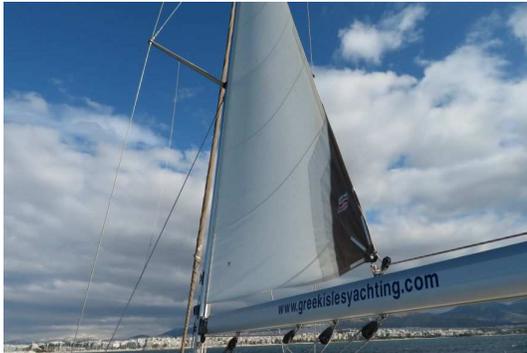
Main without damages

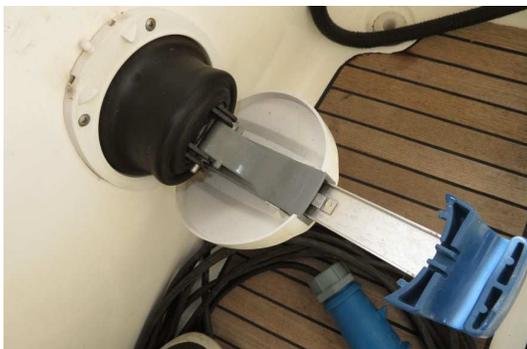
Manual bilge pump working

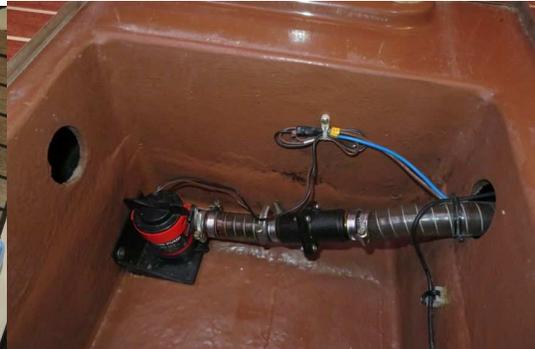
Electric bilge pump working

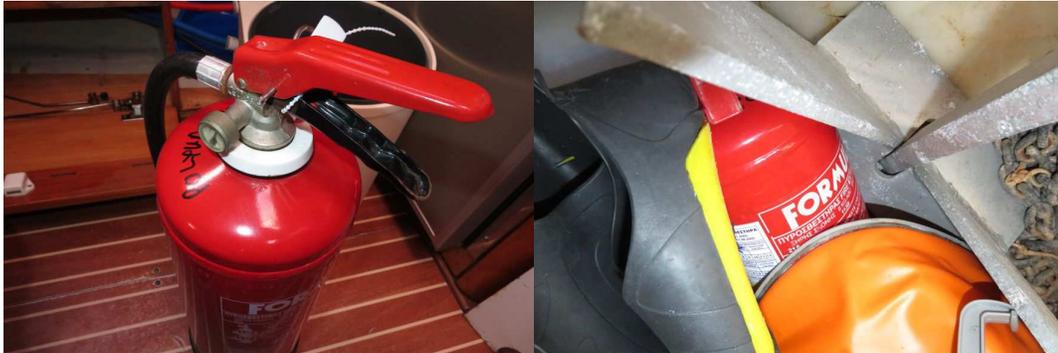
Fire extinguisher without corrosion

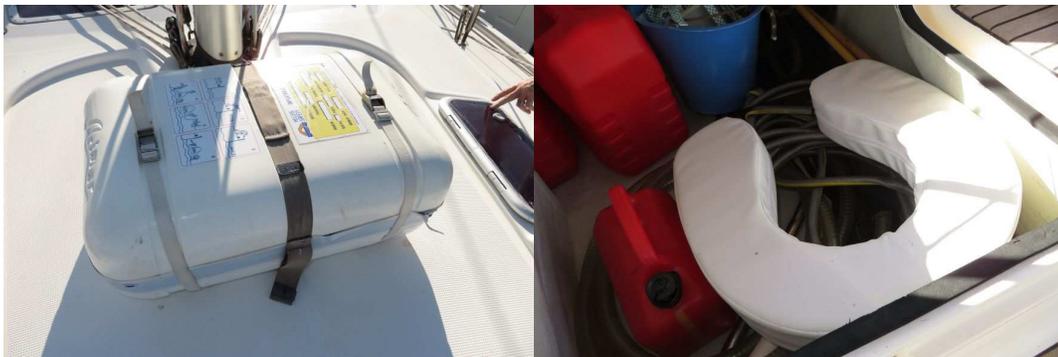
Liferaft on deck with manual release

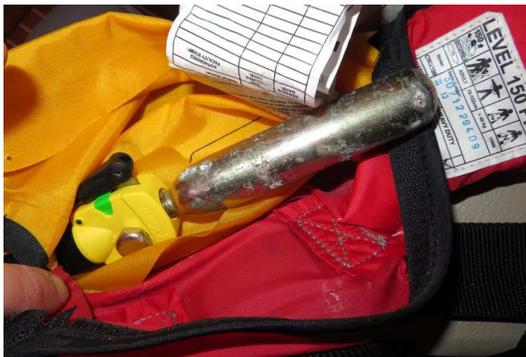
Gas inflated 150N lifejackets. There was no servicing certificate. They require minimum 5 year service interval. Acceptable for private use is owner visual inspection, 24 hour inflation and check for leak. Then rearm with new firing head and cylinder.

Lifejacket cylinder minor corrosion

*Recommendation : Gas inflated lifejackets. There was no servicing certificate. They require minimum 5 year service interval. Acceptable for private use is owner visual inspection, 24 hour inflation and check for leak. Then rearm with new firing head and cylinder.*

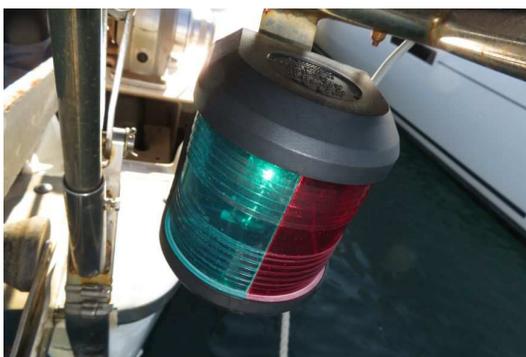
Bow bicolour working

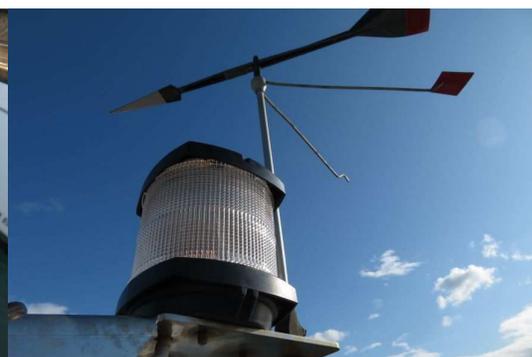
Anchor light LED at switchboard is blinking but the light is working. It is not very bright. Check the bulb.

Anchor light dim

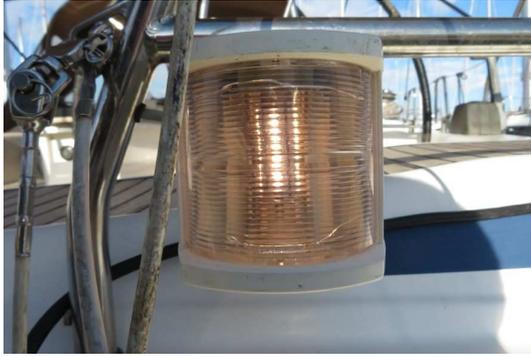
Stern light working

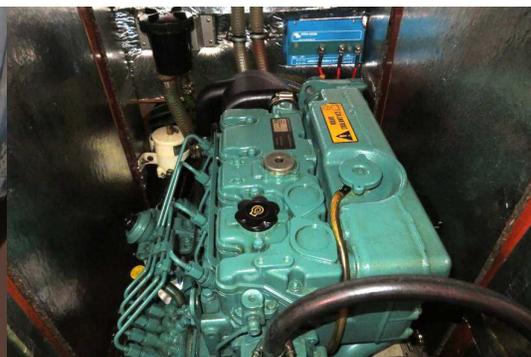
The engine was in excellent external condition without corrosion or significant leak and looked practically brand new.

Engine without corrosion

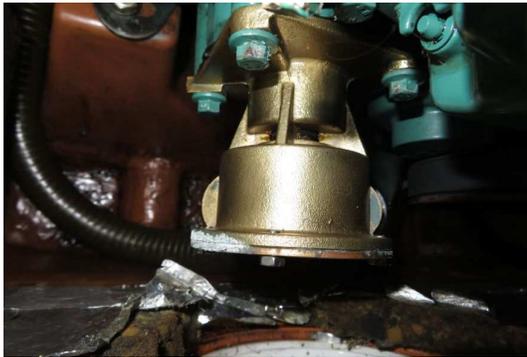
Minor leak at impeller

*Suggestion : Engine impeller casing is with small leak and probably requires o-ring replacement.*

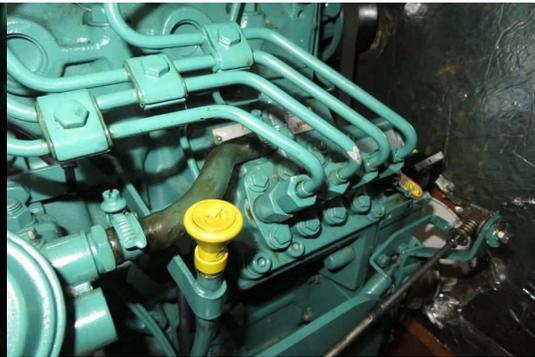
No fuel leak at injection pump

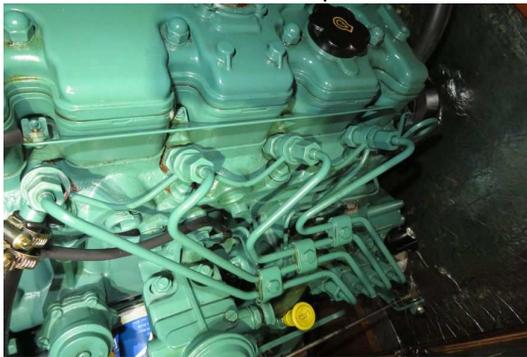
No fuel leak at injectors

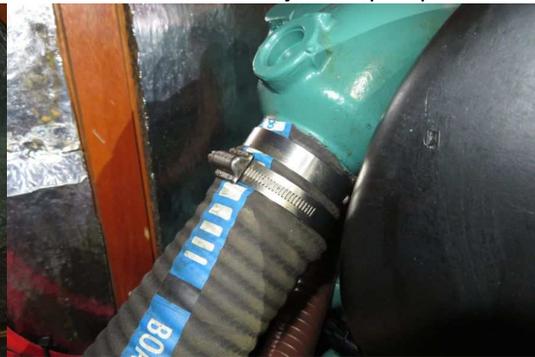
No corrosion or leak at exhaust mixing elbow

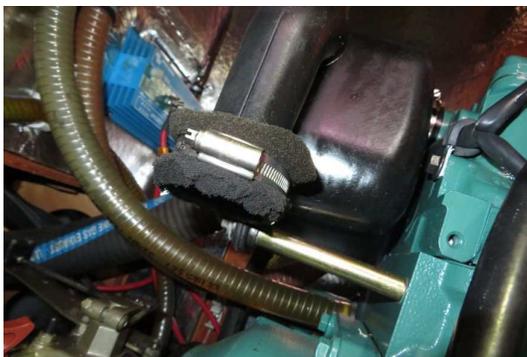
Air filter missing

*Suggestion : Engine air filter is missing and requires to be fitted.*

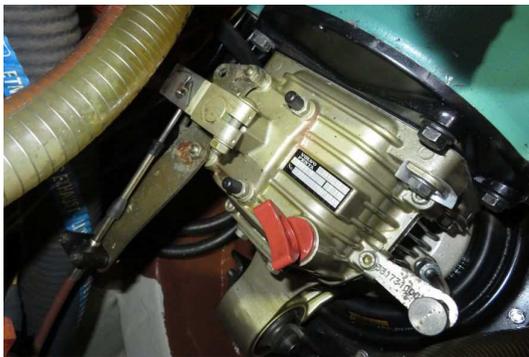
Saildrive without corrosion

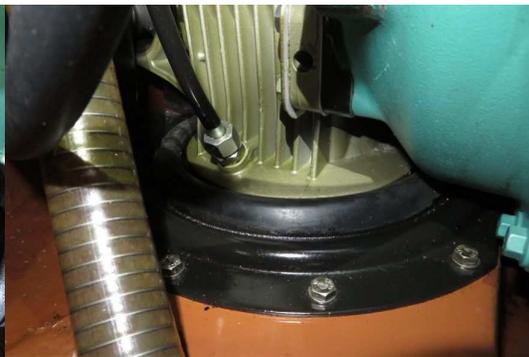
Seal without deterioration or leak

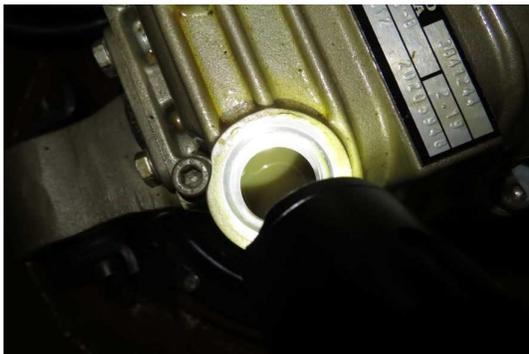
Oil without emulsions

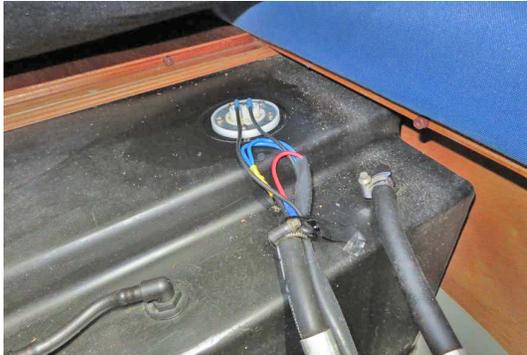
Fuel tank has small leak at the level sensor. It requires to be removed and resealed with sikaflex.

Small leak at level sensor

*Suggestion : Fuel tank has small leak at the sensor. It requires to be removed and resealed with sikaflex.*
