Date : 13 January 2020

## PRE-PURCHASE CONDITION SURVEY REPORT

### S/Y BAVARIA 46

At Athens Jan/20

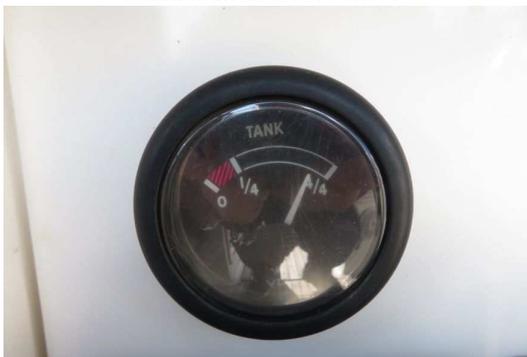
Level gauge working

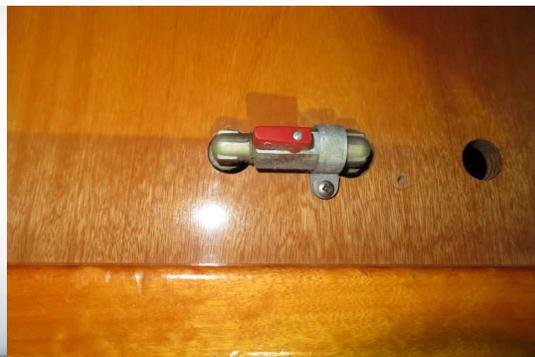
Shut off valve

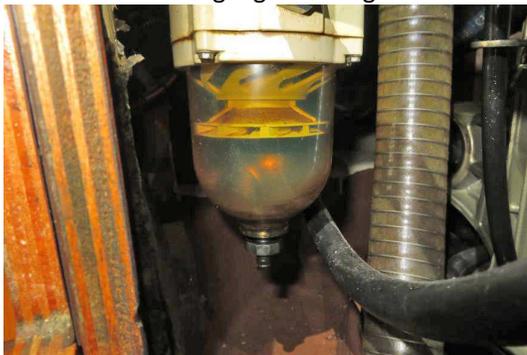
Primary filter without water  
and with minor sediment

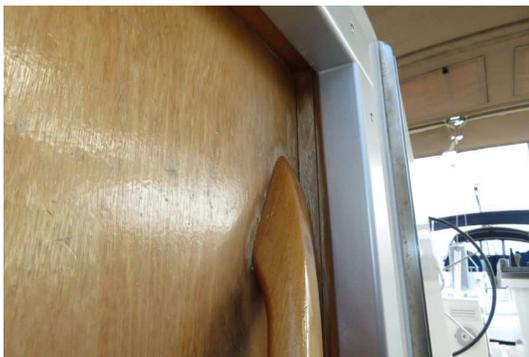
The accommodation was generally in order but requires localised revarnishing by carpenter to the woodwork due to previous leaks.

Varnish deterioration at companionway

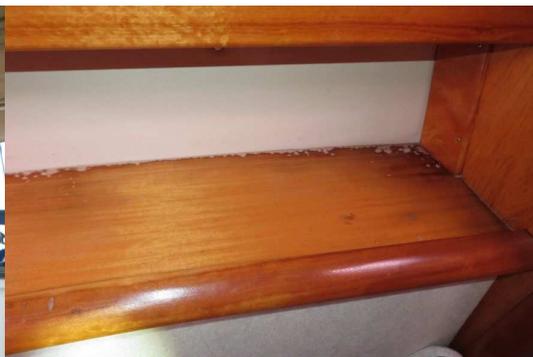
Varnish deterioration at forward cabin shelf

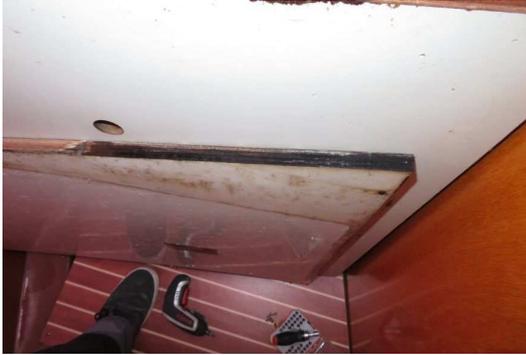
Due to leaks from the cabin hatch windows the plywood flooring in the forward cabin, twin cabin and corridor from the saloon to the forward cabin is blackened at the edges therefore rotting and requires replacement with original bavaria replacement flooring.

Blackening of sole boards due to leaks

*Suggestion : Due to leaks from the cabin hatch windows the plywood flooring in the forward cabin, twin cabin and corridor from the saloon to the forward cabin is blackened at the edges therefore rotting and requires replacement with original bavaria replacement flooring.*

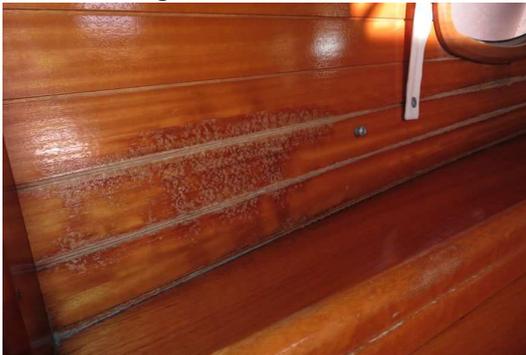
Varnish deterioration at saloon side

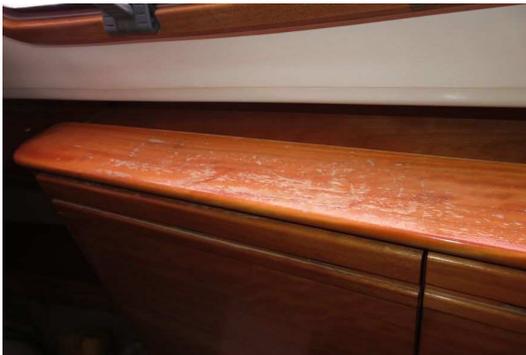
Varnish deterioration at aft cabin

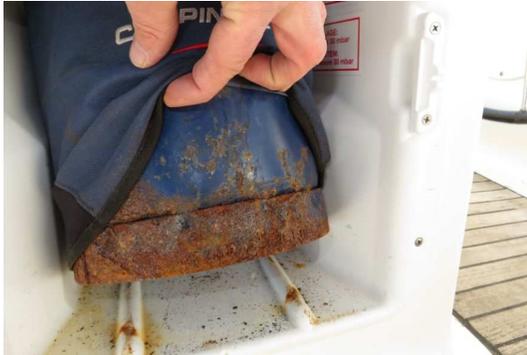
Dedicated gas locker with vent and drain via the door. The gas cylinders are corroded and require exchanging. Single cylinder installation. Regulator not corroded. Gas flexible hoses were not labelled. Cooker with minor corrosion. Gimbal lock working. Shut off valve provided near the cooker.

Gas cylinder corroded

*Suggestion : The gas cylinders are corroded and require exchanging.*

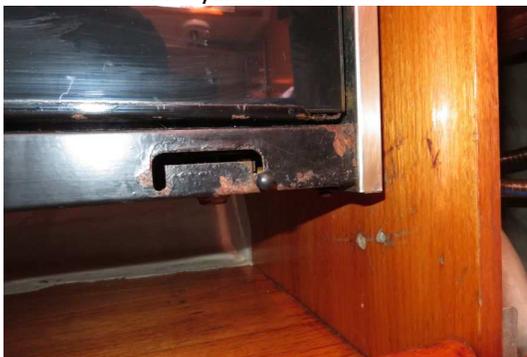
Cooker with minor corrosion

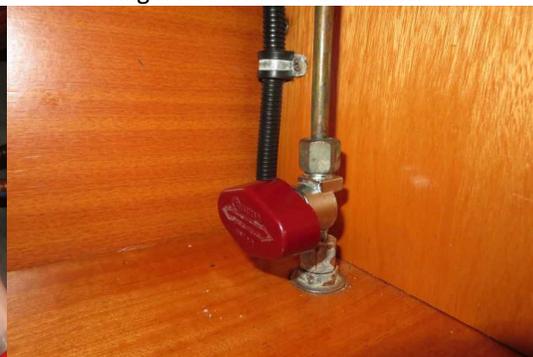
Shut off valve without corrosion

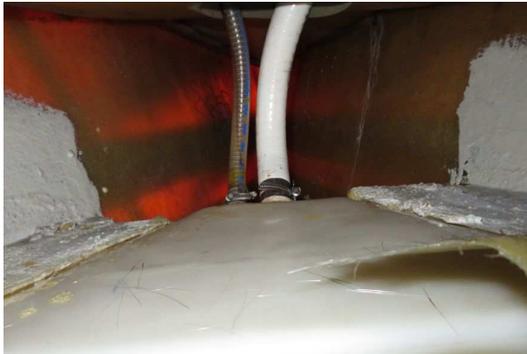
Fill and vent secure

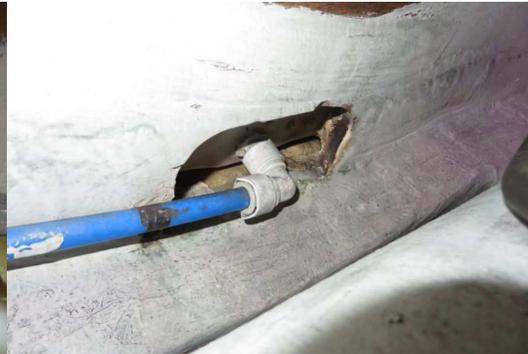
No leaks at forward tank delivery line

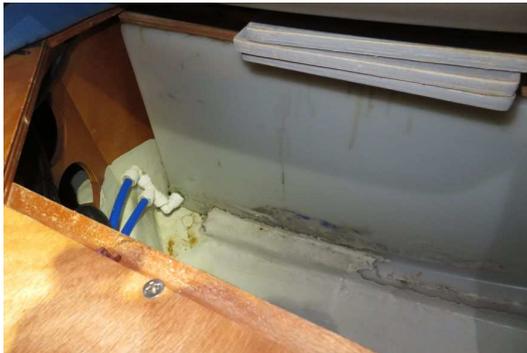
No leaks at aft tank delivery

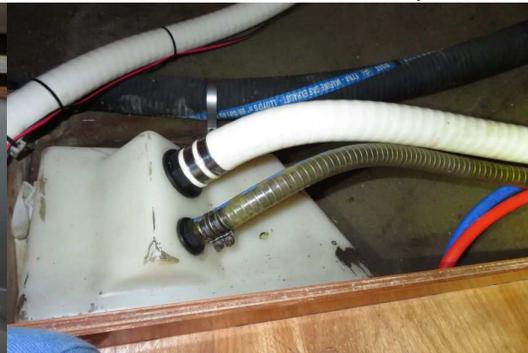
Fill and vent of aft tank secure

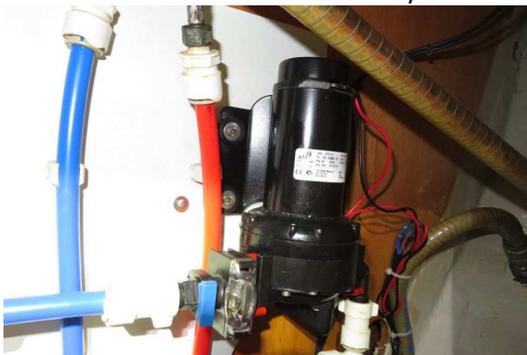
No leaks at fresh water pump

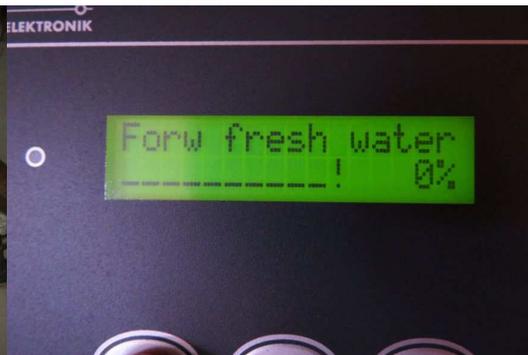
Forward tank seems empty

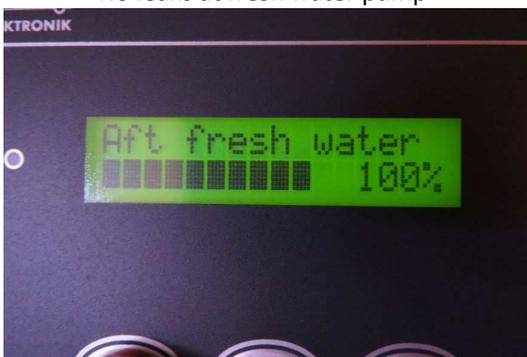
Aft tank level gauge working

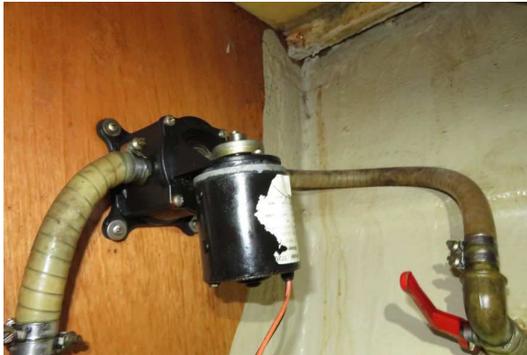
Forward shower drain pump no leaks

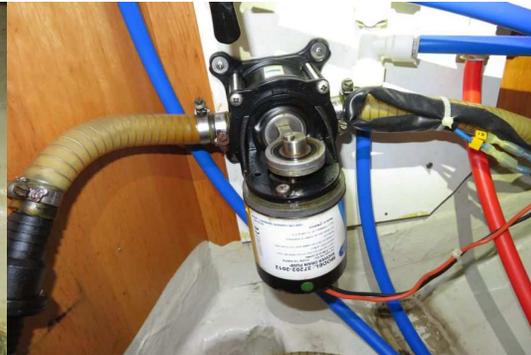
Aft shower drain pump no leaks

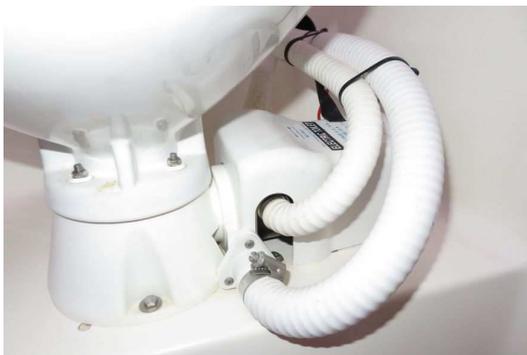
No leaks at toilet pump

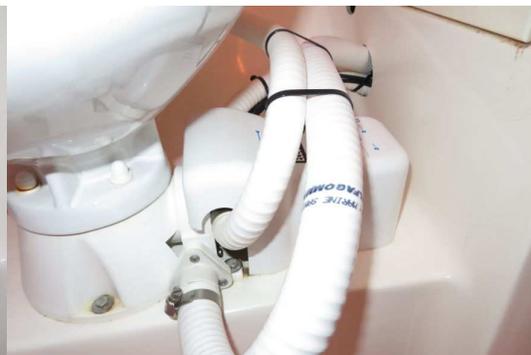
No leaks at toilet pump

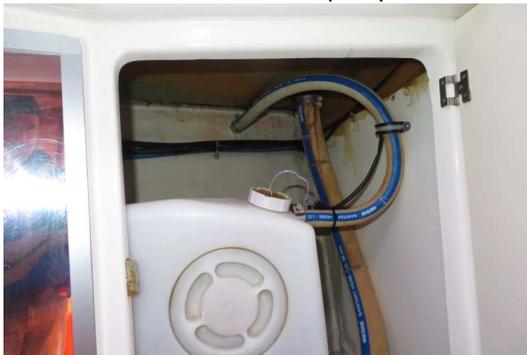
Holding tank no leaks

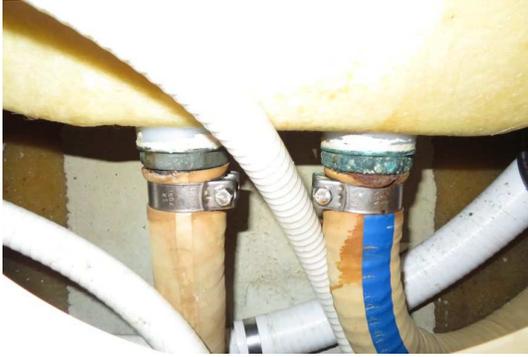
No significant leaks at tank connections.

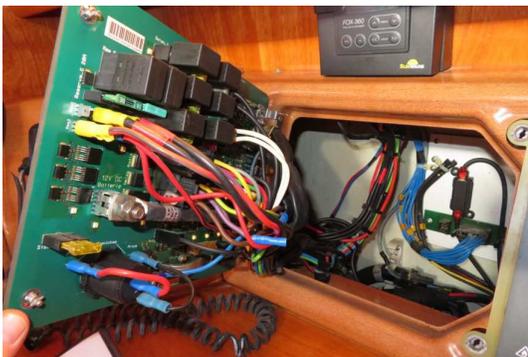
No burnt items  
or wet damage at switchboard

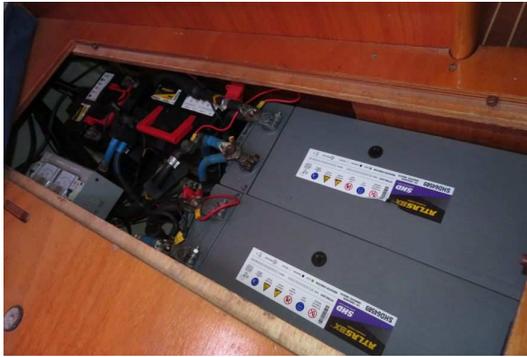
Batteries

During the survey the service battery voltage became unexpectedly low. The service battery bank requires testing and it is likely replacement is required.

*Recommendation : During the survey the service battery voltage became unexpectedly low. The service battery bank requires testing and it is likely replacement is required.*

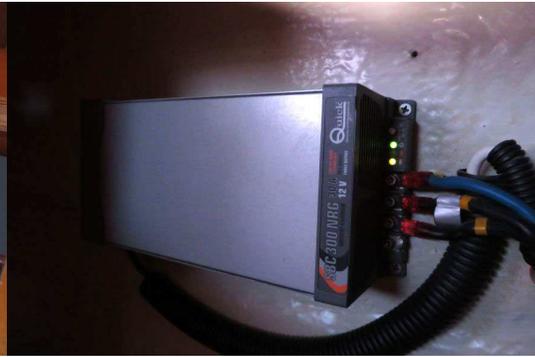
Battery charger working

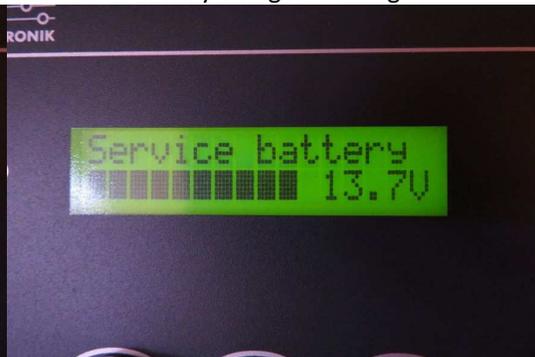
Service battery voltage

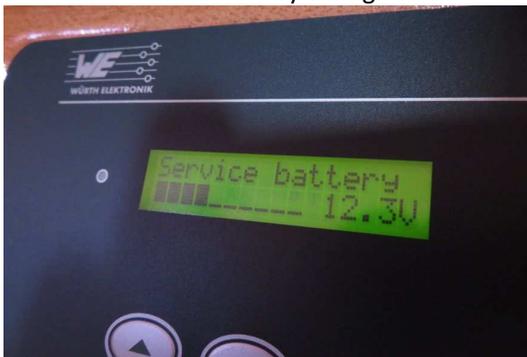
Service battery voltage drop

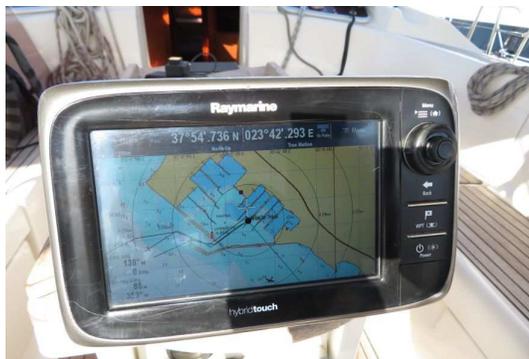
Chartplotter working

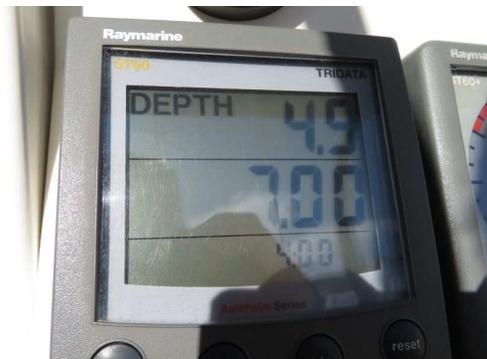
Depth working

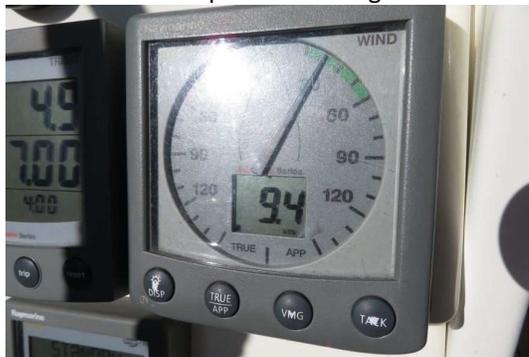
Wind Indicator working

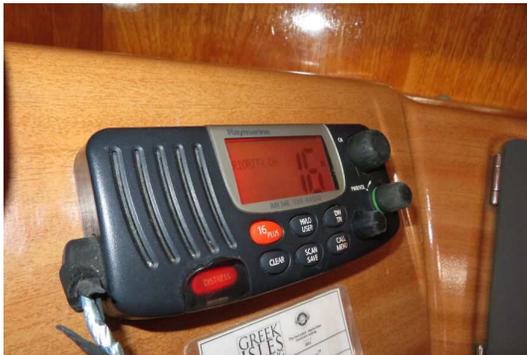
VHF working

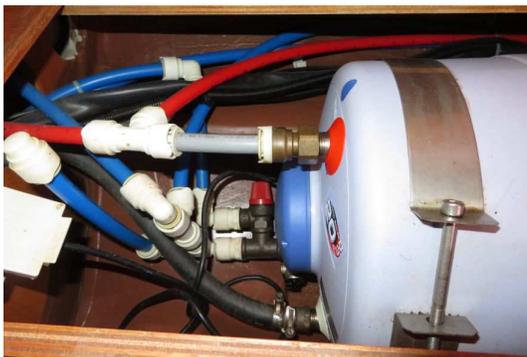
Water heater no leaks

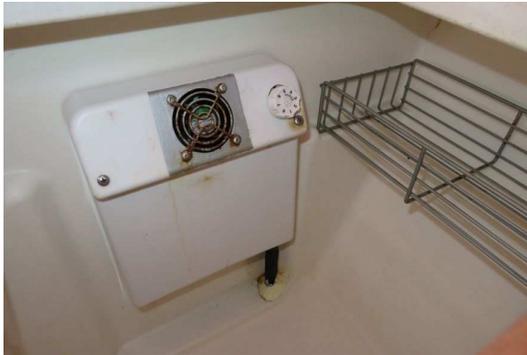
Refrigerator small fan grille is corroded and could be replaced. Refrigerators were checked working. Top opening refrigerator compressor was without corrosion.

Refrigerator fan grille corroded

*Suggestion : Refrigerator small fan grille is corroded and could be replaced.*

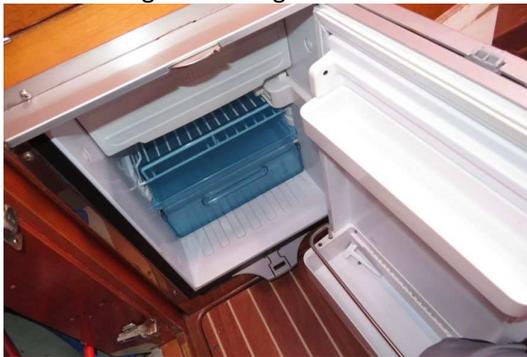
Side opening refrigerator internals intact

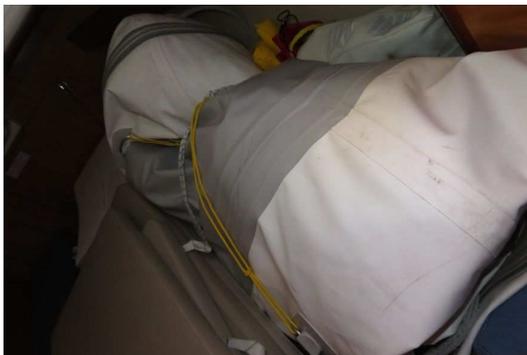
Tender looked satisfactory

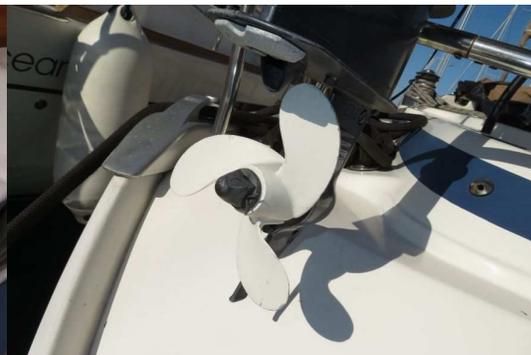
Outboard propeller without damages

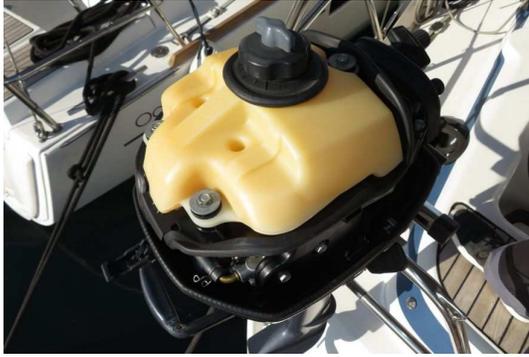
Motor without corrosion

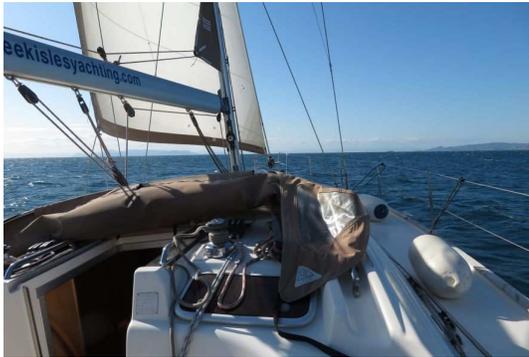
On sea trial

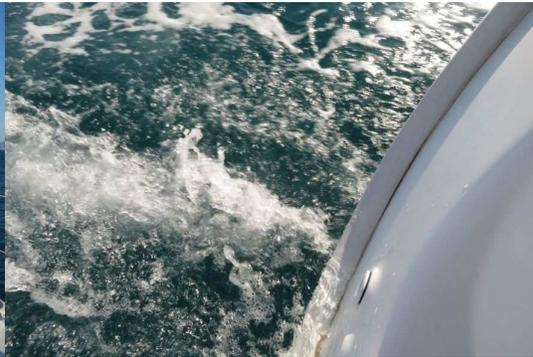
Exhaust clean at full rpm
