## PRE-PURCHASE CONDITION SURVEY REPORT

### ACHILLEAS II At Lavrio Nov/21

IN accordance with instructions received from CLIENT, the undersigned performed a condition survey on the following yacht on 04/11/2021. The following report details the condition of the yacht on the date of survey.

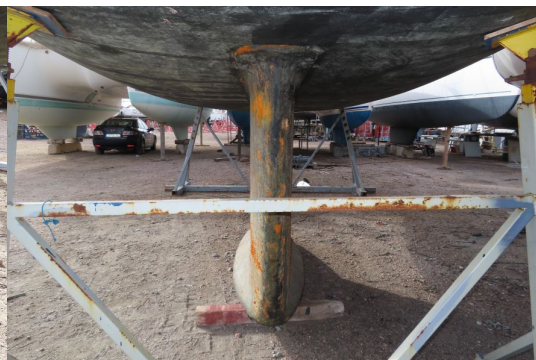
Keel looks square to the hull

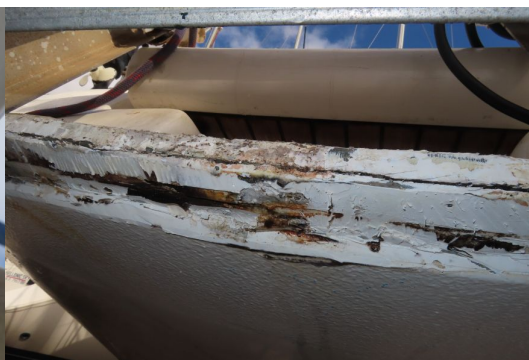
Chipping of gelcoat at bow stem requires gelcoat repairs.  
Unfinished stern repair requires sanding and gelcoat.  
Stainless rubbing strake part missing at starboard topsides.  
Stainless rubbing strake part missing at port topsides.

Stern requires overlaminating

*Suggestion : Unfinished stern repair requires sanding and gelcoat.*

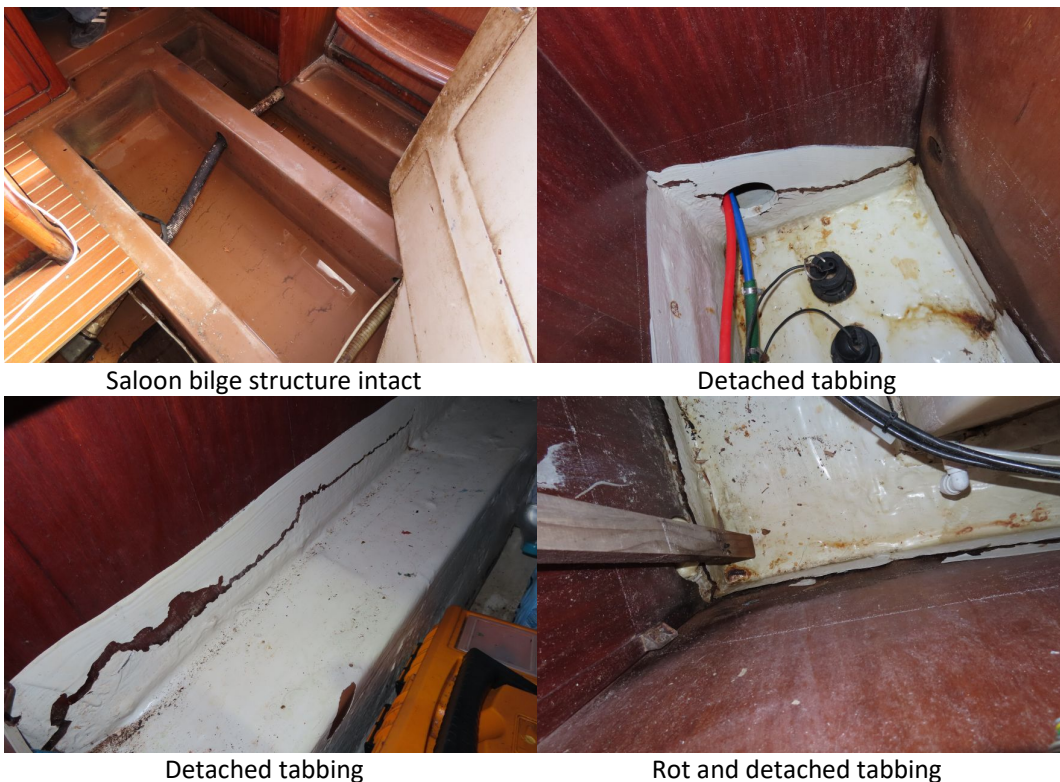
Forward cabins non structural under bed furniture and longitudinal non structural bulkhead. Tabbing overlaminations are detached and require renewal. Rotten wood requires removal and sister pieces fitted.

Tabbing under forward seat of saloon requires renewal because detached.

*Suggestion : Forward cabins non structural under bed furniture and longitudinal non structural bulkhead. Tabbing overlaminations are detached and require renewal. Rotten wood requires removal and sister pieces fitted.*

*Suggestion : Tabbing under forward seat of saloon requires renewal because detached.*

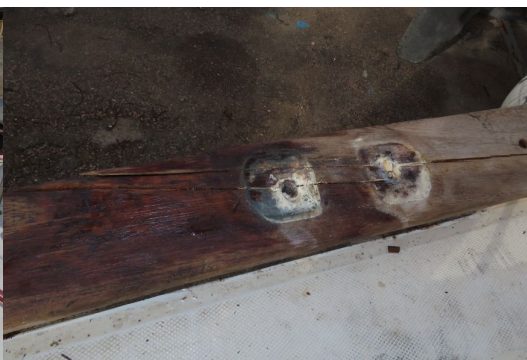
Teak caprail is broken in many locations and requires part replacement (Aft port cleat, Port stanchions Nos. 2, 4 and 5, Starboard stanchions Nos. 3,4 and missing No. 6 stanchion to stern).

Cracked caprail

*Suggestion : Teak caprail is broken in many locations and requires part replacement (Aft port cleat, Port stanchions Nos. 2, 4 and 5, Starboard stanchions Nos. 3,4 and missing No. 6 stanchion to stern).*

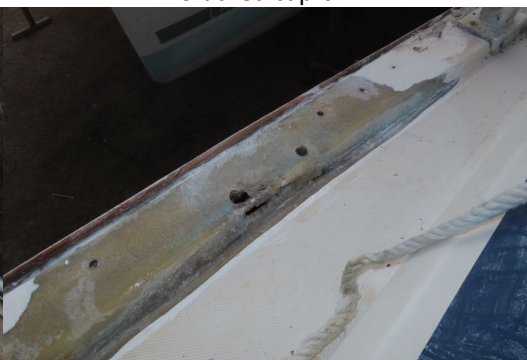
Hull to deck join is leaking. Requires overlamination or sealing with sikaflex.

Repairs to hull to deck join

*Suggestion : Hull to deck join is leaking. Requires overlamination or sealing with sikaflex.*

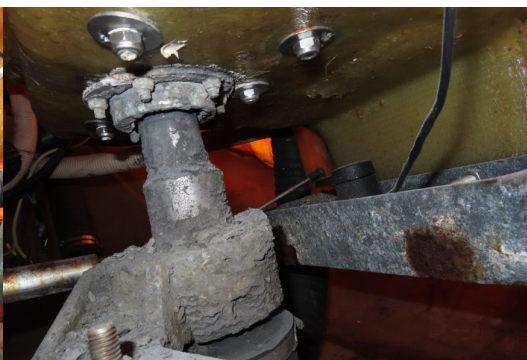
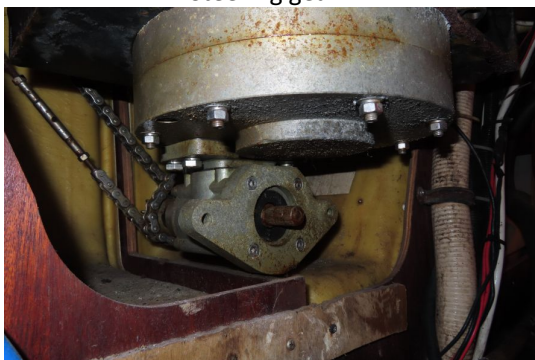
Steering quadrant has leaks from deck level and corrosion. Looked satisfactory for now but requires cleaning for close inspection.

Leaks from deck level leading to corrosion

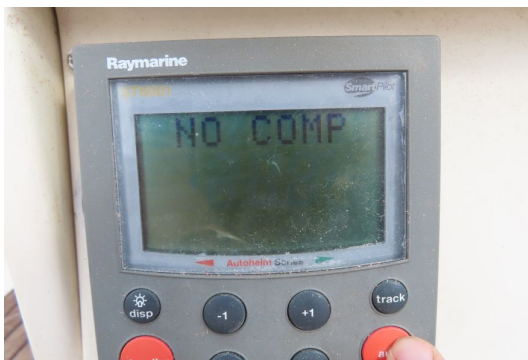
Electric autopilot requires service.

Autopilot does not work

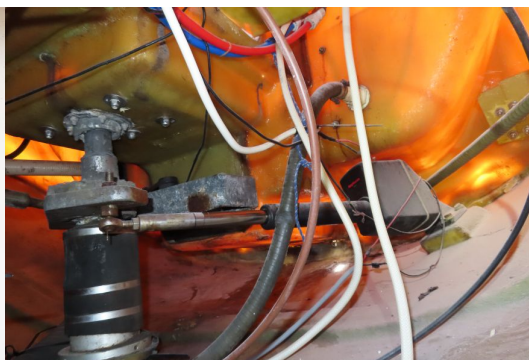
Linear drive was secure

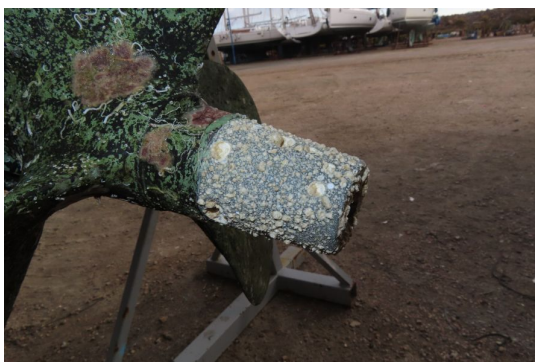
Propeller nut anode

Anodes were suitable for further use. No abnormal galvanic action seen.

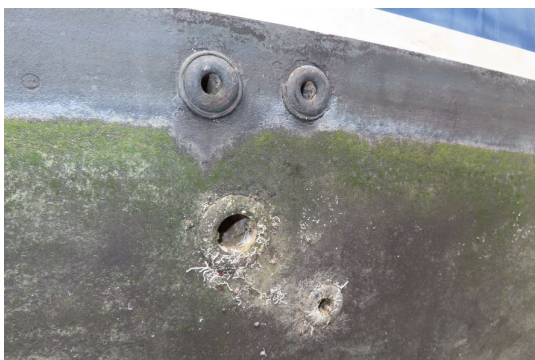
Through hull fittings without wastage

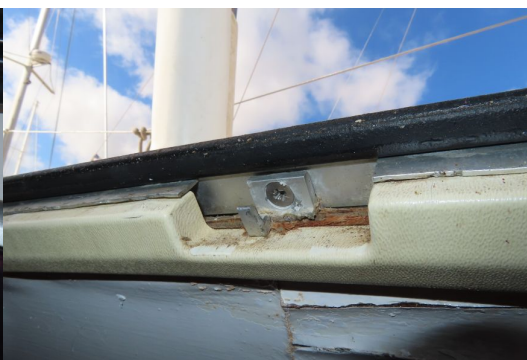
Missing clip

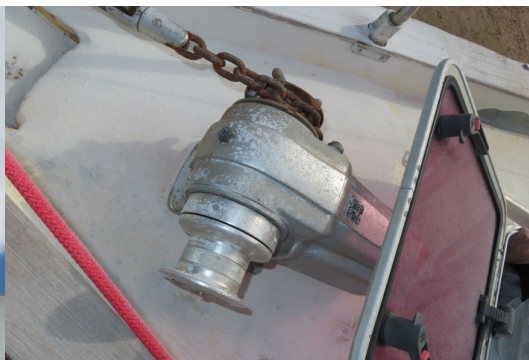
Anchor windlass was secure

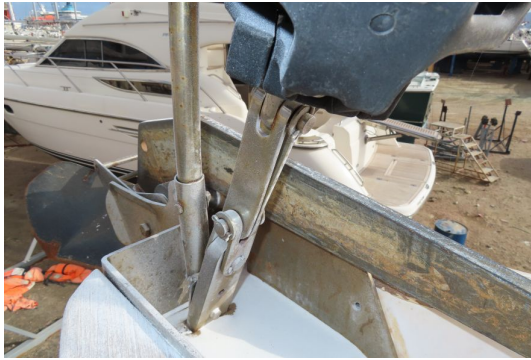
Furler fork not twisted

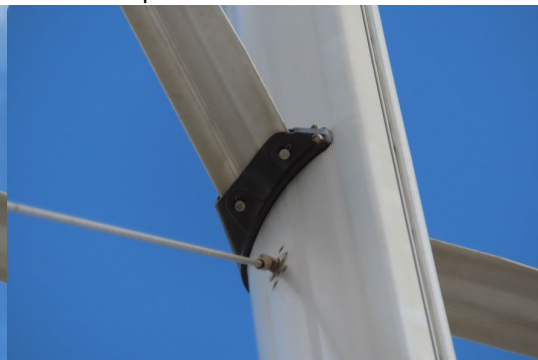
Spreaders looked secure

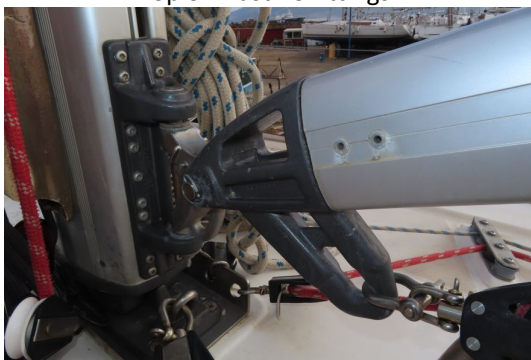
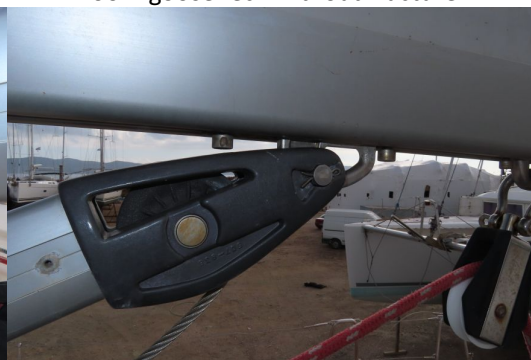
Boom vang fittings were secure

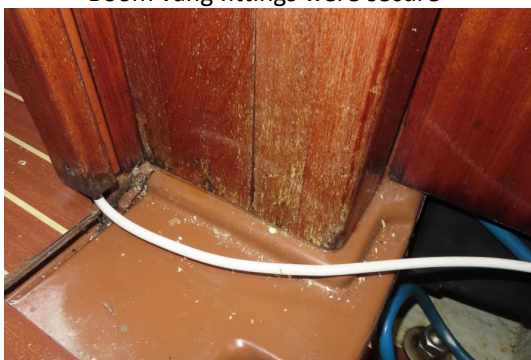
Compression post was secure

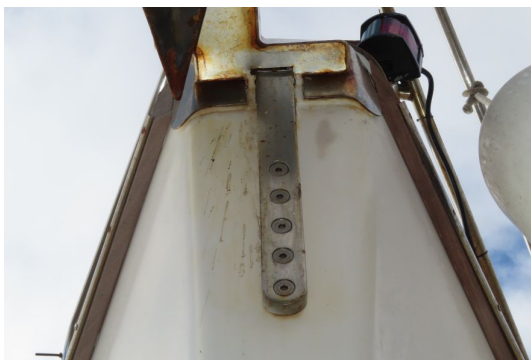
No corrosion at stemhead fitting

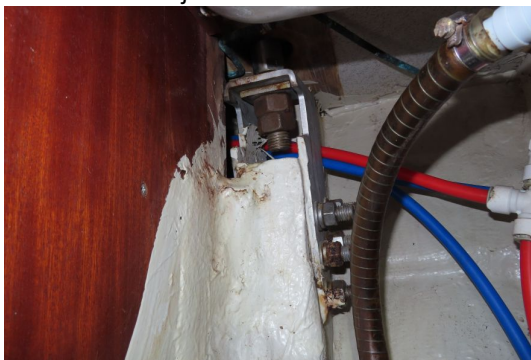
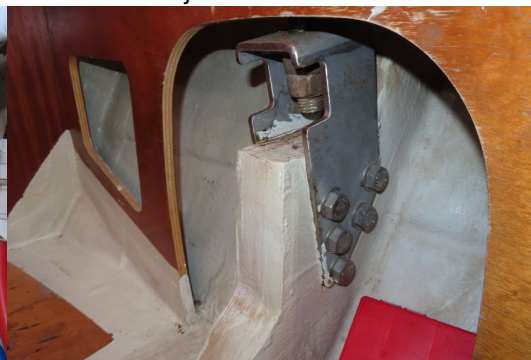
Shroud chainplates were secure

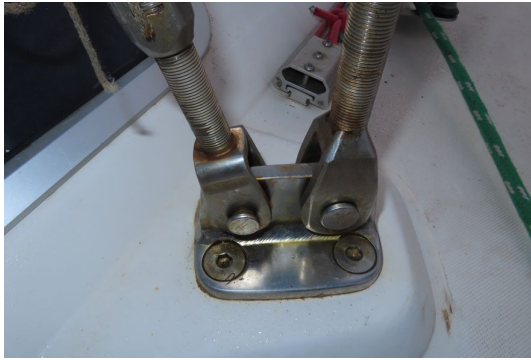
No cracks at shroud deckplates

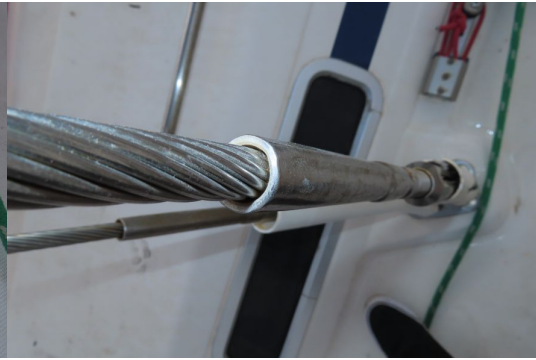
No broken wires

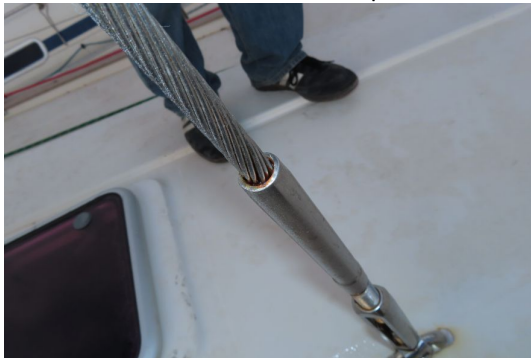
Swage terminals were straight

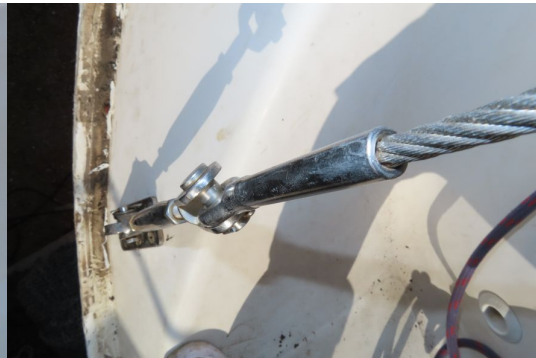
Backstay no broken wires

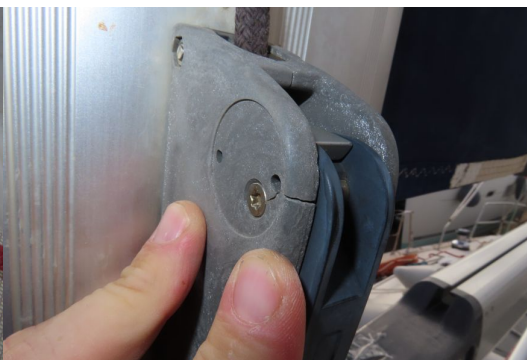
Mast main halyard rope jammer is cracked therefore requires replacement.  
Starboard cockpit rope jammers two handles are missing.

Cracked rope jammer

*Recommendation : (B) Mast main halyard rope jammer is cracked therefore requires replacement.*

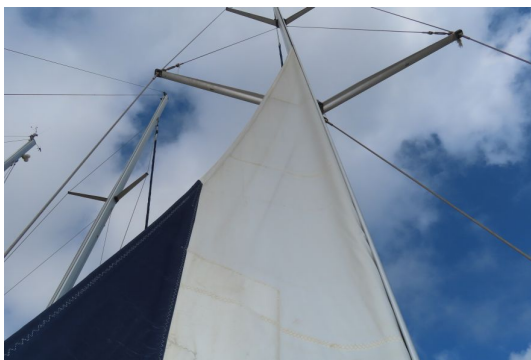
Mainsail

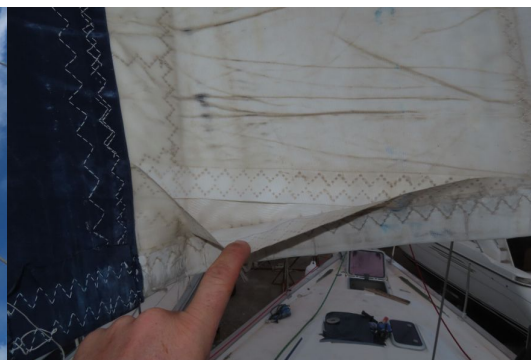
Genoa sail is temporary whilst the other is being repaired.  
Main sail requires restitching.

Mainsail requires stitching

*Suggestion : Main sail requires restitching.*

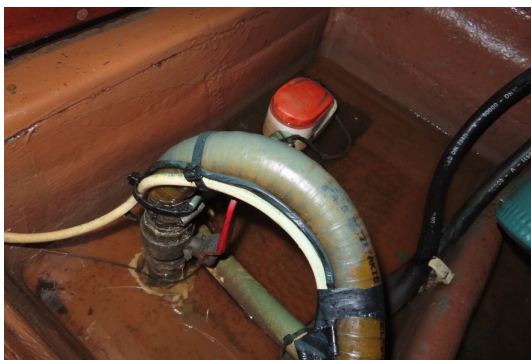
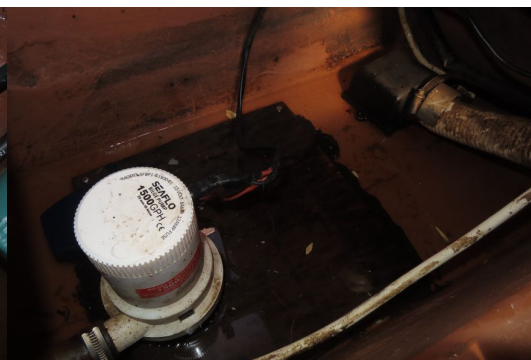
2 x electric bilge pump small capacity and high capacity checked working. Manual pump also working. All serving the saloon common bilge.

Bilge pump

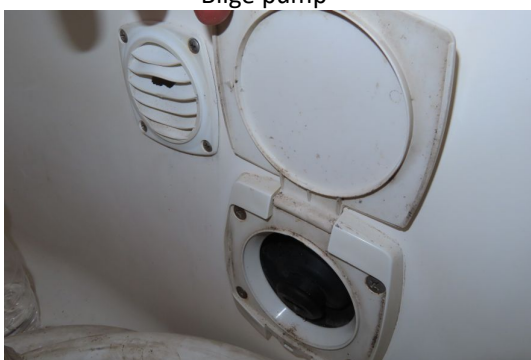
Manual pump

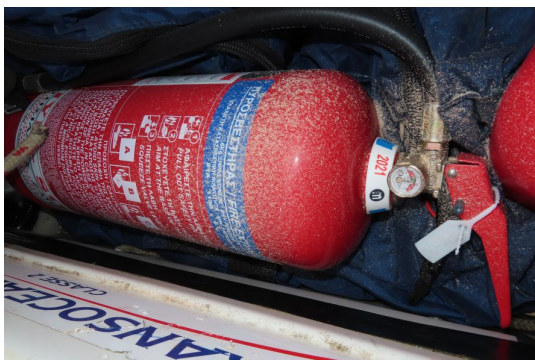
Fire extinguisher without corrosion

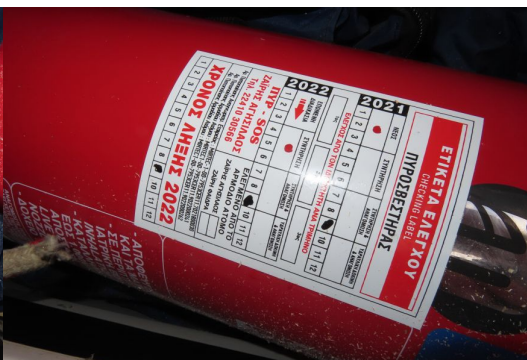
Servicing in date

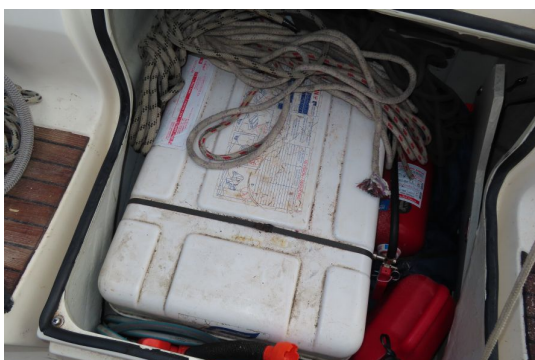
Liferaft casing was intact

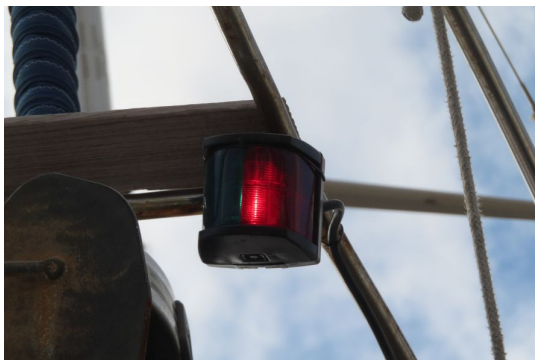
Side lights working

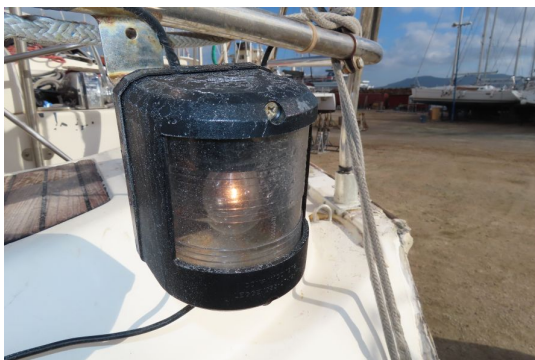
Stern light working

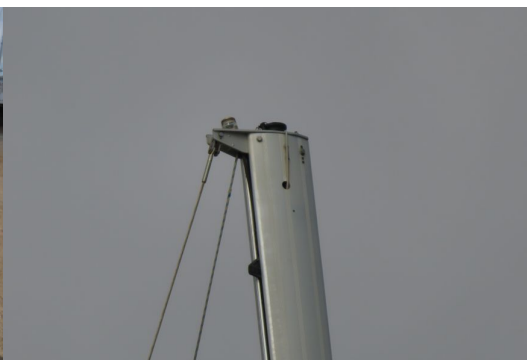
Anchor light working

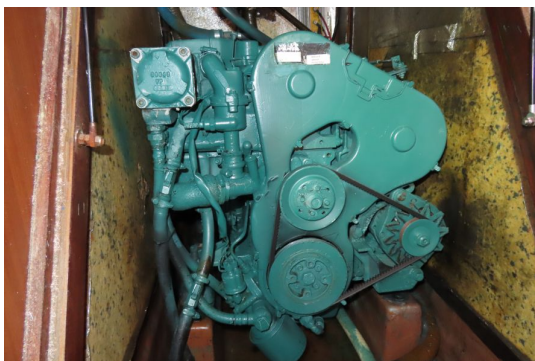
Engine was painted

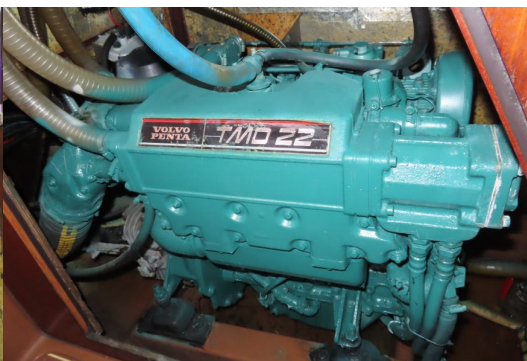
No leaks

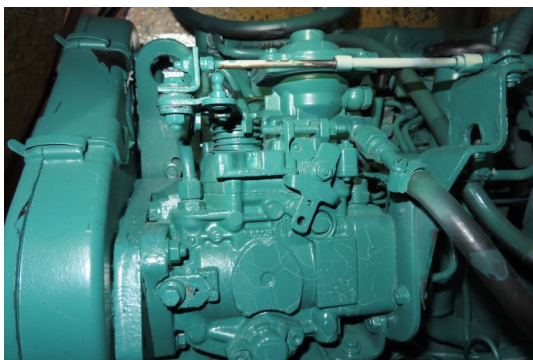
No leaks at fuel injection pump

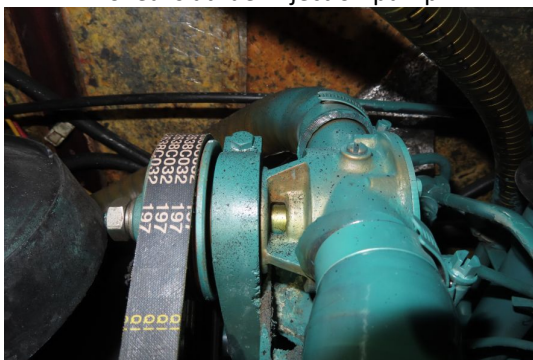
No leaks at seawater pump

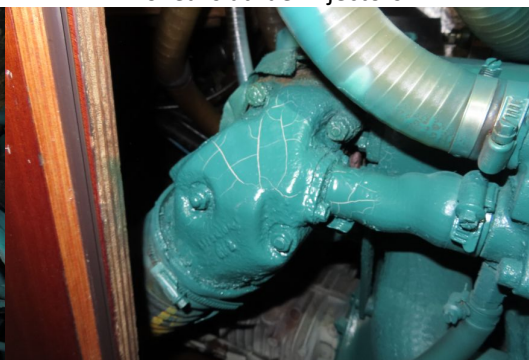
No leaks at exhaust elbow

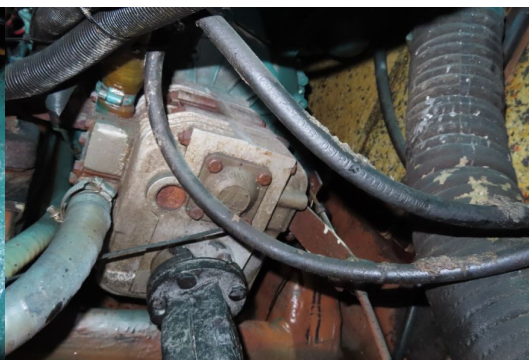
Reverse gear Volvo Penta MS25A-A. Reverse gear was without corrosion or leak of oil. Gearbox does not work well. Requires checking by mechanic. Controls and cable also require checking/greasing or replacement.

Another view

*Recommendation : (B) Gearbox does not work well. Requires checking by mechanic. Controls and cable also require checking/greasing or replacement.*

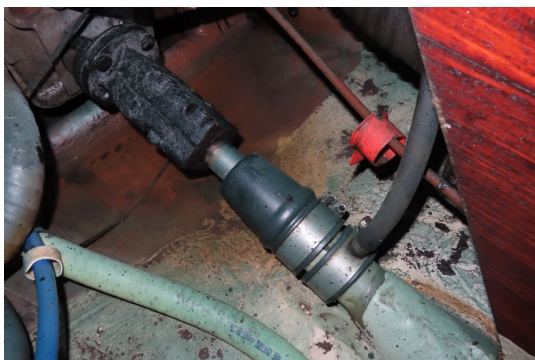
Volvo type shaft seal no deterioration.

Volvo shaft seal

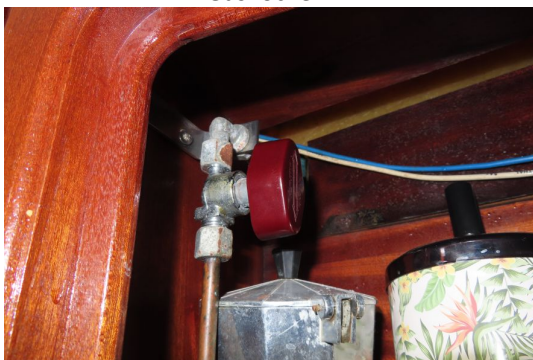
Shut off valve without corrosion

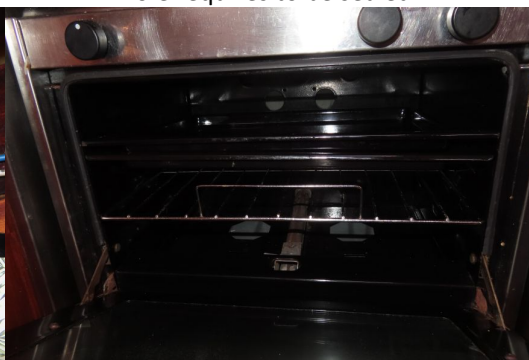
Gas cooker without corrosion

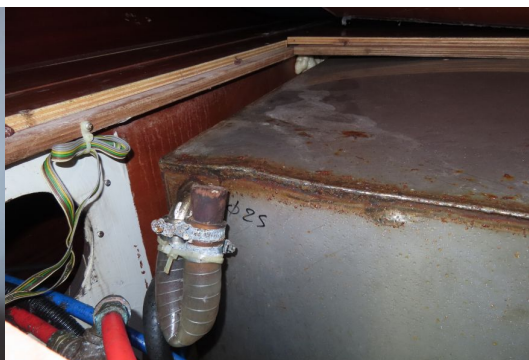
Stainless tank no sign of leaks

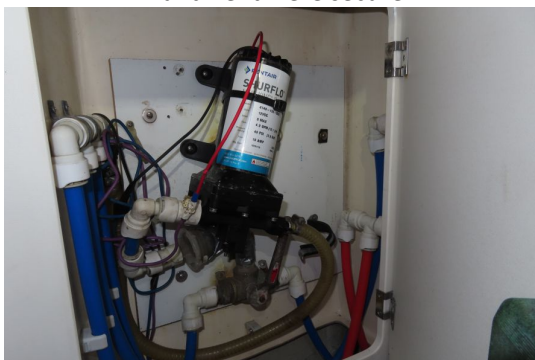
Fresh water pump no leaks

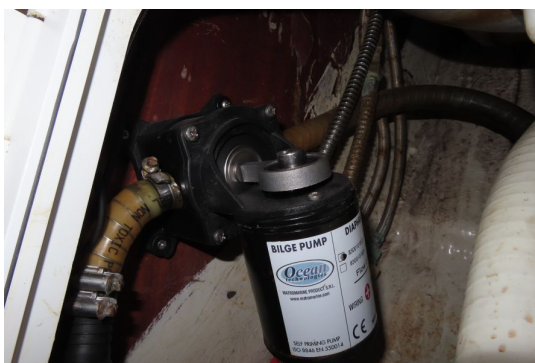
Shower drain pump no leaks

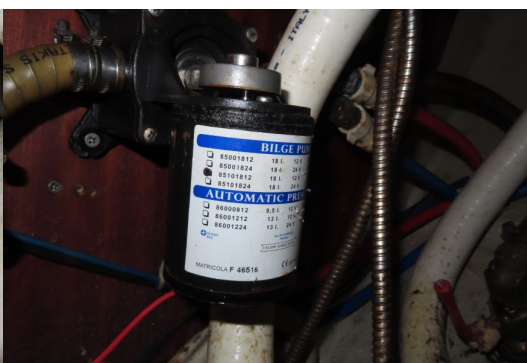
Shower drain pump no leaks

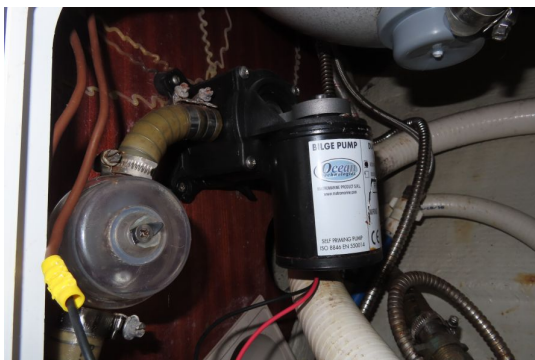
Shower drain pump no leaks

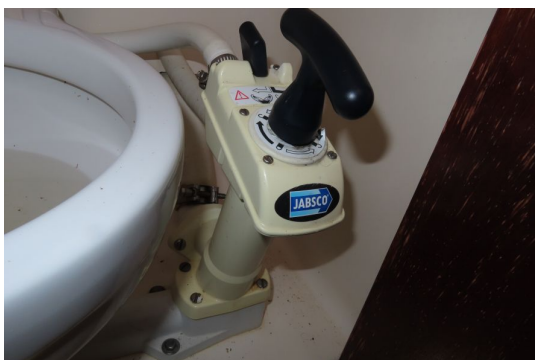
No leaks at toilet pumps

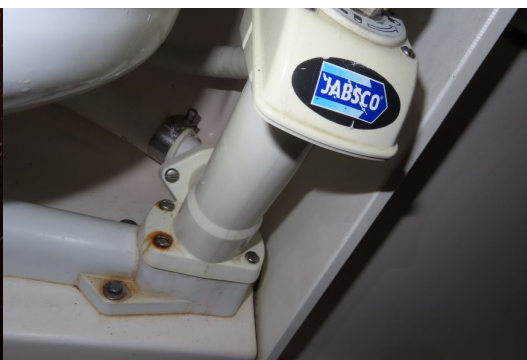
No leaks at toilet pumps

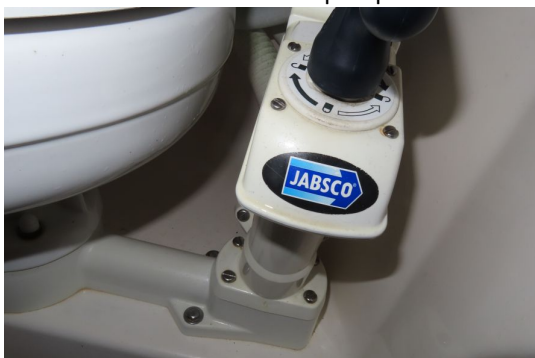
Manual toilets no holding tanks.  
Forward toilet pump requires repair.

No leaks at toilet pumps

*Suggestion : Forward toilet pump requires repair.*

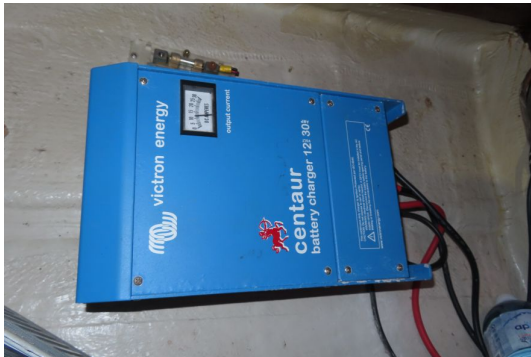
Battery charger was working

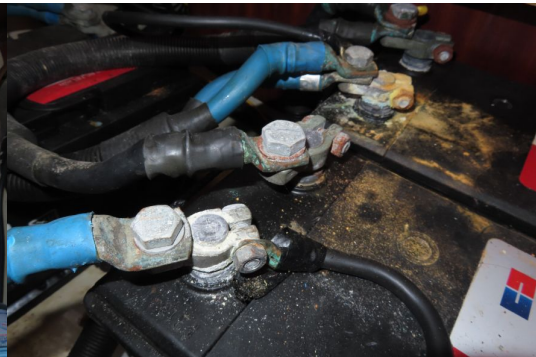
Service batteries one battery has sulphation at a terminal. Requires replacement of all the set.

Sulphation at battery terminal

*Suggestion : Service batteries one battery has sulphation at a terminal. Requires replacement of all the set.*

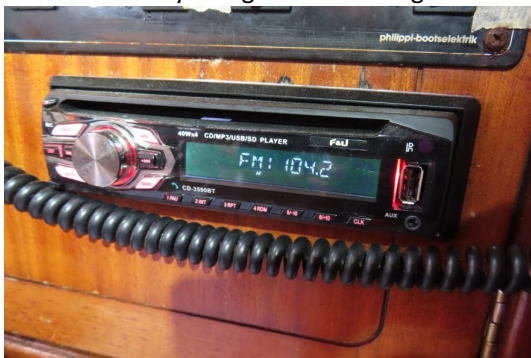
Stereo was working

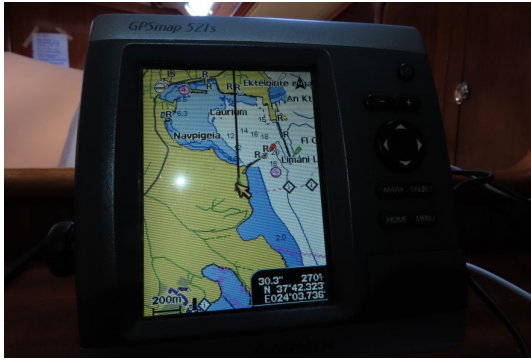
Chartplotter working

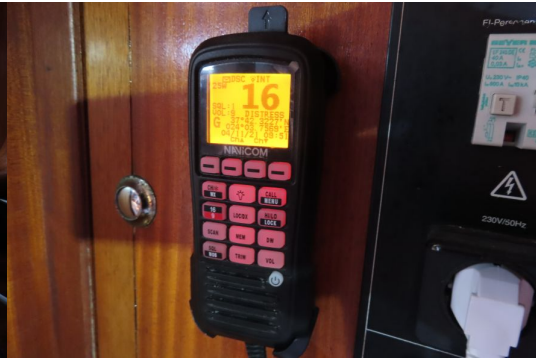
VHF working

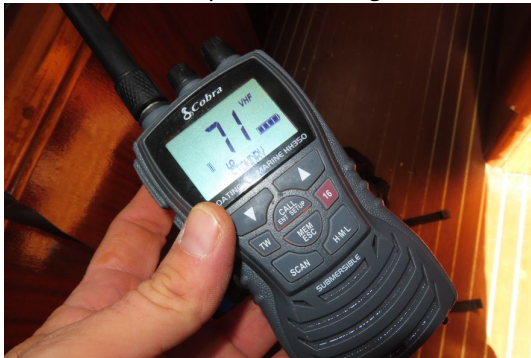
Portable VHF working

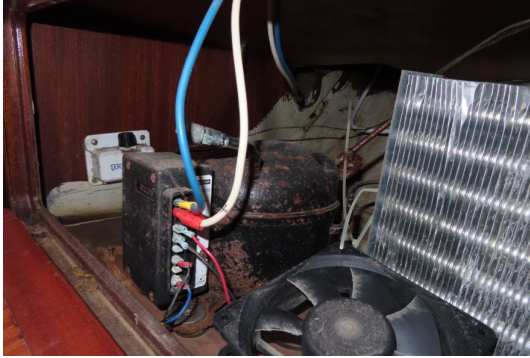
Refrigerator compressor requires repaint. Refrigerator was working.

Refrigerator compressor requires repaint

*Suggestion : Refrigerator compressor requires repaint.*

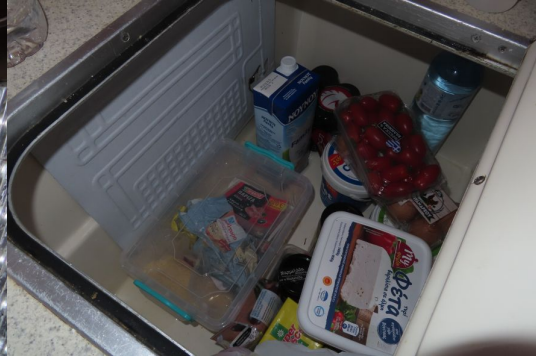
Refrigerator internals were intact

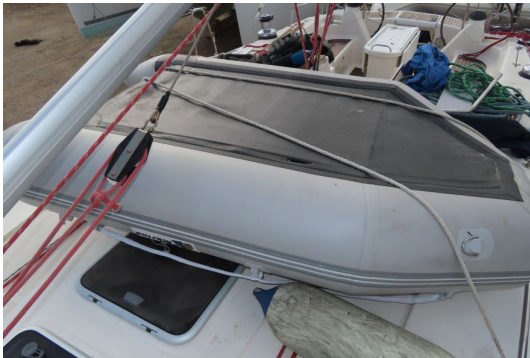
Outboard Chinese Parsun 2.6hp. Externally complete. Tender fully inflated and without damages.

Tender
