## PRE-PURCHASE CONDITION SURVEY REPORT

### M/Y MAIORA At Cannes Jan-Feb/17

IN accordance with instructions received from CLIENT, the undersigned performed a pre-purchase survey on the following yacht on 16/Jan/17 and 22/Feb/17. The following report details the condition of the yacht on the dates of survey.

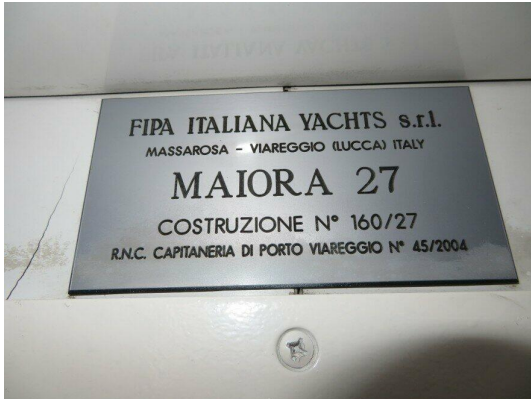
Builders plate

Build plate in engine room : 2004 (Hull in construction date).  
Flag Registration : 2006  
MCA Coding Documents : 2005  
RINA Class Survey Report : 2006  
RINA Stability Document : 2005

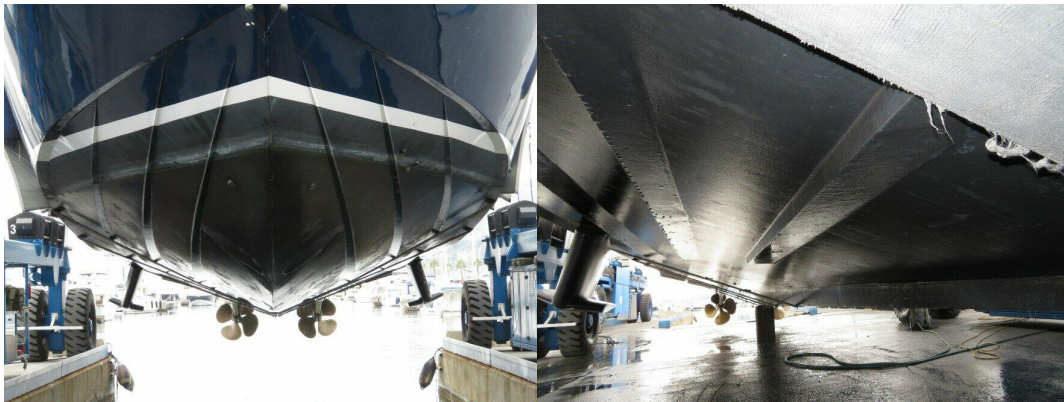
Underwater hull was found fair and was hammer sounded. Solid construction was noted there was no delamination found by hammer sounding.

Underwater hull no damages

Surfaces fair

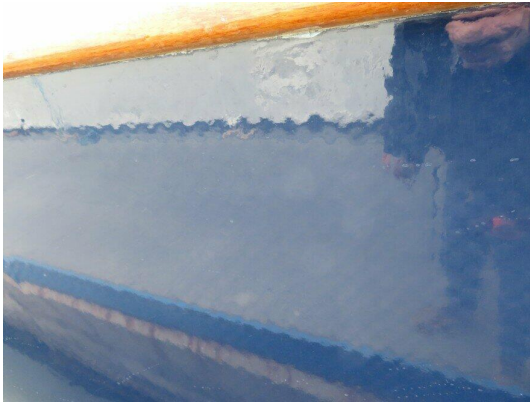
The topsides navy blue paint was not faded but the fairing underneath the paint is detaching and cracking in various areas. It was a cheap job. Therefore the yacht requires repair and paint at great expenses. No stress crazing or damages seen at the topsides which were fair.

Poor topside fairing under the paint with the laminate weave clearly visible (poor)

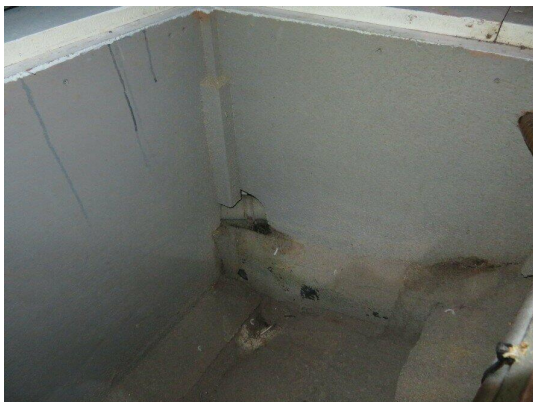
The internals were inspected via various bilge accesses and the entire structure was not inspected. Where inspected there was no damage to stiffeners or bilge separations. Part of the bilges were with spray foam insulation which is unusual as coatings cannot be maintained.

Bilge with spray foam insulation

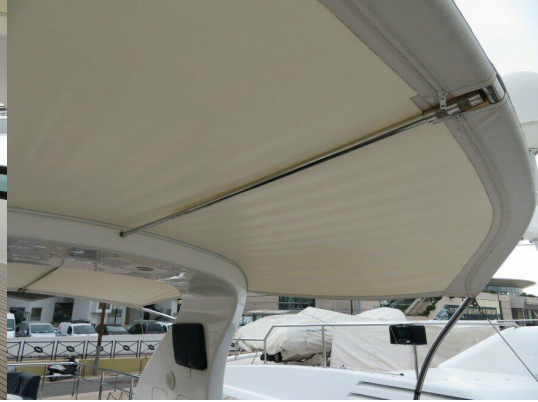
Bimini in satisfactory condition

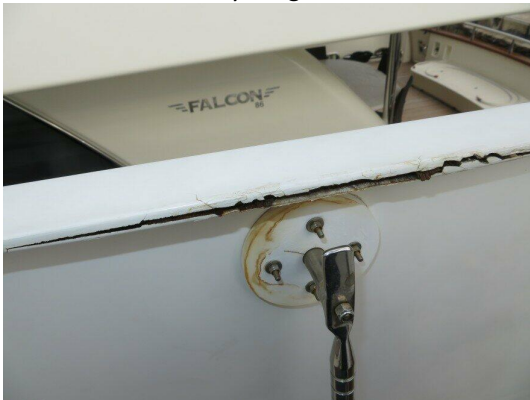
The exterior hatch from cockpit to flybridge requires fibreglass repairs. The holding up strut for the flybridge wet bar cover requires resecuring. The flybridge engine controls are with corrosion but still work.

Hatch to flybridge requires fibreglass repairs

*Suggestion : The exterior hatch from cockpit to flybridge requires fibreglass repairs.*

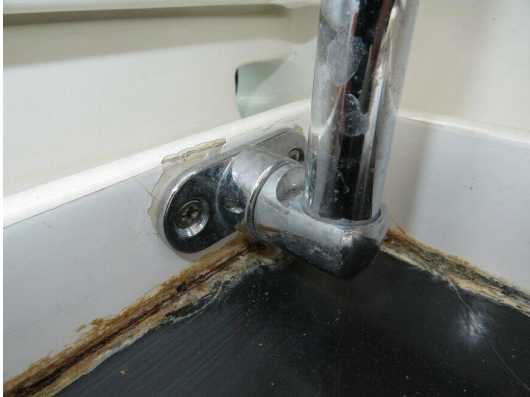
Holding up strut for wet bar to rescrew

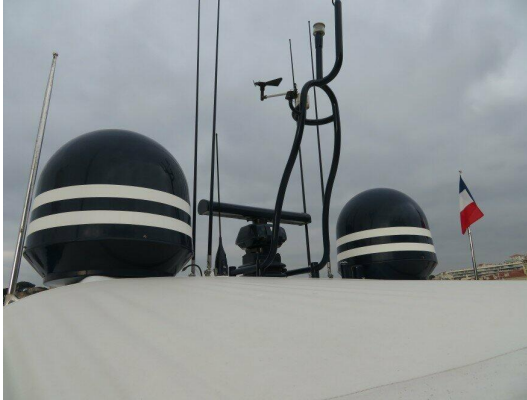
Radar arch equipment coatings intact

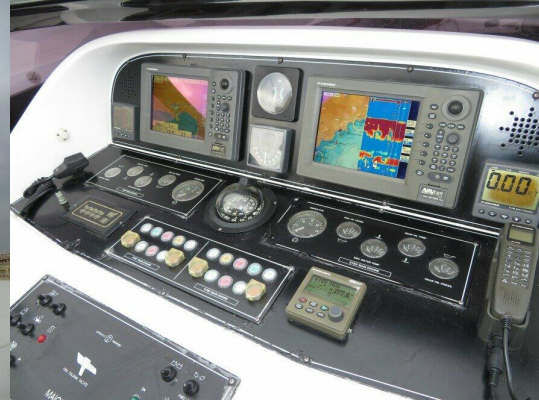
Flybridge console

The flybridge was in satisfactory condition. The flybridge console could use some refurbishment and paint.

*Suggestion : The flybridge console could use some refurbishment and paint.*

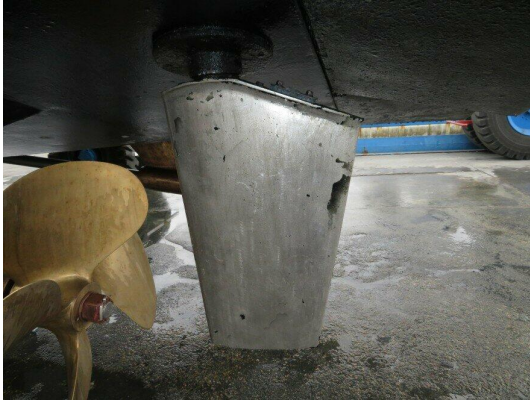
Port rudder without wastage

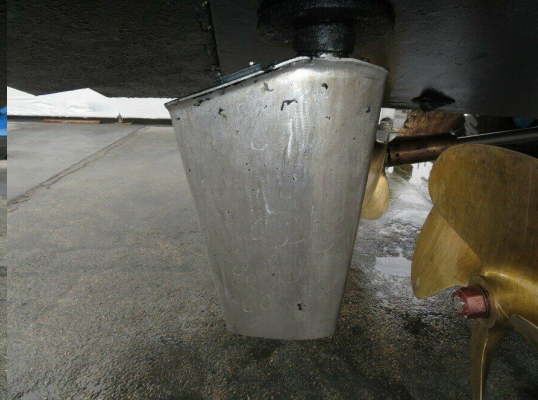
Starboard rudder without wastage

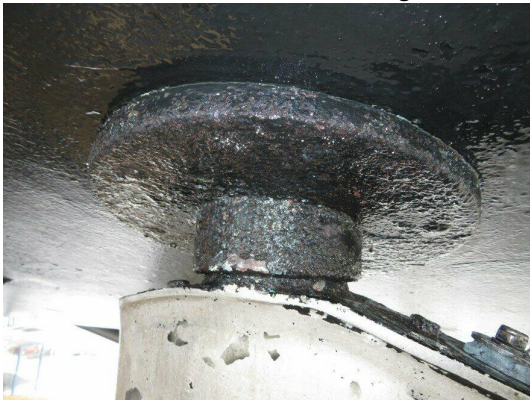
No corrosion at bearing

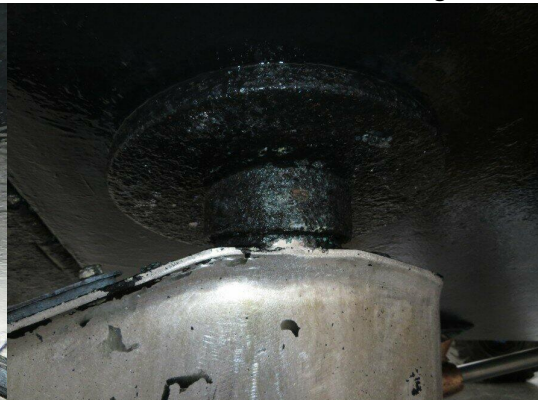
No corrosion at bearing

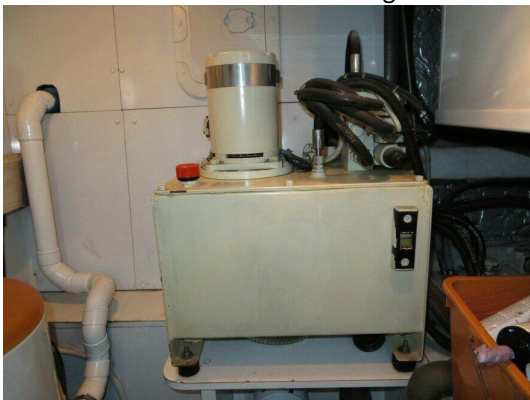
Steering hydraulic power pack no leaks

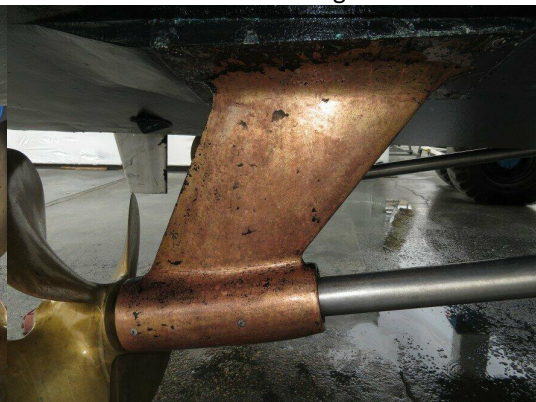
P-bracket no wastage

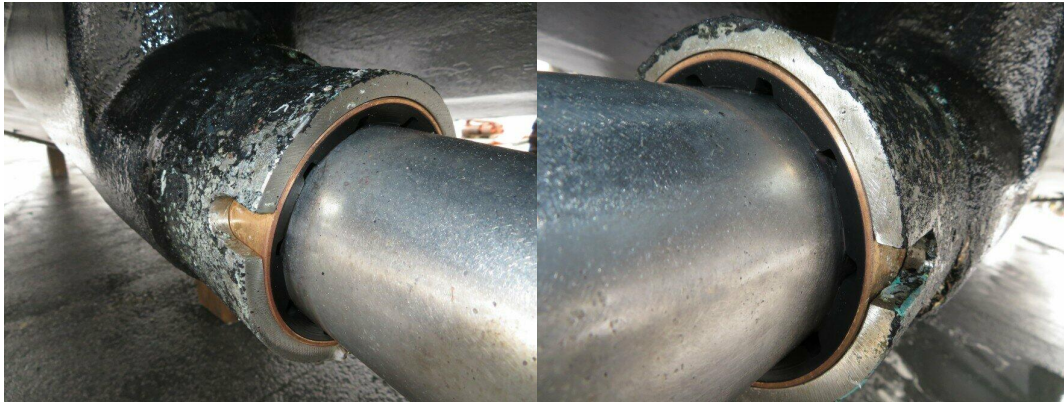
Cutlass bearings new

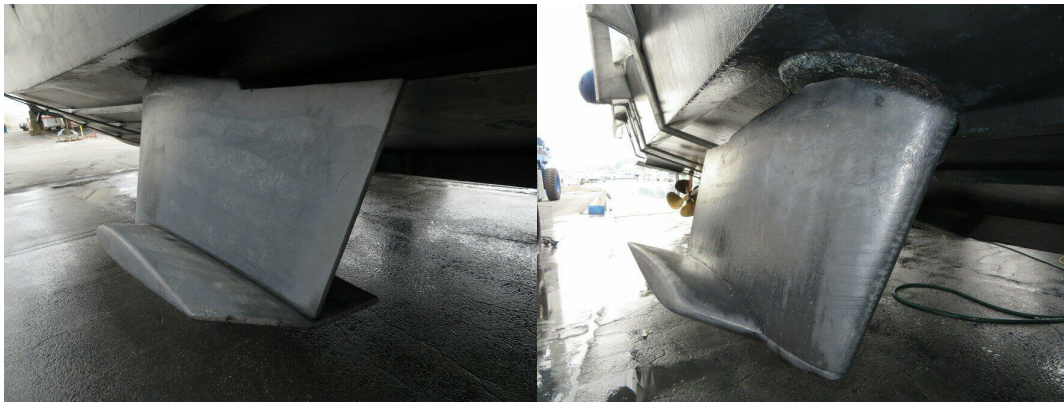
No damages to fin

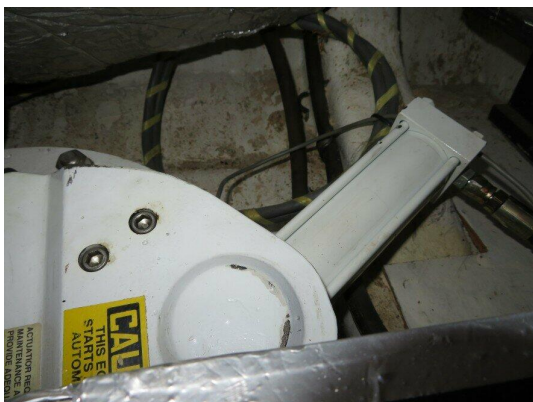
Stabiliser no corrosion

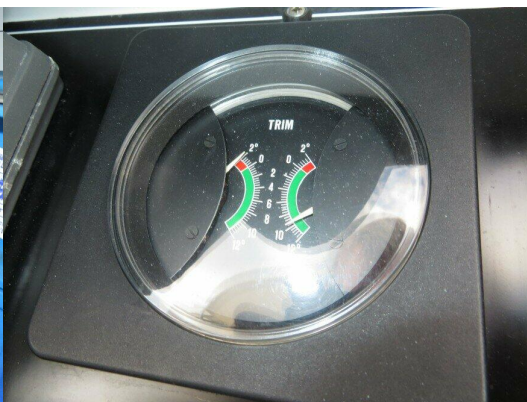
The flybridge trim tabs angle indicator the port side does not work properly.

Port flybridge trim tabs angle indicator does not work properly

*Suggestion : The flybridge trim tabs angle indicator the port side does not work properly and the gauge likely requires replacement.*

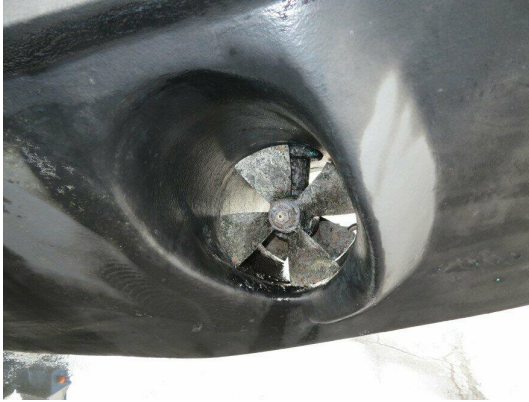
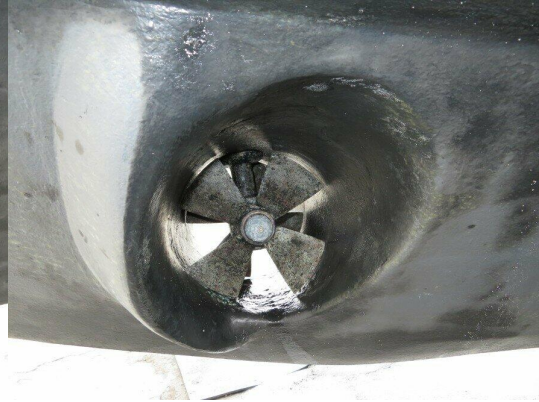
The bow thruster tunnel laminations were secure and checked with hammer sounding. The propellers were without damage. There were no leaks around the pump or corrosion.

Bow thruster tunnel secure to hull

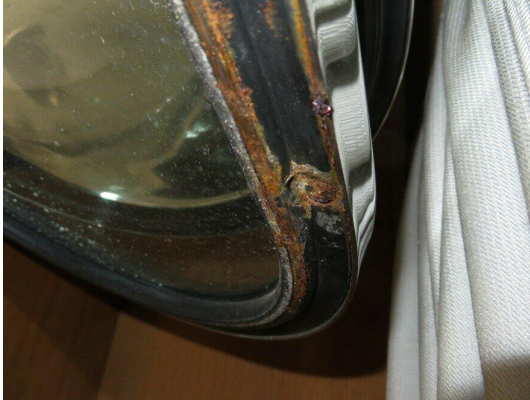
The cabin hull window seals require replacement as they are making minor leaks. It is possible the windows require rebedding but it is not sure.

Portlight seal leaks

*Suggestion : The cabin hull window (portlight) seals require replacement as they are making minor leaks. The rebedding of the window frames cannot be ruled out.*

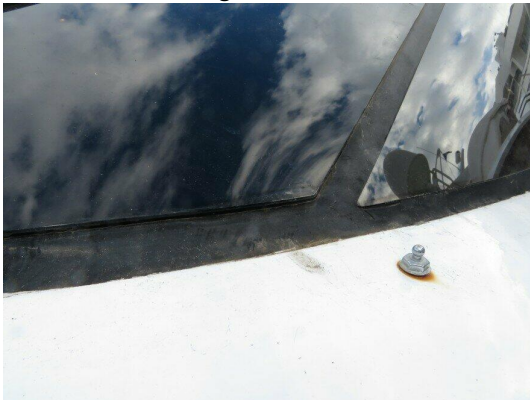
Wheelhouse window seals not deteriorated

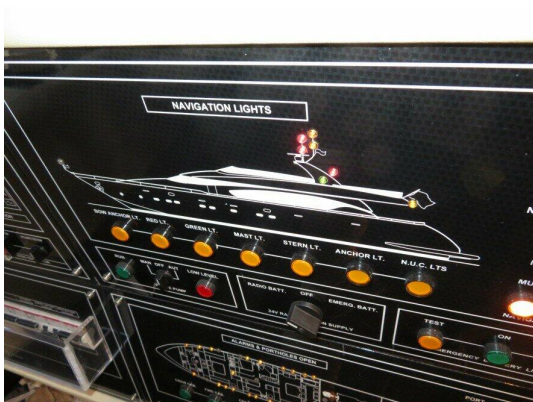
Illogical Nav light panel

*Suggestion : The navigation light panel is reversed with lights not working when lit on panel. It is illogical and could be changed by electrician.*

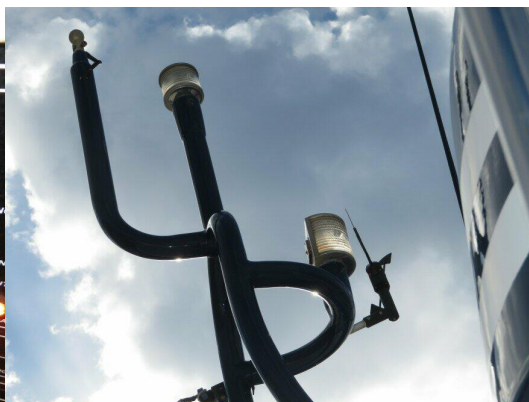
The mast navigation lights could be renewed as their lenses are sun crazed.

Mast Nav light lenses sun crazed

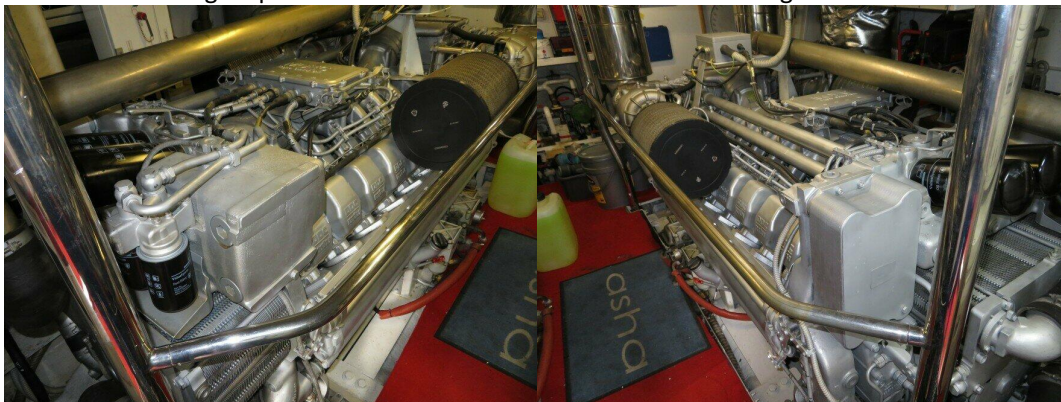
The engines were in very good condition with even no leaks under the water jacketed manifolds which are very common on this series.

Port Engine

Starboard Engine

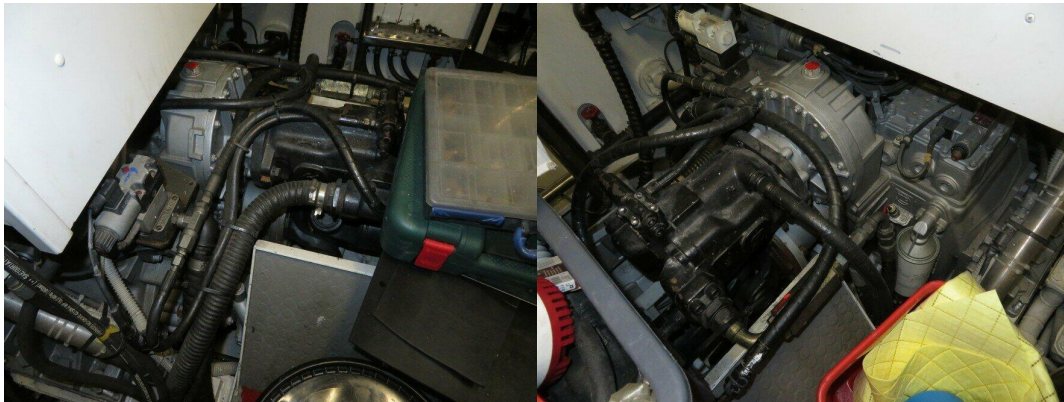
V-drives in good external condition without corrosion or leaks. No leaks from PTO pumps.

Port

Starboard

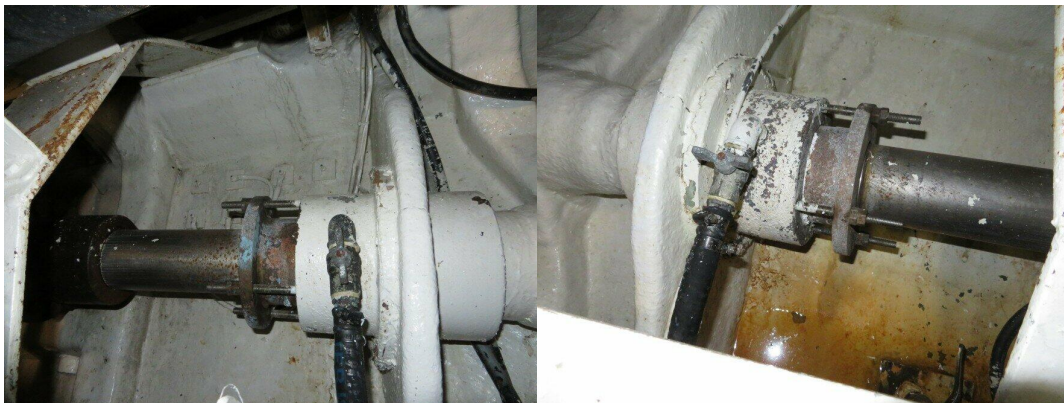
No sign of leaks from shaft seals in operation. External condition satisfactory.

Port

Starboard

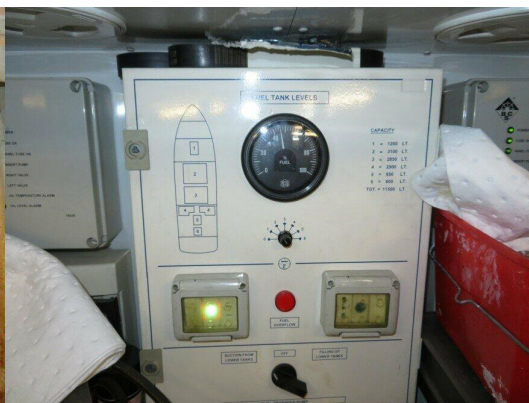
Checking fuel transfer

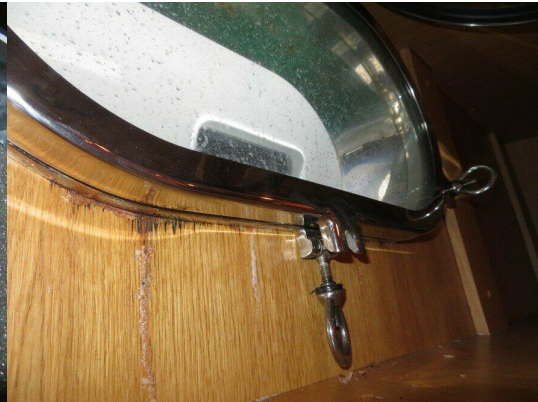
Small extent of wetting around portlights

*Suggestion : There are various minor wetting to the linings around the cabin windows and replacement of panelling there could be considered.*

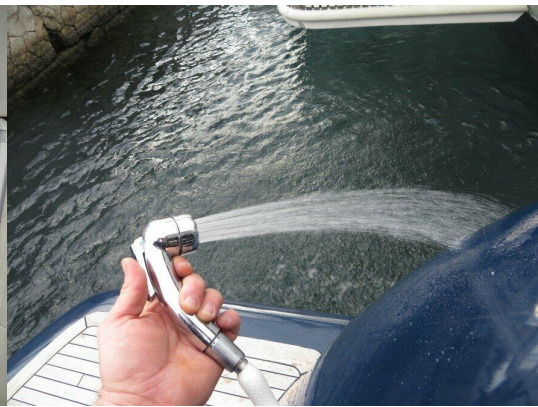
Water pressure good

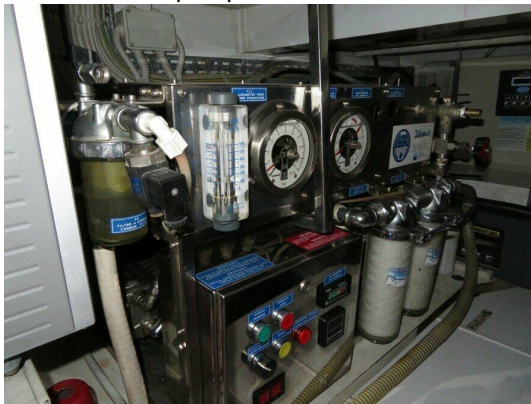
Watermaker without corrosion or leaks

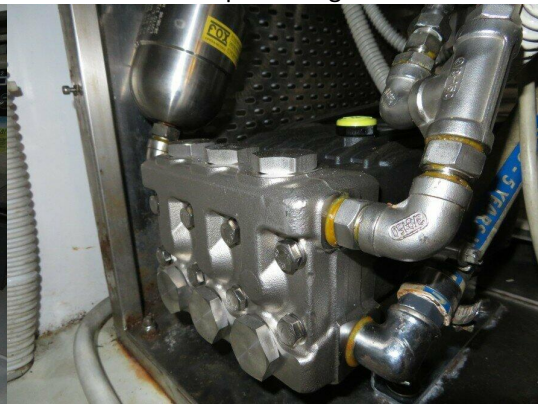
New watermaker high pressure pump

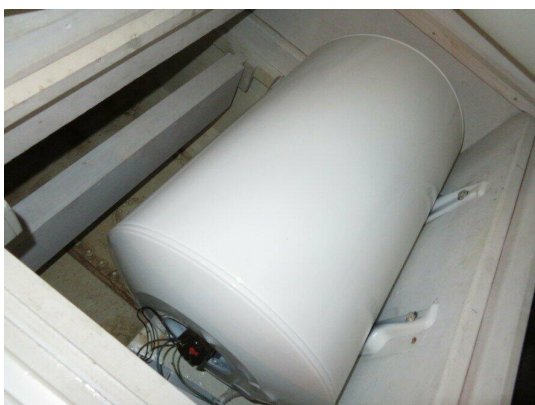
Water heater secure

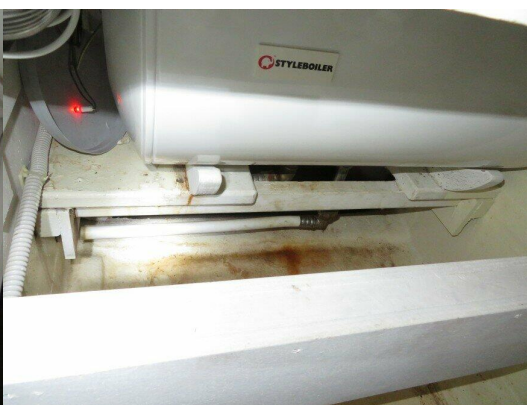
Water heater no corrosion or leaks

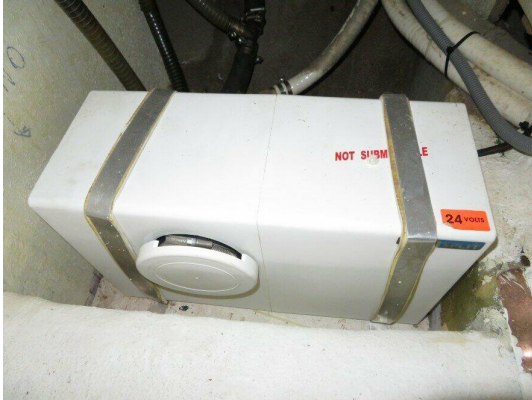
Grey water sumps externally intact and secure

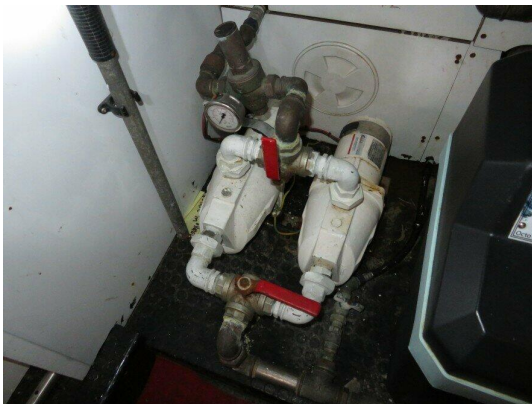
Black water pumps no leaks or corrosion

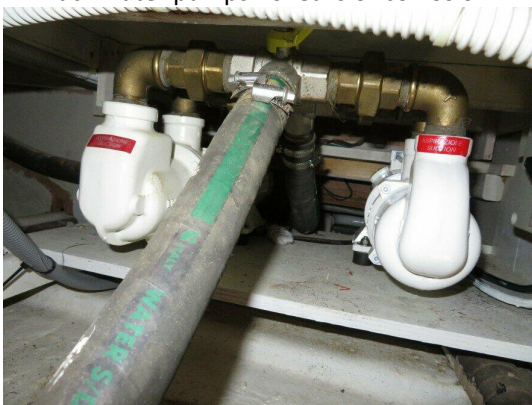
Black grey water pumps no leaks or corrosion

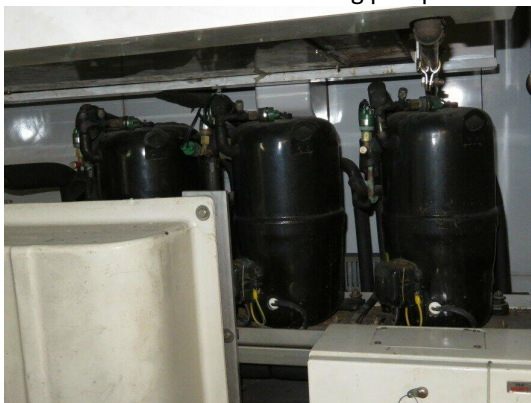
Compressors with coatings intact

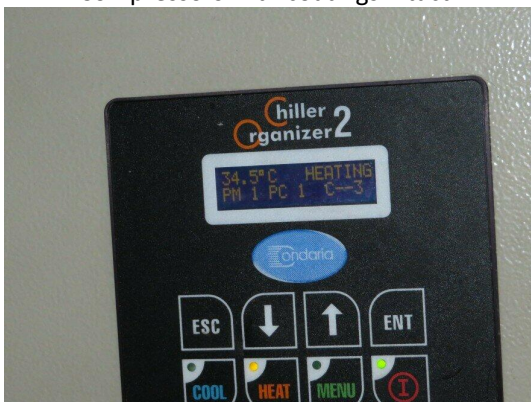
Checking airconditioning

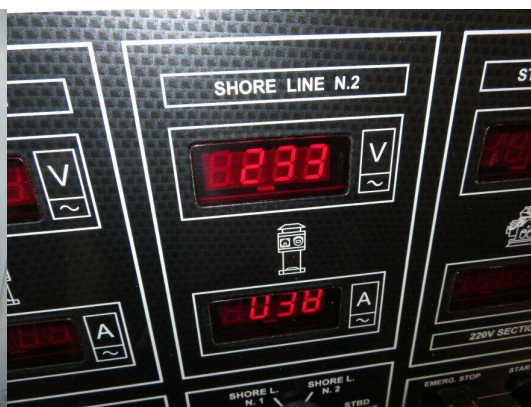
Shore power working

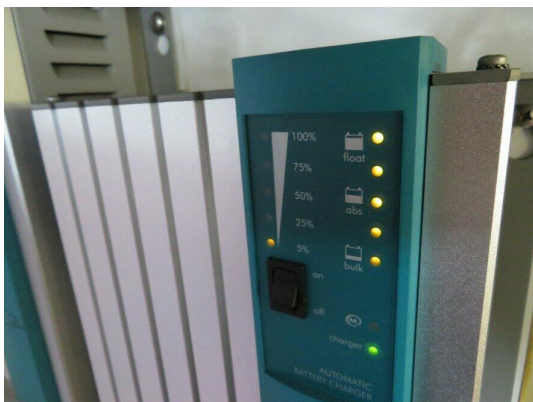
Battery charger working

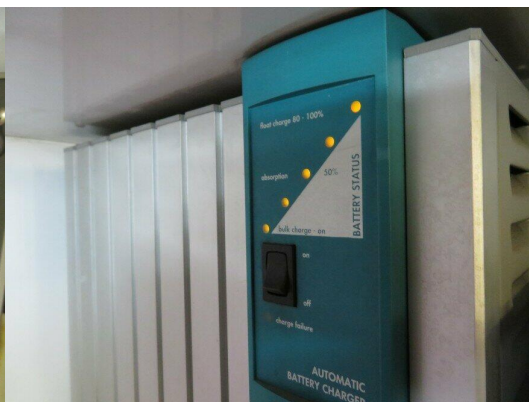
Battery charger working

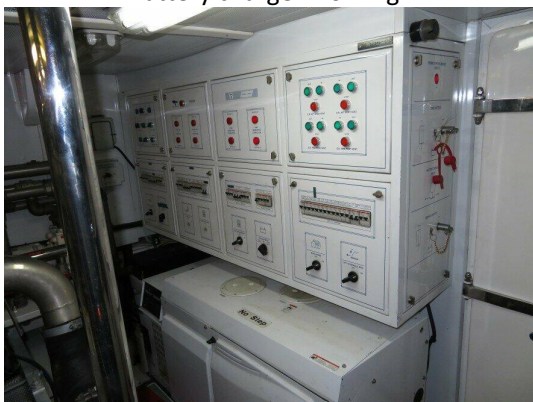
Heavy duty electrical installations

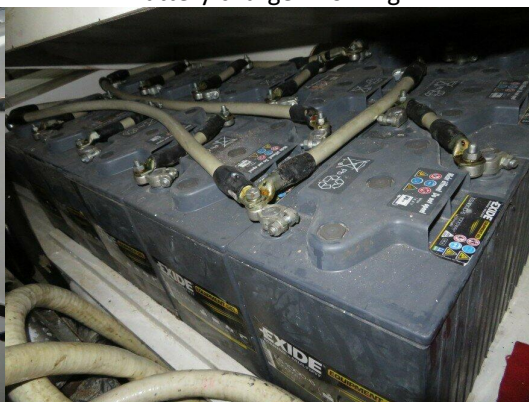
Batteries bulging

*Suggestion : Batteries are 3 or more years old and therefore replacement may be required soon. The batteries are bulging at the sides.*

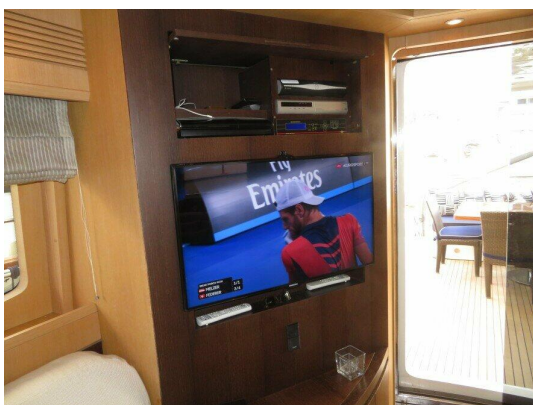
TV working

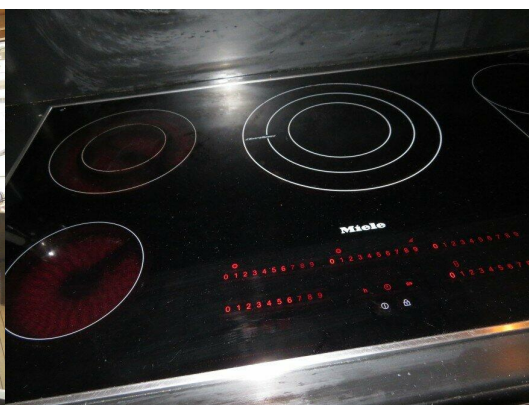
Hob working

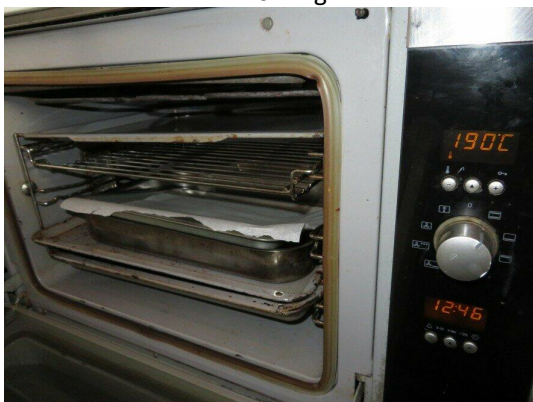
Oven working

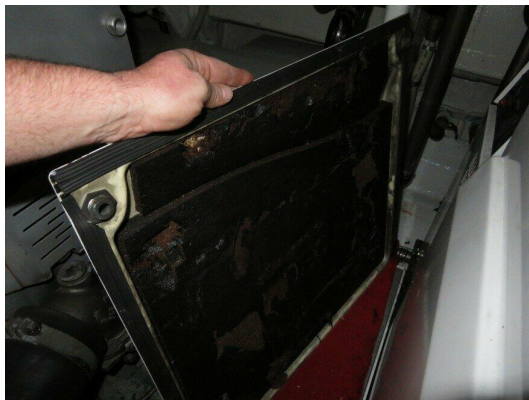
Generator soundproofing to renew

*Suggestion : The starboard generator soundproofing requires replacement.*

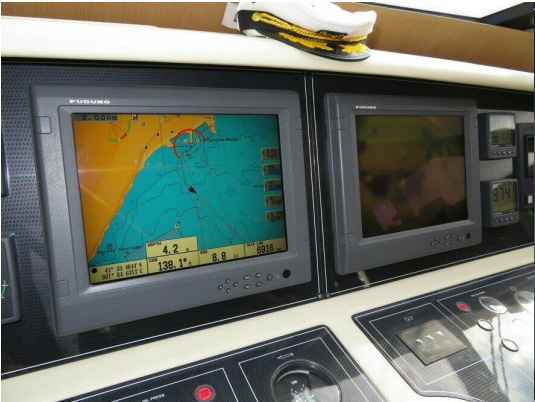
Charplotter working

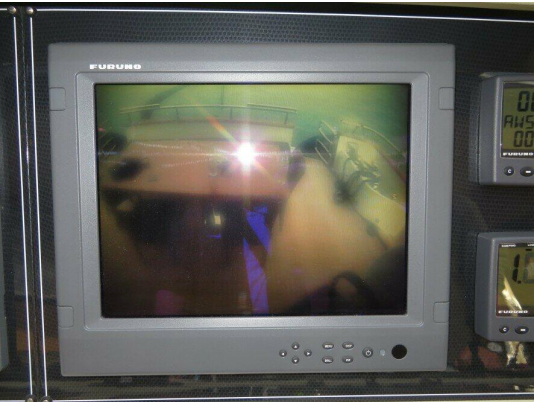
CCTV working

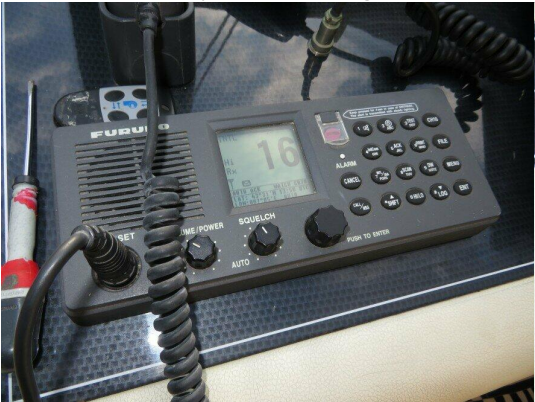
DSC VHF working

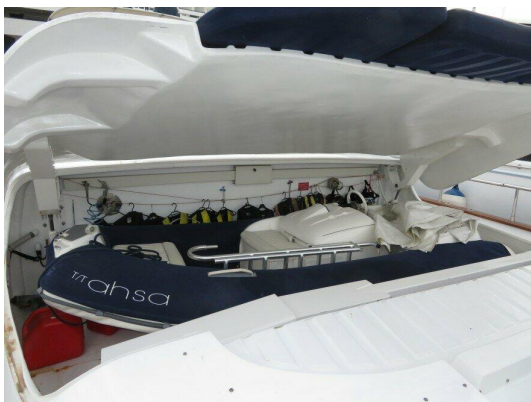
Tender external condition good

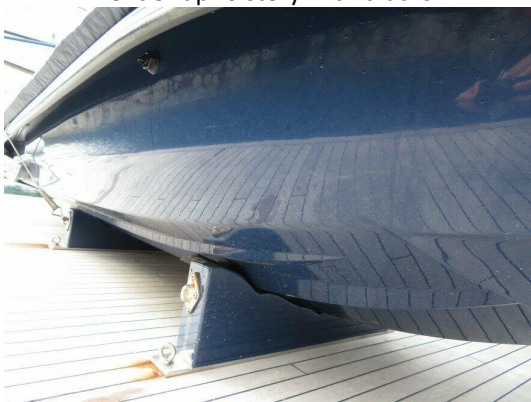
Jet ski hull without damages
